CONSERVATION INSIGHTS 2020

Lectures

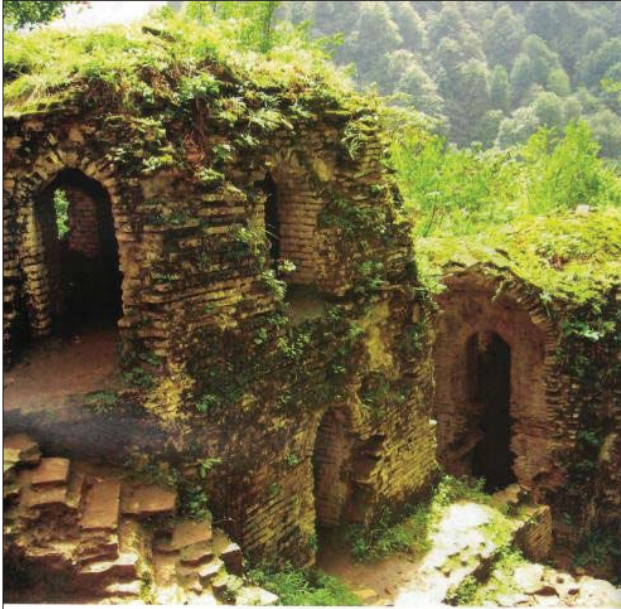
Climatic conditions and high humidity in the growth of wild plants and trees a few hundred years has been effective and is the main reason for destruction of the monument. ■

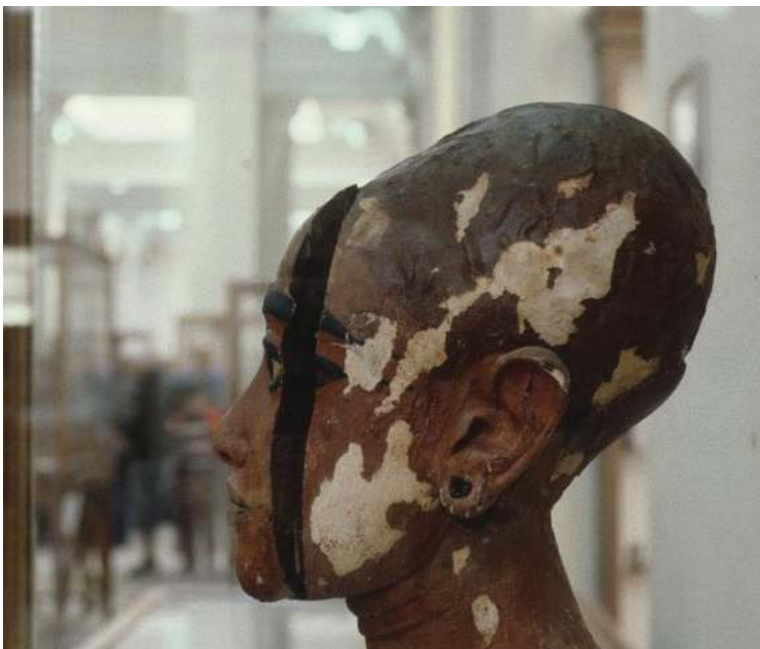
(Left): NO, nature is not responsible for this wooden polychrome head of King Tutankhamun (which was found in good condition in 1922 in the tomb in the Valley of the Kings) that has been damaged seriously in last 70 years.

In the museum, the damage is not due to climatic conditions but by human errors of museum staff who have not been able to create in the museum the climatic conditions identical to those existing in the chamber for 3300 years allowing this sculpture to reach us in a sound state.

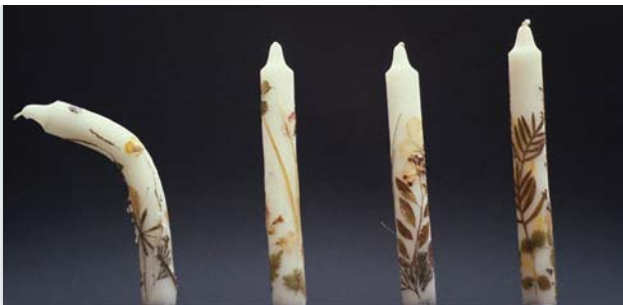
(Above): NO, it is not heat that has been bending this candle! The person responsible is the staff who had placed the candle near a radiator.

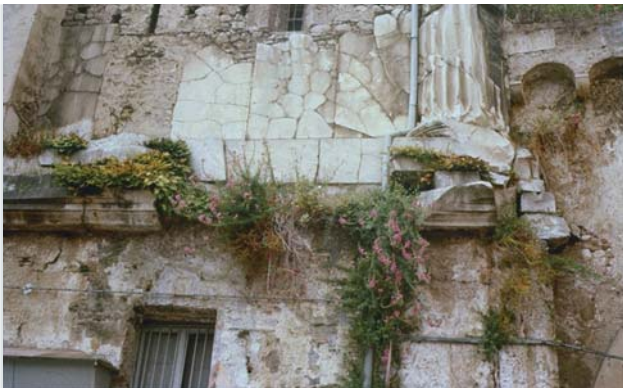
(Above): NO, it is not these lovely flower bearing plants which are breaking those roman marbles slabs but the person in charge of this archaeological site who has not done his job of regular maintenance

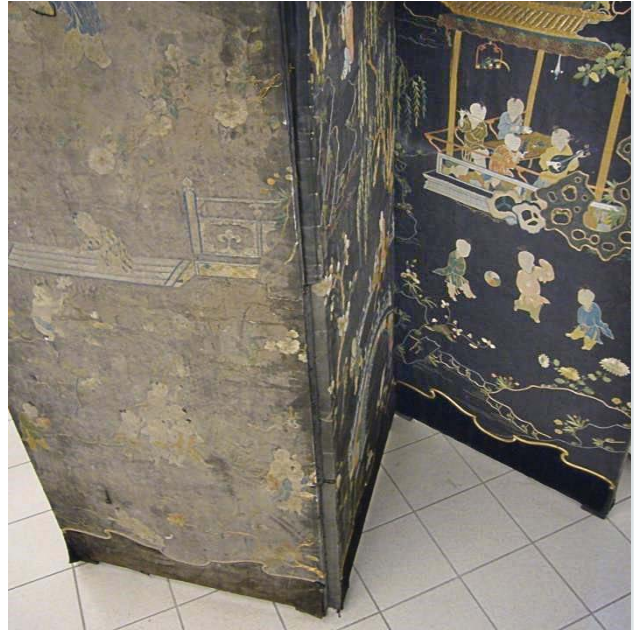
(Above): NO, dust is not responsible for the damage on this panel of paper screen. The staff or the person who had not covered it with a simple piece of newspaper (it was stored in horizontal position) is responsible.

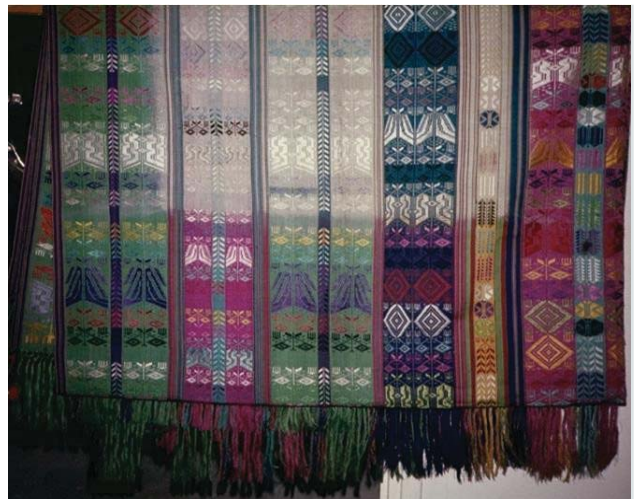
(Above): NO, it is not artificial light which has faded this textile from Madagascar, it is the human staff of the museum who have exhibited it directly under artificial fluorescent tubes with no protection during its 70 years in the museum

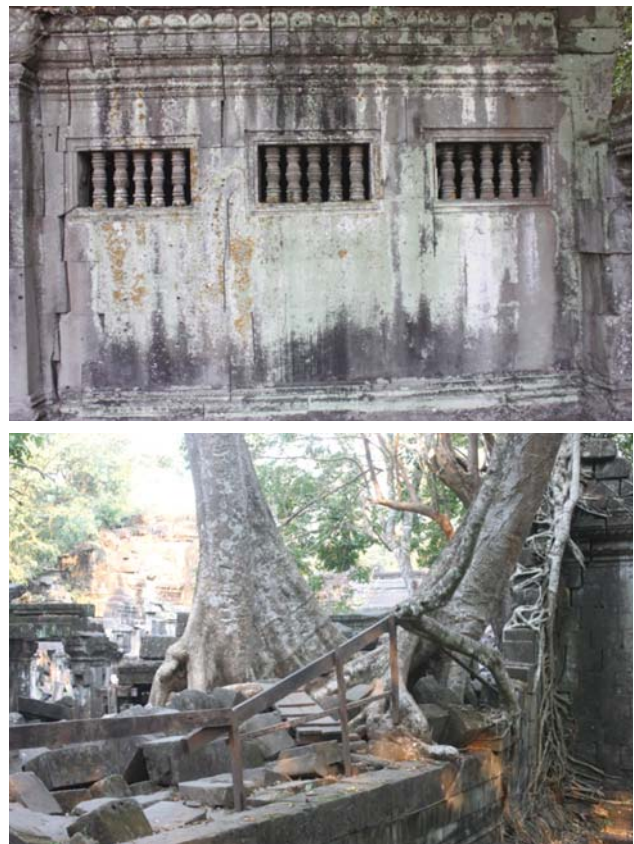
Fig 1: Angkor UNESCO site (Cambodia), biodeteriogens flora

The artefacts, ruins and monuments exposed to outdoor conditions, are affected by biological colonisation (see fig. 1). Many organisms can use the substrate only as support (i.e. phototroph organisms); however, they can favour more complex colonisation, with possible biodeterioration effects. Consequently, when the colonisation cause biological decay effects are called biodeteriogens. (Caneva et al. 2008; Cuzman et al. 2011).

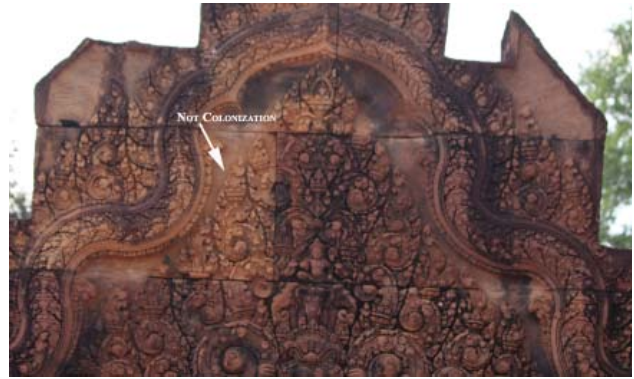
Fig. 2: Different bioreceptivity of stone, Angkor site (Cambodia)

The whole substrate properties, defined as "Bioreceptivity", contribute to biological colonisation (Guillite 1995; Miller et al. 2012) and concur to the establishment, anchorage and development of flora and/or fauna. Finally, the organisms' ability to colonise and transform a substrate is closely linked to suitable adhesion through species-specific structures (Caneva et al. 2008). Hence, in this habitat water, temperature, light, and nutrients, often operate a primary role in the colonisation of stone surfaces, limiting environmental factors for the genesis and the development of each organism (see fig. 2). As a result, the presence and the variability of potential biodeteriogens depend

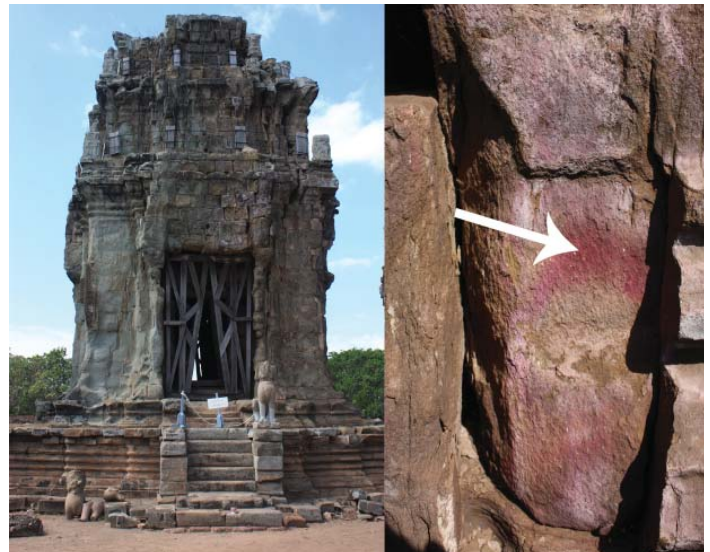
Fig 3: Phnom Krom Temple, detail of the pink encrustation

An example is the case of study in the Angkor archaeological area (see Fig. 3), wherein on Phnom Krom temple surface occurs an unusual pink layer (Tescari et al. 2016).

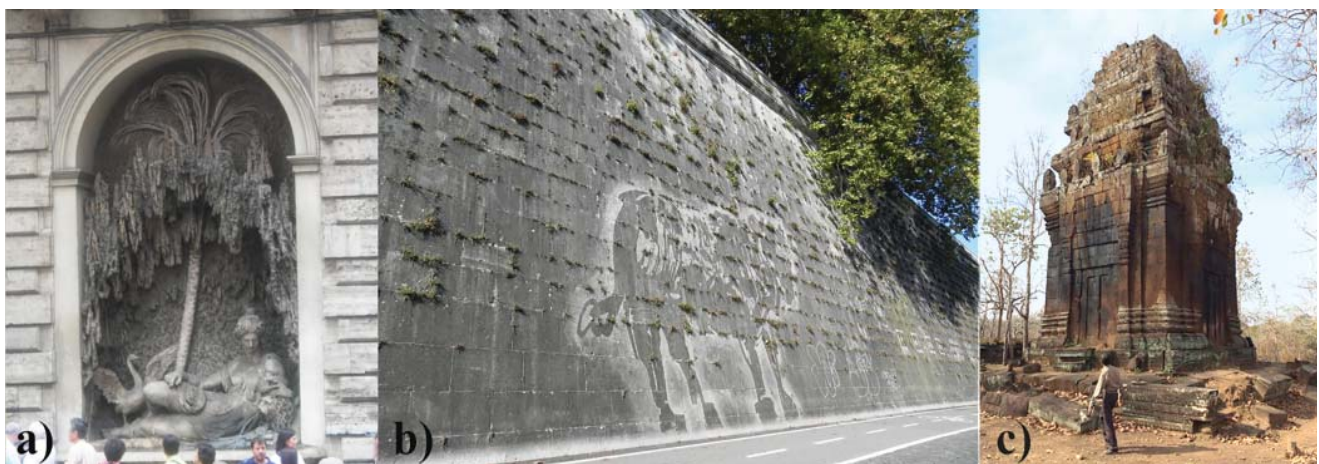
Fig. 7: The different origin for the black/grey patina. a) The four fountain "Giunone" (Rome): car pollution; b) Tiber embankment (Rome): biological colonisation; c) Khmau temple (Cambodia): geological processes

Not always microorganism takes characteristic shape on the art objects surface, which is simple to confuse biodeterioration with chemical and physical phenomena (Caneva et al. 2014). For example, a geological process, or a pollution situation, or a biological attack can be all the possible solution to clarify the presence of a

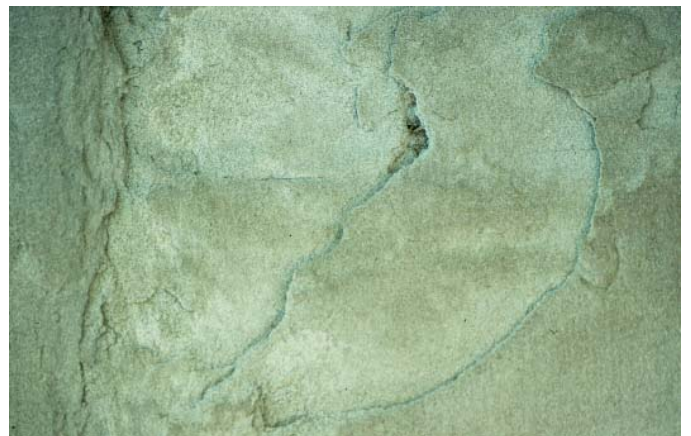
Fig. 2: Multiple layers of delamination in 1998

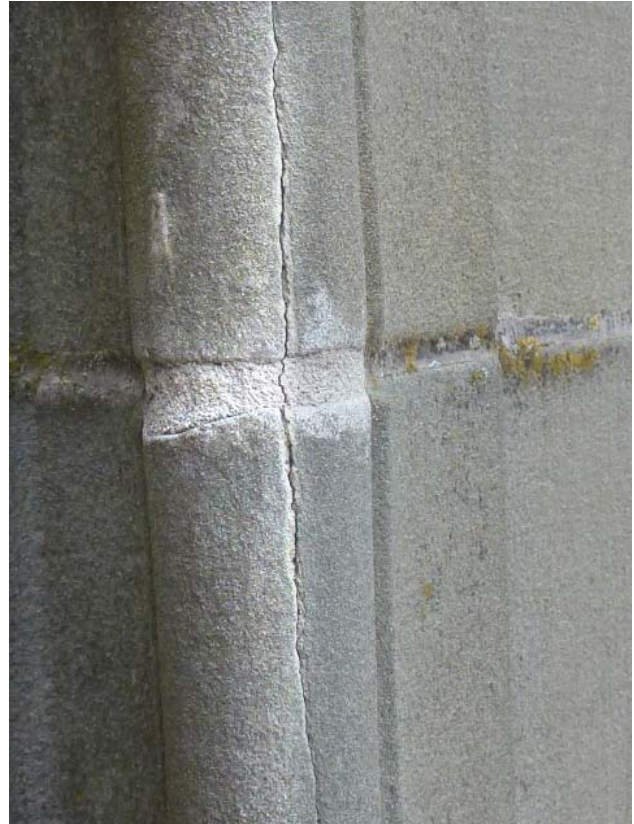
Fig. 4: Newly opened gaps in 2013

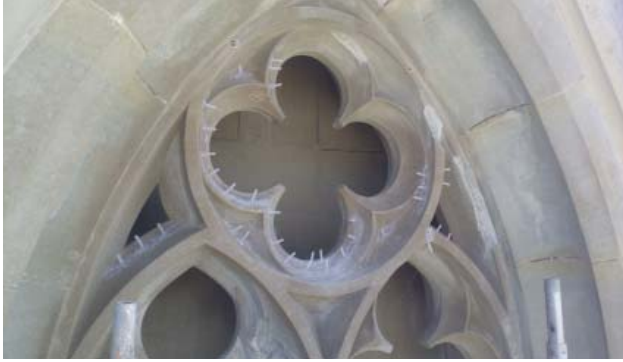
Fig. 5: Preparation for consolidation and grouting

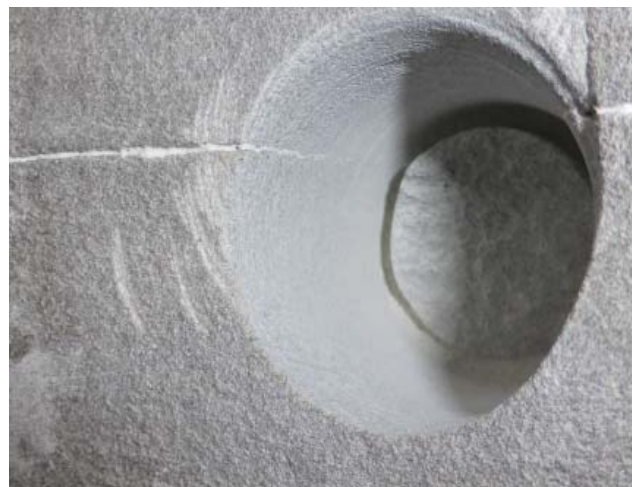
Fig. 6: Gap refilled with silicic-stone-adhesive. Diameter of hole 28 mm.

Samples were made using this technique and evaluated by extracting drill cores. The cracks showed to be filled to a point where a crack could barely be seen with the naked eye. This procedure of consolidation and grouting did not turn out to be more laborious than the originally intended process.

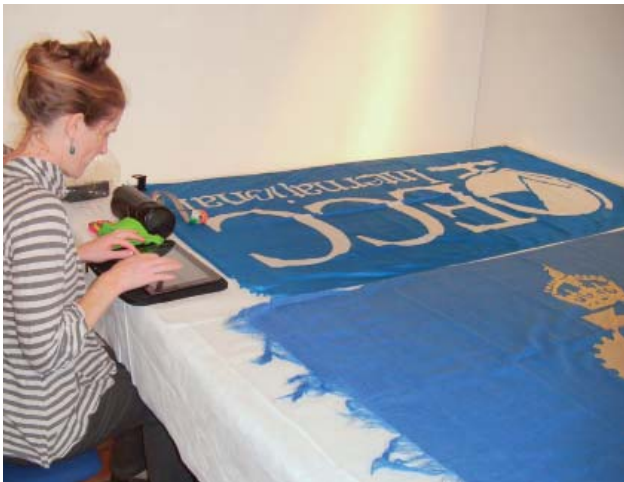
Fig. 11: Condition assessment of a China Clay industrial flag, Bodmin surgery

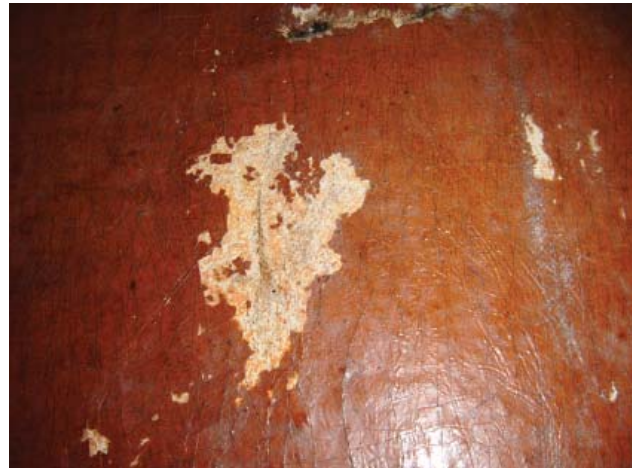
Fig. 15: Surface damage – loss of paint layer from being rolled during working life

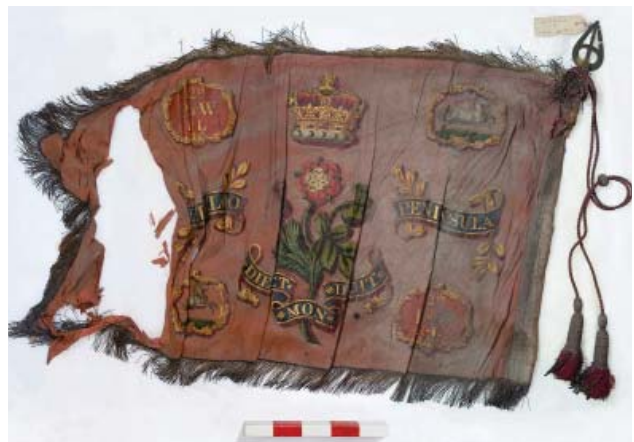
Fig. 17: Chemical deterioration – embrittled silk and tarnished metal threads

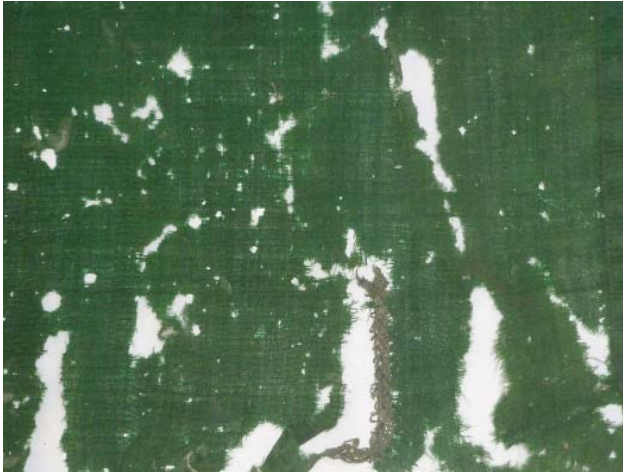
Fig. 18: Biological deterioration -clothes moth damage to wool bunting ground

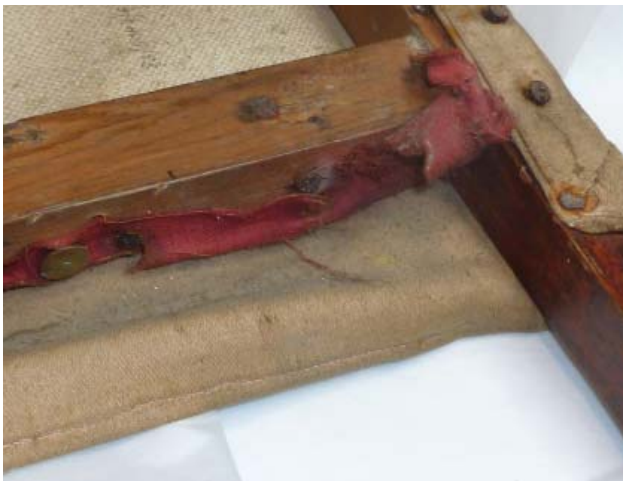
Fig. 19: Accretions - dust and encrusted corrosion products

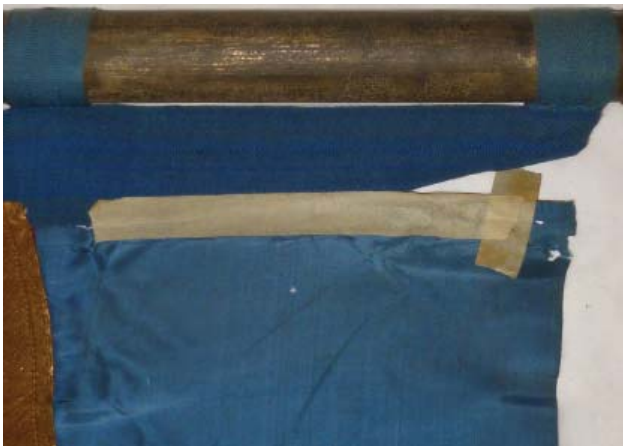
Fig. 20: Damaging repairs - adhesive tapes used on a painted silk banner

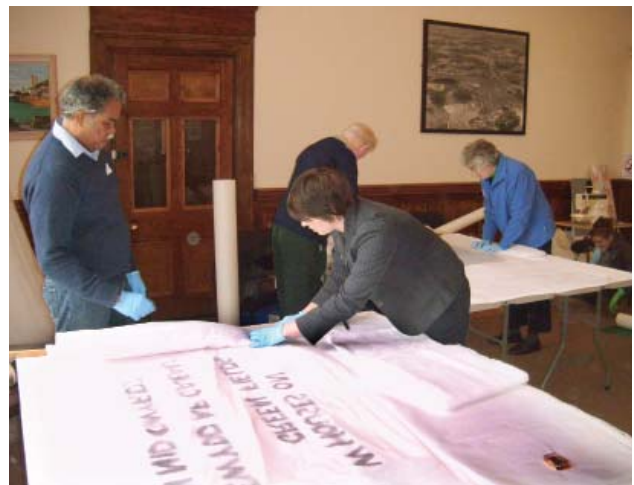
Fig. 21: Workshop participants preparing to roll banners

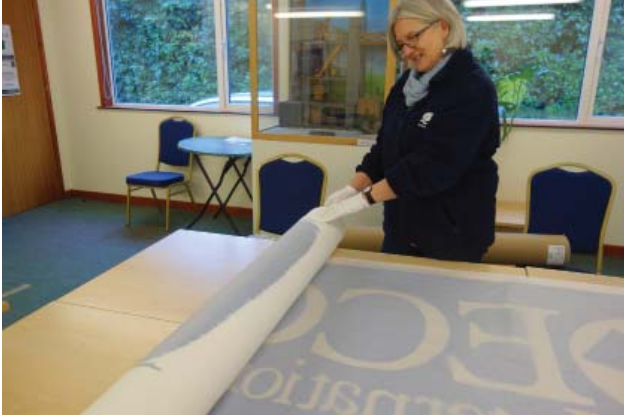
Fig. 25: Rolling a flag between two layers of unbuffered acid free tissue, site visit to Wheal Martyn China Clay Museum

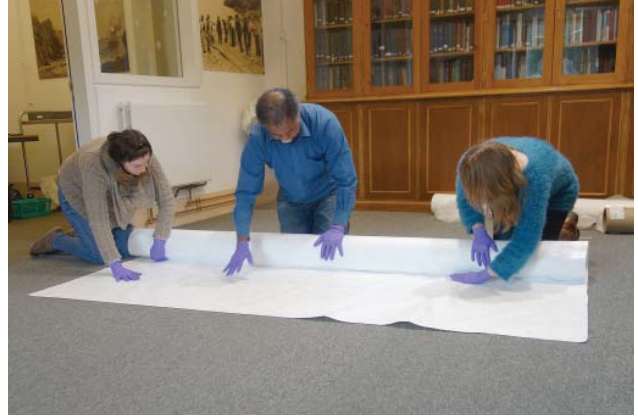
Fig. 28: Applying the Tyvek dustcover to a rolled flag, Porthcurno Telegraph Museum

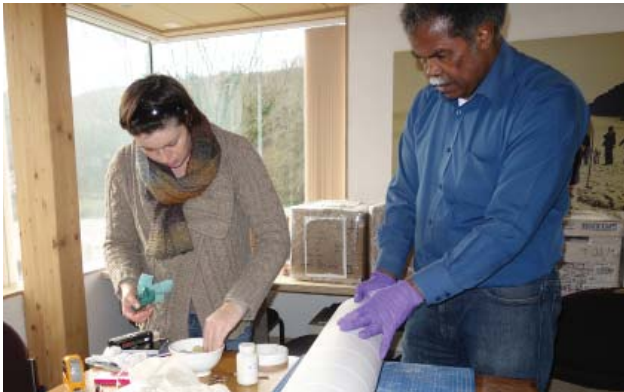
Fig. 27: Extending an acid-free tube to roll a large flag, Porthcurno Telegraph Museum site visit

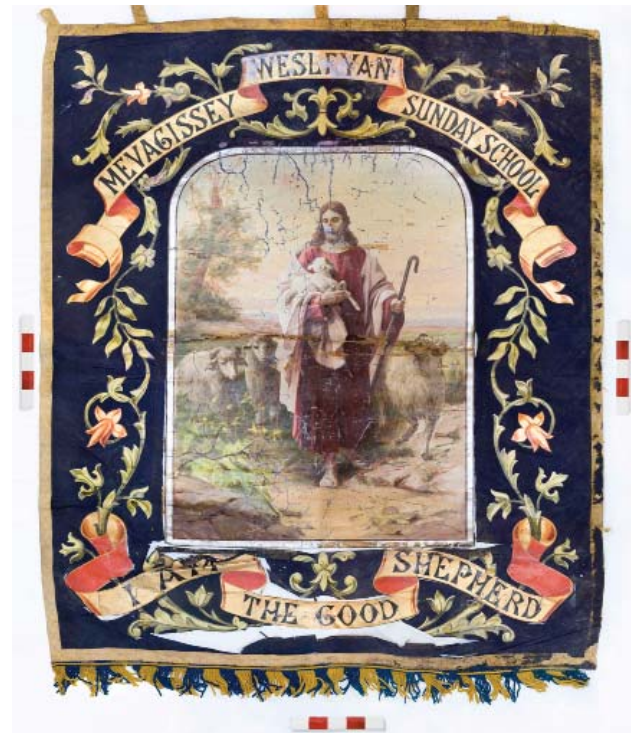
Fig. 31: Mevagissey Wesleyan Sunday School banner, obverse before conservation

The double-sided, professionally painted, navy silk banner depicts Christ with sheep in large central areas on each face, painted in greater detail on face 1, with inscriptions and foliage motif borders. The banner is trimmed with yellow silk and cotton braid, also used for hanging tabs along the top edge. It measures 1.94 x 1.52m. Fragments of paper which had been adhered over the especially damaged inscription 'Wesleyan', could date from the

The banner had severe splits around the borders of the central painted area, and a full width horizontal split across the centre. There was loss to the border, hanging tabs and fringing, and generalised creasing. There was extensive damage to the paint layer from flexing, failed adhesive tape repairs and damp, with loss, abrasion and staining. Some structural damage was due to severe black fungal infestations, especially on the hygroscopic braid; and webbing clothes moth (*Tineola bisselliella*) damage to the wool fringing. Further accretions included vegetable matter, dust and peeling adhesive tape. Various adhesive tapes had been used across the splits and were failing, having deposited thick, discoloured and embrittled adhesive residue onto the silk and painted surfaces.

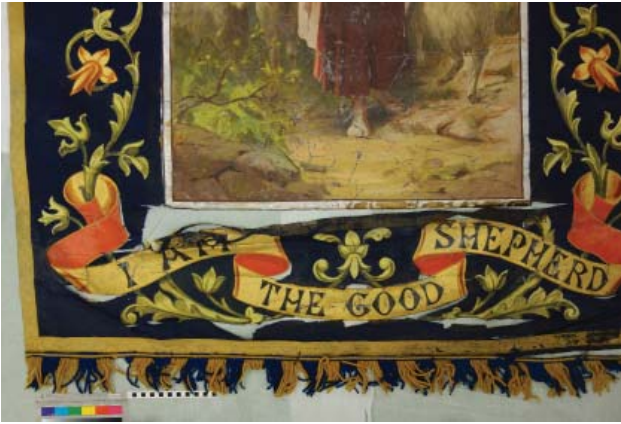
Fig. 33: Obverse bottom left before conservation - splits, loss, adhesive tape damage, paint loss

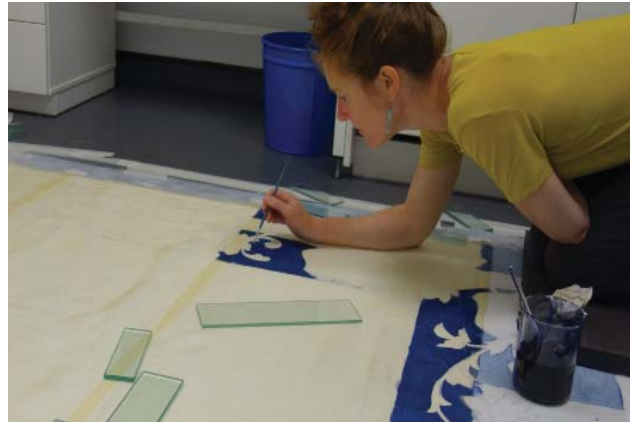
Fig. 36: Painting dyed silk crepline with dye paste to support reverse

Heavyweight silk habutai and fine nylon bobbin net were dyed with Huntsman Lanaset (1:2 metal complex and reactive) dyes to colour-match the brocade ribbon border and to match the navy ground. In order to fully support the areas of damage without obscuring the painted areas on Side 2 of the banner a painted semi-transparent support was prepared. Silk crepe-line was dyed to blend with the yellow/gold/cream of the painted areas. The outline of the painted areas was traced onto 'Melinex' (polyester film) which was then placed face down over white paper and covered with polyethylene. The dyed silk crepe-line was placed over this and painted dark blue in the areas corresponding to the ground with a 0.25% Lanaset dye and 3% sodium carboxymethyl cellulose mixture, as described by Zagorska-Thomas (2009).

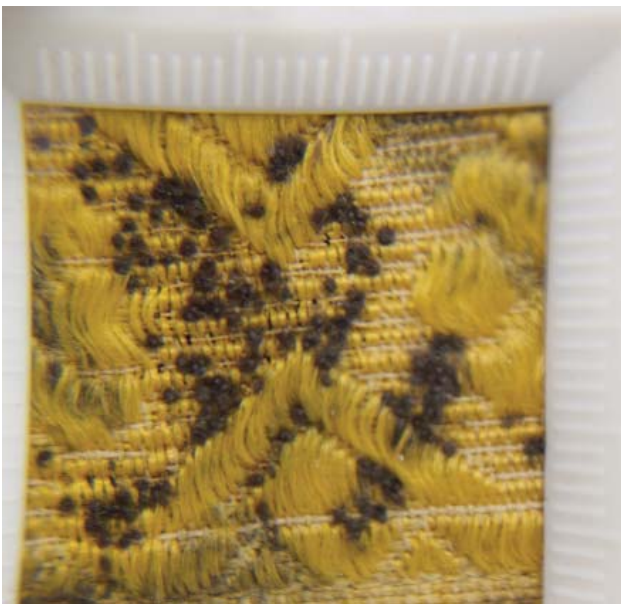
Fig. 34: Braid border with fungal colonies

The fungal debris was removed in a quarantine room using a HEPA (high efficiency particulate air) filter vacuum and artists' brushes, with the conservator wearing a FFP3 half mask respirator. The banner was then taken to the textile conservation laboratory for further treatment. The banner textiles were cleaned using Smoke Sponge (vulcanized natural rubber cleaning sponge) to remove more ingrained soiling.

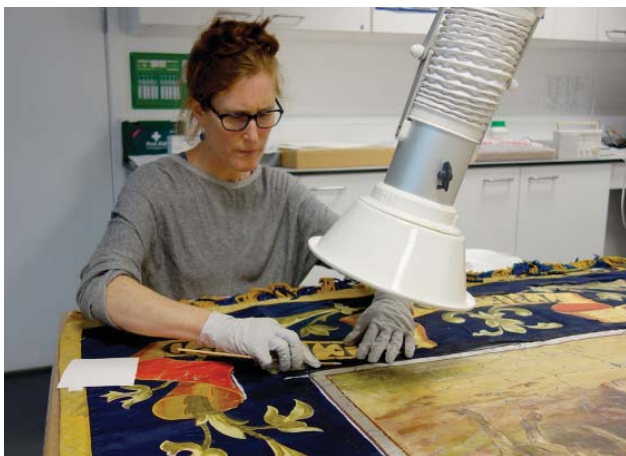
Fig. 35: Removing adhesive residue

Before treatment of the painted areas, the Paintings Conservator made a detailed inspection of the banner using ultra violet (UV) light, raking light, and the microscope. Loose adhesive tape was mechanically removed. Other remnants of adhesive residue were removed using acetone. The painted surface was then cleaned using swabs of saliva, cleared with swabs of deionised water. This removed a very thick, black surface dirt. Paint losses were consolidated using 10% w/v Aquazol 200 (Poly (2-ethyl-2-oxazoline)) dissolved in deionised water.

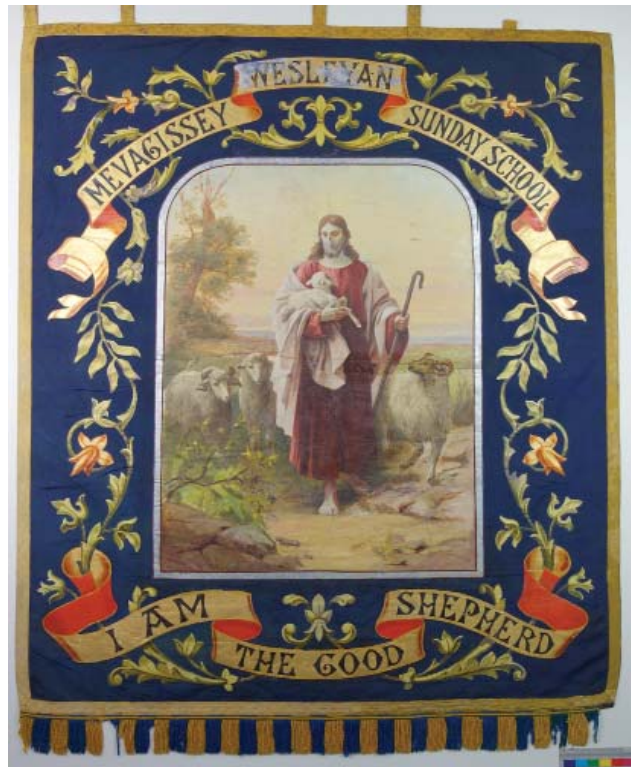
(Right) Fig. 38: Mevaggissey Wesleyan Sunday School Banner obverse after conservation

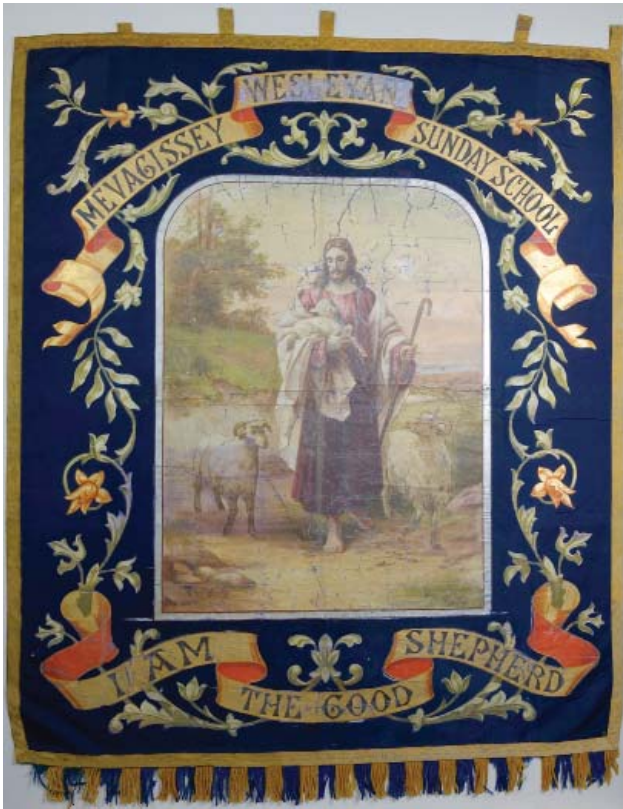
Fig. 39: Mevagissey Wesleyan Sunday School Banner reverse after conservation

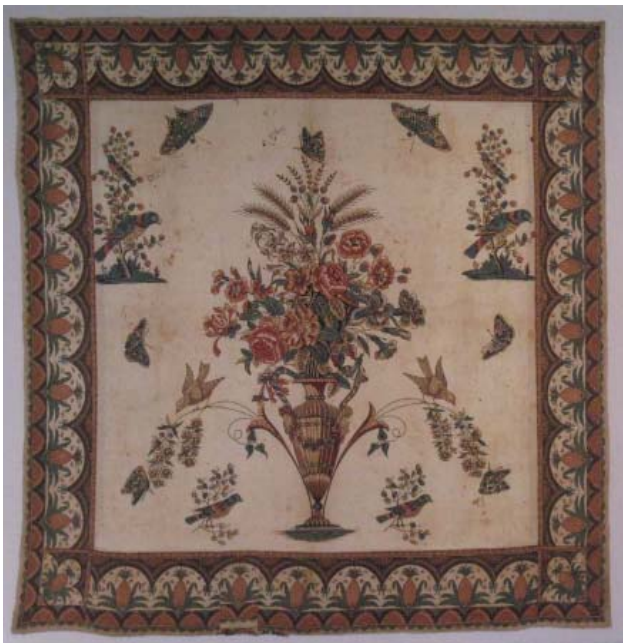
Fig. 1: Textile attributed to John Hewson. Block-printed plain weave cotton. 1780-1810. Private collection

The first among these case studies is a John Hewson Textile that Caring for textiles treated in 2010 (Figure 1). A young private client brought in the studio and was very excited to care for her heirloom piece, as she is a descendant of John Hewson. John Hewson was a prolific American textile artist during the late 18th century. Born in London and trained in a cotton-printing factory, he moved to the United States and set up a calico printing company of

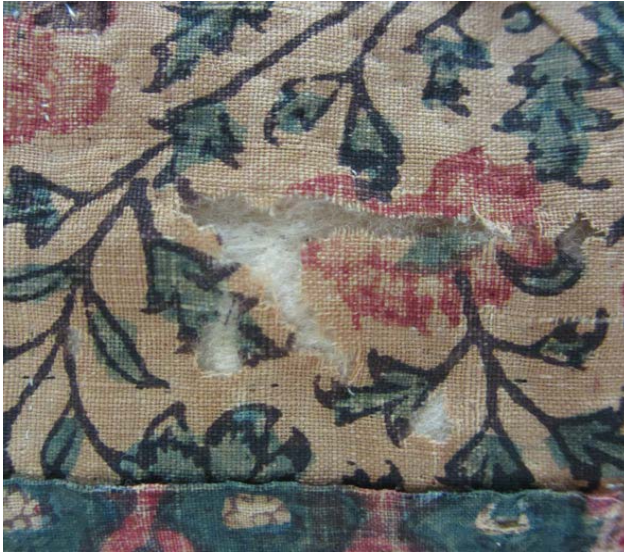
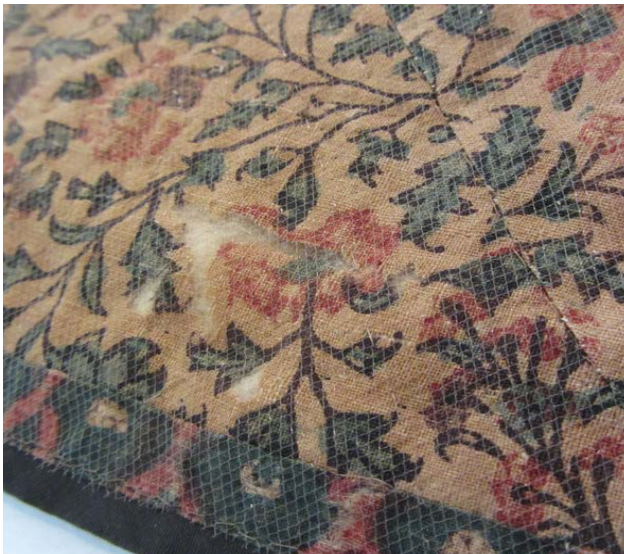
Fig. 4: Before and after treatment, fine nylon netting is applied to encapsulate and protect areas of loss

the damaged/split/torn and holed areas on the face of the textile. The technique to preserve these areas was the application of sheer beige polyester netting, in a dyed shade close to the color tone of the textile. Because of the sheer quality of the netting, it will only minimally mask the clarity of the patterns. It is not noticeable from a distance and will effectively support damages. This netting was attached by hand with fine back-stitching and Skala, a mono filament polyester thread in 15 areas of the kalamkari. In many of these areas of application, we were able to use lines of the quilting pattern to further disguise our treatments and stitching (Figure 4). 44 other areas throughout the pieces did not require such encompassing treatment

but were carefully repaired using fine hand stitching and Skala thread to draw splits and tears back together. After treatment it, was stable enough to be mounted for display.

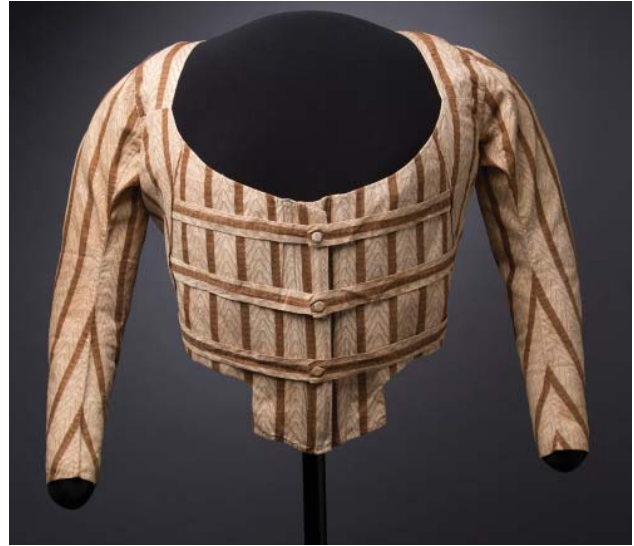
*Fig. 5: Bodice. Block printed cotton. 1790-1800. (W-1525)
Photo © George Washington's Mount Vernon*

In 2013, Caring for Textiles conserved and prepared this bodice worn by Martha Washington for display at Mount Vernon. It is dated to the late 18th century and made from a cream colored cotton with a brown and pink block-print pattern, and lined with plain cream-colored linen (Figure 5). There were many areas of damage throughout which required

stabilization, especially along the vertical brown stripes which were opening to show the linen lining beneath. All areas of damage were stabilized using overlays of fine monofilament nylon net. The sheer net allows for visibility of the printed fabric, and will best protect all the damages from developing overtime (Figure 6). Part of the treatment was mounting on a customized mannequin for display. Mounting a fragile printed garment can be very challenging, the wrong tug, no matter how gentle can potentially create new splits in weak areas that are not visible to the eye.

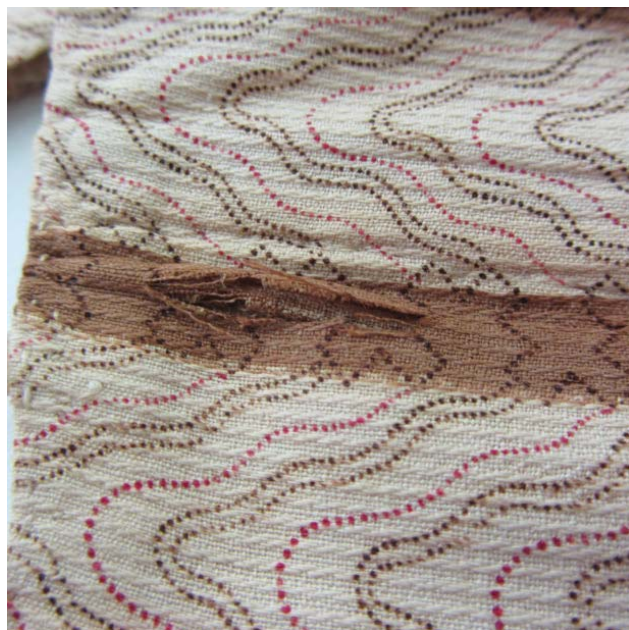
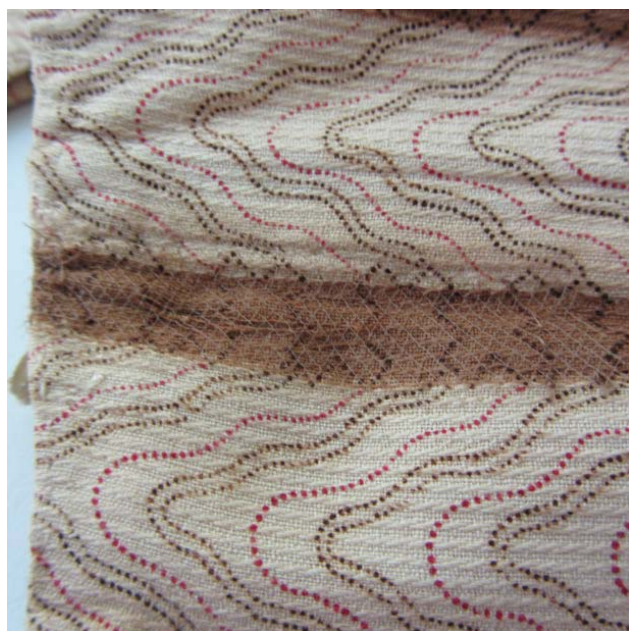
Fig. 6: Before and after treatment, fine nylon netting is applied to encapsulate and protect areas of loss

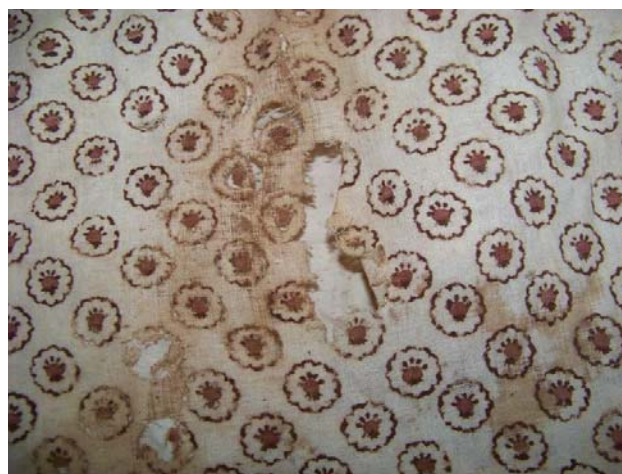
Fig. 8: Examples of damages and previous repairs on the banyan

a garment that was very well used and loved. There are scattered stains and foxing throughout. It also of course, has many damages throughout, many are clearly due to the burn out of the print, areas of complete loss where the print is missing or where new areas of loss are beginning. It is unknown whether or not this printed cotton was imported from India but it is visually similar to other floral motifs produced there for English and American market.

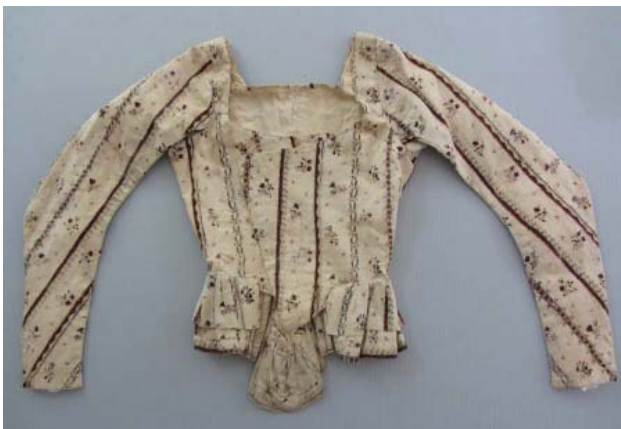
Fig. 9: Jacket. Block printed cotton. 1790s. Private collection

Mary Doering, notable collector of 18th century costume, graciously loaned this lovely jacket dated to the 1790's to us for research (Figure 9). We were fortunate to examine it in person, the jacket is an excellent case study of repair techniques over time. Caring for Textiles examined this jacket in 2016, we were able to take microscopic photos of many of the damaged "burn out areas" so we could understand the edges up close. The jacket is made from a lovely lightweight cotton with a striped and floral printed motif, it is lined in linen. Here are some of the image, really good examples of this type of burn out damage up close. On the left, you can see the individual threads and their breaking points. On the right you can see an area where an area of the brown printed motif is gone. More good examples, the left, the area of brown is actively degrading, there is a possibility of full loss of the area in the

future. In the right image, you can see that the right spring is lost, but the others still remain.

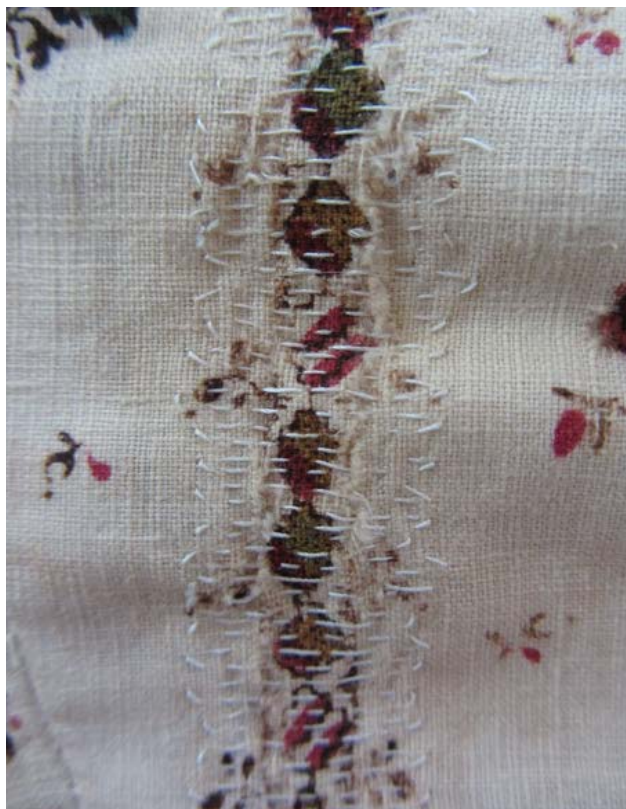
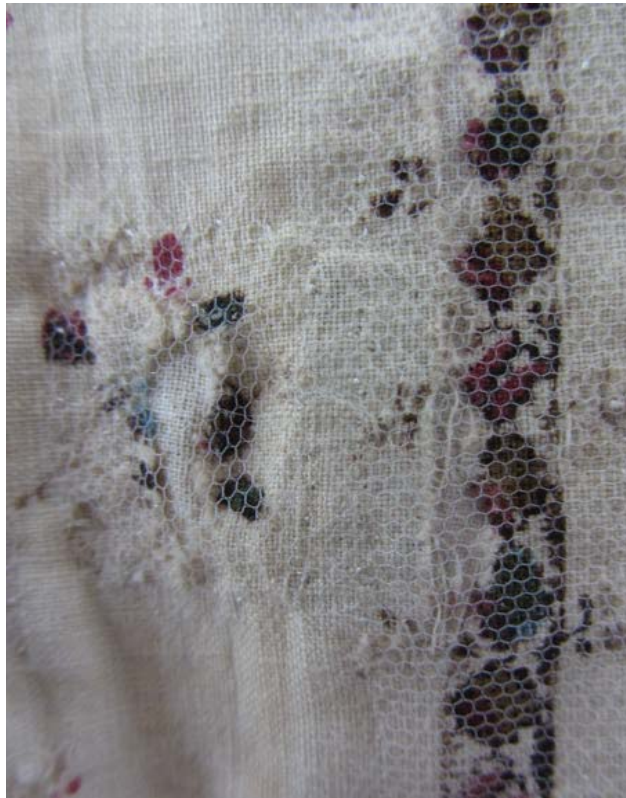
Fig. 10: Examples of previous repairs in jacket, re-weaving and net encapsulation

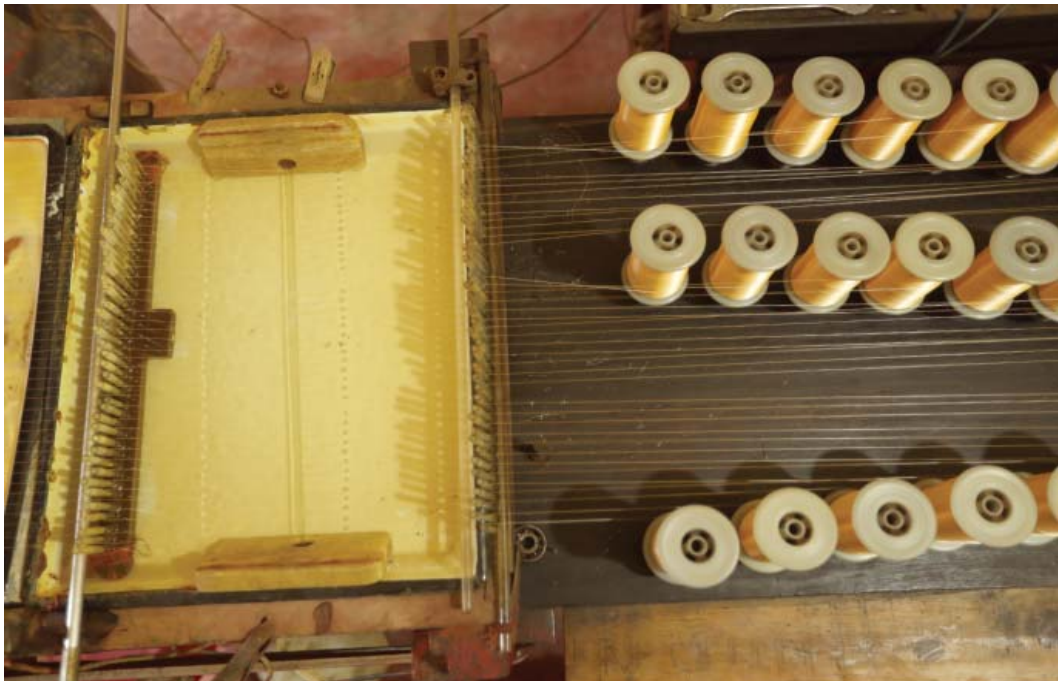
Zari making

Zari is a combination of yarn (silk/cotton/rayon/polyester) and some metals like gold, silver or copper which is used by the textile, handicraft and other industries in the country. The zari craft has been developed in the country over centuries and produced mainly in Surat and Banaras. *Real* zari is made by electroplating gold over a silk or cotton core yarn coiled with flattened silver wire. These days in place of flattened silver wire (*Badla*), an alloy made of silver and copper is used to cut down the cost of zari. In case if *Imitation* zari, the alloy is made of copper and a little quantity of silver. The core yarn may be artificial silk or polyester. Lacquering or fast gilding is done over the coiled yarn to give a look of gold. This is very cheap compared to Real zari. Now-a-days, there is one more class of zari called *Plastic* zari which is made of thin plastic strip coiled over core yarn.

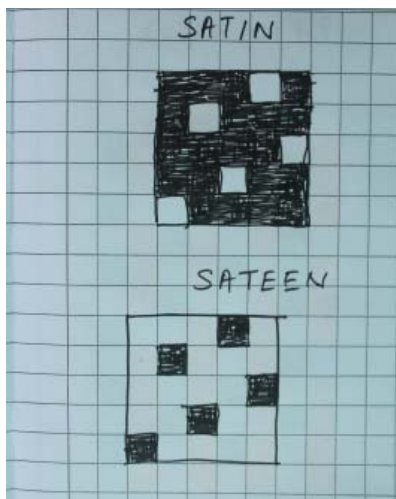
4. Extra warp designing

Extra warp design is made by inserting extra design threads in the warp direction. These threads lie in between base or ground warp threads in various proportions such as 1:1 (1 ground 1 design), 1:2 (1 ground 2 design), 2:1 (2 ground 1 design), 2:2 (2 ground 2 design) etc. as per requirement. Therefore, there are two series of warp and one series of weft in this weave. Design threads interlace with weft threads in a particular fashion as suitable for the pattern to come up on the surface of the fabric. If these extra design threads are taken out, ground fabric remains intact. They are manipulated

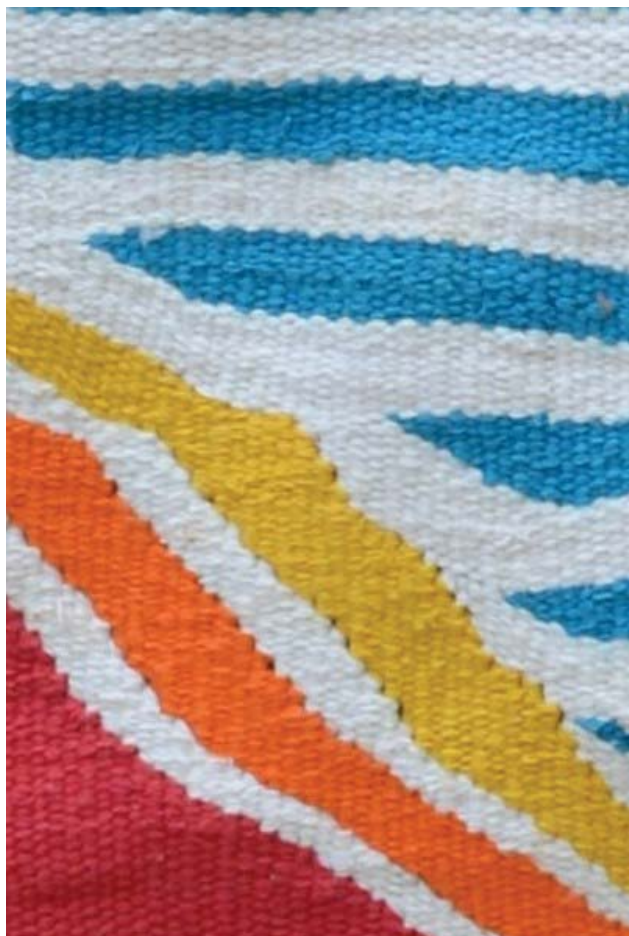
Tapestry technique is the most unique, complicated and time-consuming method of designing. This technique is applied in weaving of very coarse material like durrie (*cut-shuttle durrie*) as well the *finest Pashmina Shawl*, *Kullu Shawl*, *Kinnori Shawl* and silk saris such as

Paithani. There is neither extra series of warp nor weft. Design is made by inserting different colours of weft of small lengths, one after another following the contour of the pattern across the width of the fabric by hand with the help of small shuttles or weft package locally called as *tili* or *kani*. All such small lengths of design threads jointly make one pick.

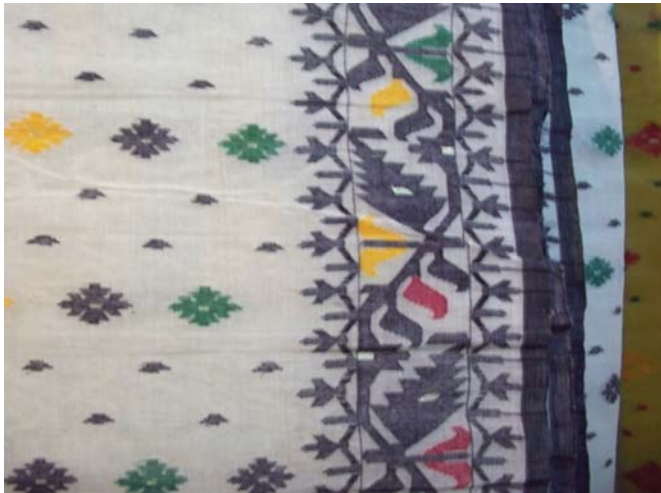
Jamdani of West Bengal, Uttar Pradesh & Andhra Pradesh

Item	Details
Base warp	Cotton
Base weft	Cotton
Design warp	Cotton
Design weft	Cotton, zari, muga
Base weave	Plain
Design weave	Extra weft (plain)

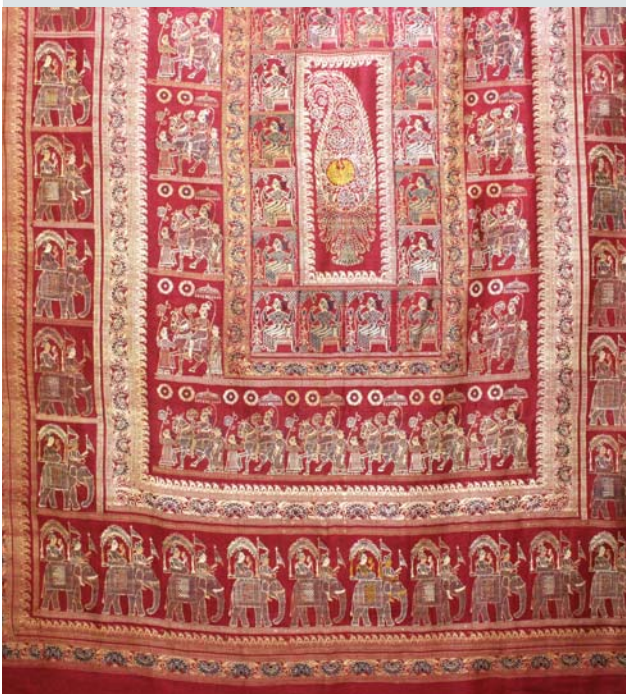
Baluchari

Items	Details
Base warp	Mulberry silk
Base weft	Mulberry silk
Design warp	Mulberry silk
Design weft	Mulberry silk
Base weave	Plain
Design weave	Extra weft (twill/satin)

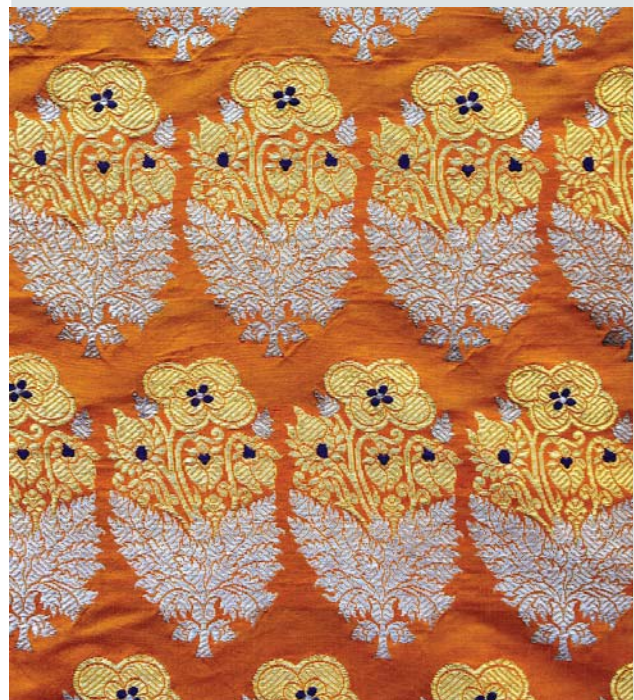
Banarasi Kimkhab Brocade

Items	Details
Base warp	Mulberry Silk
Base weft	Mulberry Silk
Design warp	-
Design weft	Silk, zari
Base weave	Satin
Design weave	Extra weft Twill/sateen

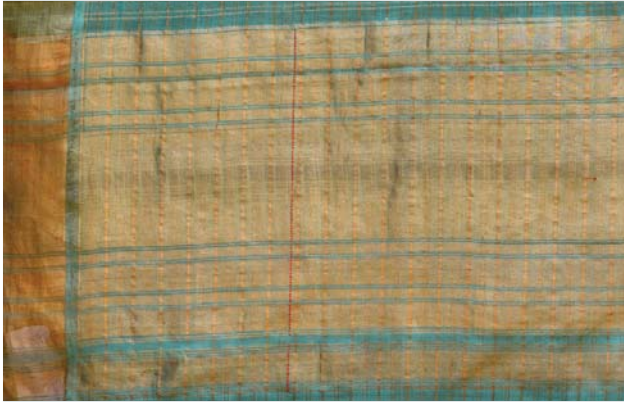
Chanderi

Items	Details
Base warp	Mulberry silk
Base weft	Cotton
Design warp	Cotton, zari
Design weft	Cotton, zari
Base weave	Plain
Design weave	Extra warp and extra weft (twill/sateen)

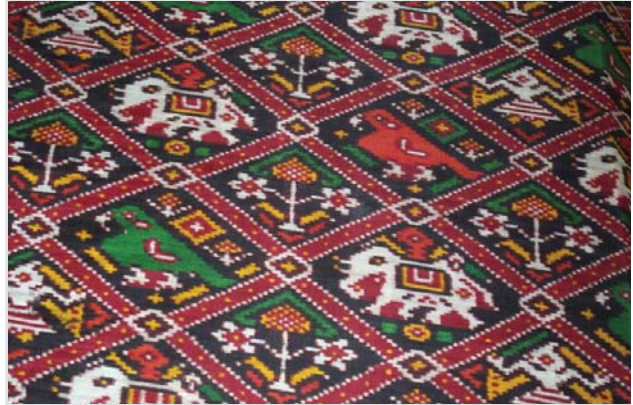
Patan patola

Items	Details
Base warp	Mulberry silk, zari
Base weft	Mulberry silk, zari
Design warp	-
Design weft	-
Base weave	Plain
Design weave	Double Ikat - resist dyeing

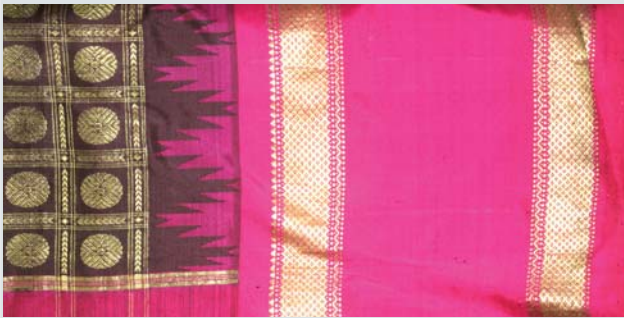
Kancheevaram

Items	Details
Base warp	Mulberry silk
Base weft	Mulberry silk
Design warp	Mulberry silk, zari
Design weft	Mulberry silk, zari
Base weave	Plain
Design weave	Extra warp, extra weft (twill/satin/sateen)

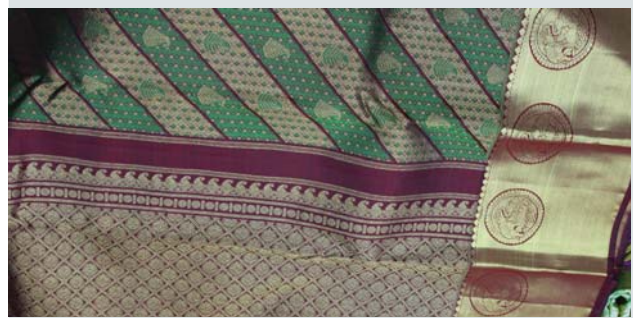
Dharmavaram

Items	Details
Base warp	Mulberry Silk
Base weft	Mulberry Silk
Design warp	Zari
Design weft	Zari
Base weave	Plain
Design weave	Extra warp, extra weft (twill/satin/sateen)

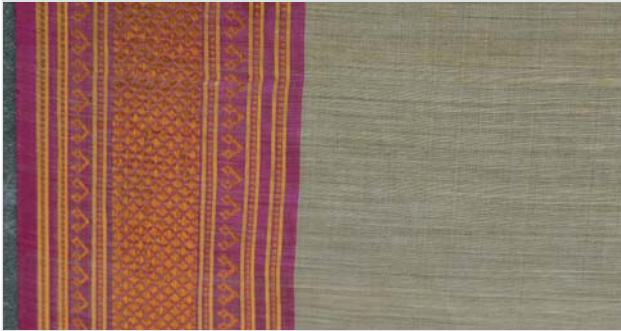
Maheswari

Items	Details
Base warp	Mulberry Silk
Base weft	Cotton
Design warp	Cotton, Zari
Design weft	-
Base weave	Plain
Design weave	Extra warp (twill/satin)
