CONSERVATION INSIGHTS 2020

Lectures

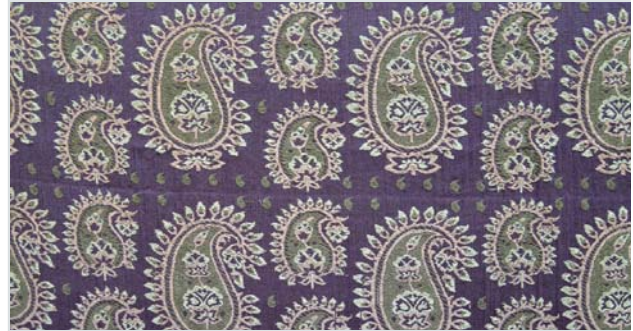
Himru

Items	Details
Base warp	Mulberry Silk, cotton
Base weft	Cotton
Design warp	-
Design weft	Mulberry Silk, cotton, zari
Base weave	Twill
Design weave	Extra weft (floats)

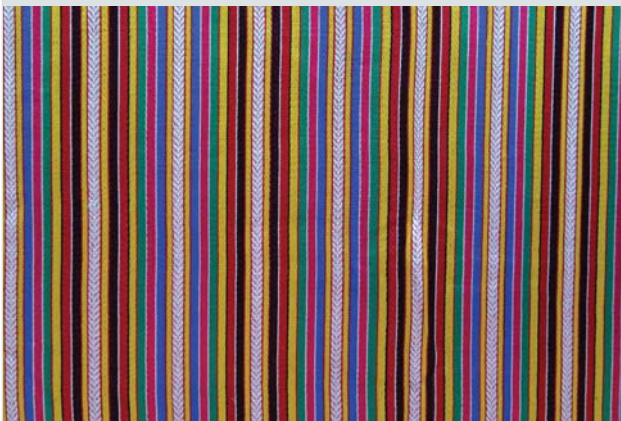
Mushru

Items	Details
Base warp	Mulberry silk
Base weft	Cotton
Design warp	Mulberry silk
Design weft	-
Base weave	Satin
Design weave	Twill, Tiny floats

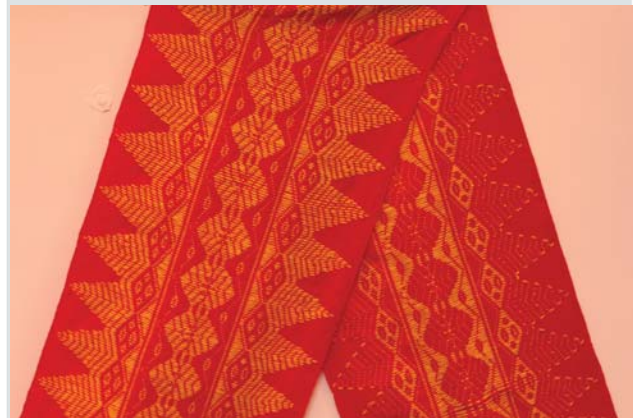
Backstrap loom products of North Eastern States

Items	Details
Base warp	Cotton
Base weft	Cotton
Design warp	Cotton
Design weft	Cotton
Base weave	Plain
Design weave	Extra weft (floats)

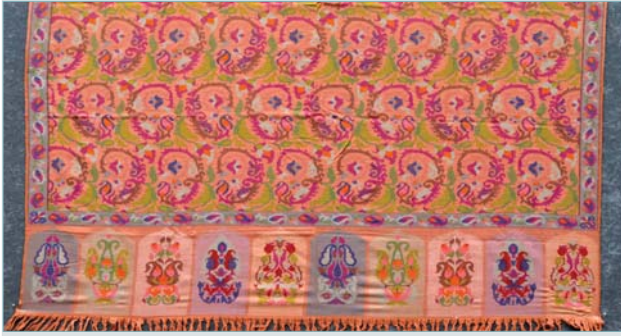
Pashmina Kani shawl

Items	Details
Base warp	Pashmina
Base weft	Pashmina
Design warp	-
Design weft	Pashmina
Base weave	Twill
Design weave	Tapestry (twill)

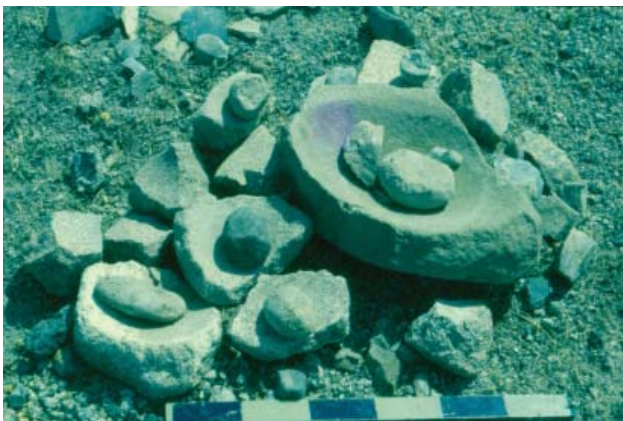
Fig. 2: Neolithic Ashmound, Wandalli, Karnataka; with mullackers or grinding stones related to gold extraction found near old gold mine workings

had open cast mines with old mining galleries with large mullacker fragments scattered about indicating ore crushing activity in antiquity (figure 2). Old timber from a 200 metres deep mine shaft was carbon dated the mid 4th century BC (Radhakrishna and Curtis 1991: 23-4), ranking amongst the deepest known old gold mines. The Jalagarus were a traditional community in the Dambal region who undertook alluvial washing and panning for gold (Foote 1874: 140).

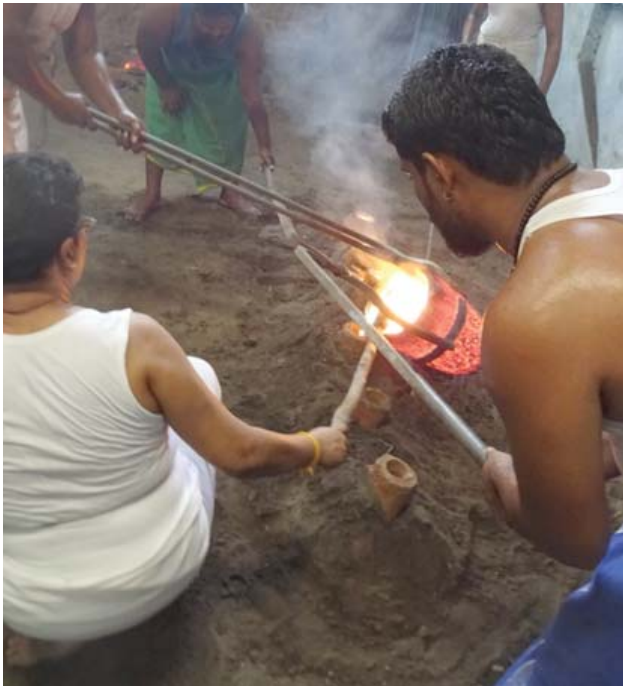
Fig. 8: Metal icon casting at Swamimalai, Thanjavur district, Tamil Nadu

with clay to form the mould. The mould was then heated to melt and get rid of the wax and then metal poured in which solidified to give the final metal icon. At Swamimalai the images are first minutely carved in wax and then covered in layers of clay to form the mould, using the fine alluvial clay of the Kaveri, the vandalmunn, and then the wax expelled by heating the mould and then metal poured in to form the castings (figure 8). The hollow casting process used a clay core and was used more in the north of India for casting. In this the final icon was made of a thin layer of metal with the clay core retained inside. Hollow cast icons can appear damaged due to the thinner layer of metal being prone to damage.

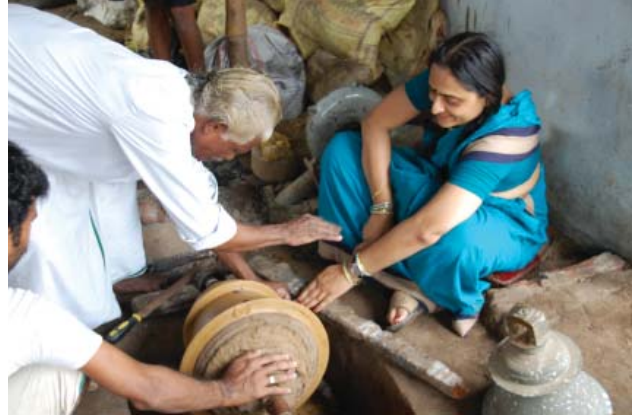
Fig. 10: Making of mould for bell casting at Nacharkoil, Tamil Nadu (Bell maker late Govindrajan with Sharada Srinivasan)

The lost wax casting of bronze bells has been practiced in the Thanjavur region of Tamil Nadu, which is another declining tradition Nacharkoil, a small village located four kilometres from Kumbakonam, has traditionally been renowned for the making of temple bells and temple lamps. In the past it had a sizeable community of Kammalar or bronze and bell metal workers. The *Kammalar* community have also been involved in making lost wax castings of large and medium sized temple bells by the lost wax process. Here the mould and wax model were build up using hand lathes in ingenious ways (figure 10), although the traditional lost wax casting of bells is declining and giving way to other industrial processes.

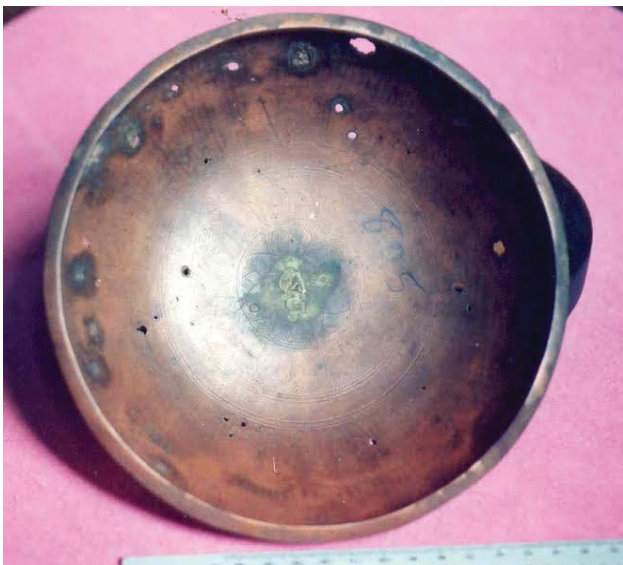
Fig. 11: Vessel from Nilgiri Cairns, Tamil Nadu, Government Museum, Chennai (early to mid 1st mill BCE)

Astonishingly, highly sophisticated and thin-rimmed bronze vessels have been uncovered from the megalithic cairns and burials of the Nilgiris (figure 11) and Adichanallur, Tamil Nadu (c. 1000-500 BC), while metallurgical investigations on some of these by the author confirmed that they were of hot forged and quenched binary unleaded high-tin beta (23% tin) bronze (Srinivasan 1994, Srinivasan and Glover 1995, Srinivasan 2010). Such an alloy of copper and tin with around 23% tin can be forged greatly at high temperatures due to the presence of a high temperature plastic beta phase which when quenched gives additionally

properties of strength and lustre to the alloy. These extraordinarily thin-rimmed vessels were fabricated by extensively hammering out such an alloy between 586-798^o C when a plastic beta intermetallic compound (Cu₅Sn) of equilibrium composition of 22.9% tin forms. This was followed by quenching which resulted in the retention of needle-like beta phase, as seen in the microstructure of a vessel from Adichanallur in figure 12, and which prevents the formation of brittle delta phase and also gives a golden polish. Low-tin bronzes have limited workability in comparison. Indian influences were also discerned in examples of high-tin bronze vessels found in Thailand in southeast Asia (Bennett and Glover 1992).

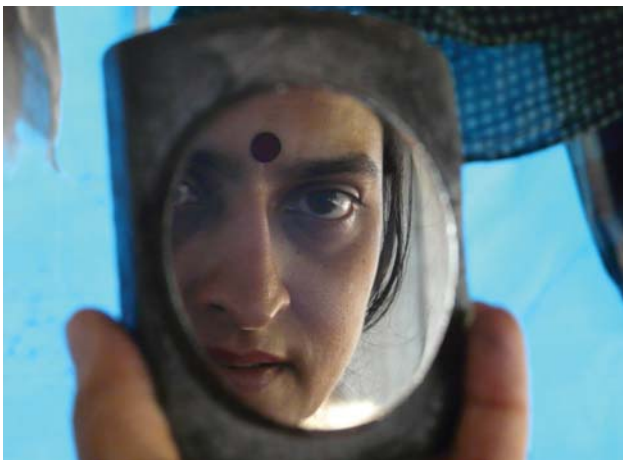
Fig. 13: Polished metal mirror blank at Aranmula (with reflection of Sharada Srinivasan)

The making of reflective mirrors of a composition of high-tin delta bronze is a rare artisanal tradition which survives in Aranmula in Kerala (figure 13). Studies by the author

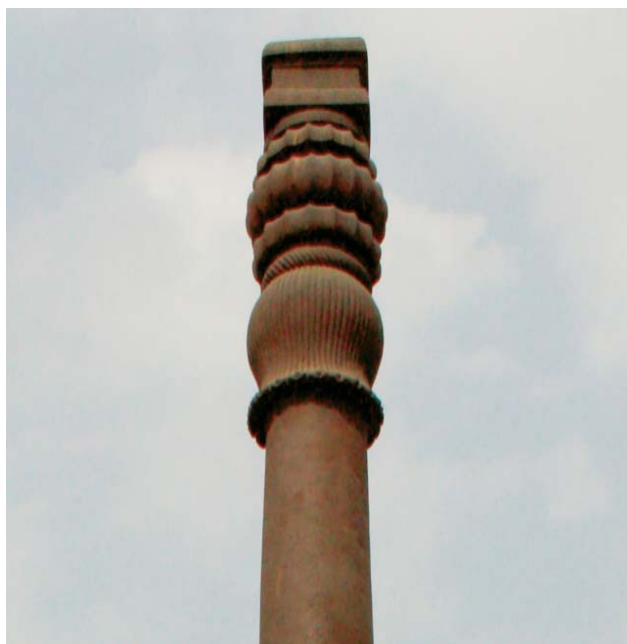
Fig. 15: Delhi Iron Pillar, Gupta, 400 CE, upper portion

The Indian subcontinent has a vibrant iron and steel in antiquity. The celebrated Iron Pillar (figure 14) is renowned as the ‘rustless wonder’ for its relative corrosion resistance. It is about 7.375 m high and 41.6 m in diameter and is the earliest surviving massive iron forging. The Sanskrit inscription on the pillar of the late 4th century to early 5th century CE is attributed to the Gupta king Chandragupta II, alluding to the erection of a *dhwaja* or pillar by Chandra, as a devotee of the Hindu deity Vishnu, on the hill of Vishnupadagiri. A sample studied by Sir Robert Hadfield was found to be iron of high purity with about 0.1% phosphorus and 0.04% carbon (Hadfield 1912). The formation of a protective passive film on the surface and an amorphous oxyhydroxide layer next to the metal-rust surface of the phosphoric iron may have aided the corrosion resistance (Balasubramiam 2008). Ultrasound investigations suggested that the pillar was built up by forge-welding cakes of wrought iron in a perpendicular and radial fashion (IGCAR).

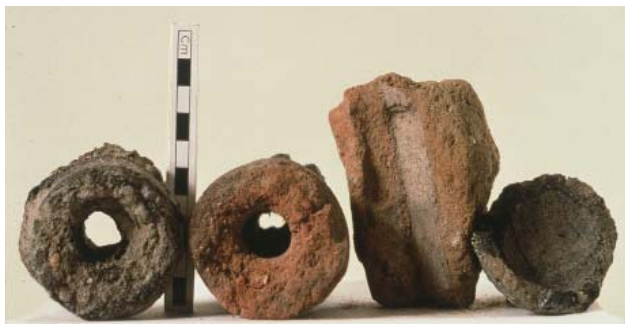
Fig. 17: Crucible and tuyere fragments, Kodumanal, 3rd century BCE

Excavations at an iron age megalithic site at Kodumanal, Tamil Nadu (3rd c. BCE), near Karur, the Chera capital of the Sangam era (3rd c. BCE-3rd c. AD) revealed furnaces with vitrified crucibles (figure 17) and iron slag (Rajan 1990). A vitrified crucible fragment from Kodumanal showed ferrous metal processing remains (Srinivasan and Griffiths 1997, Srinivasan 2007). Figure 18 is an elemental distribution map of a crucible fragment from Kodumanal, examined using EPMA-WDS by the author which shows the presence of ferrous remnants. The bardic poems of the Sangam Tamil poetess (3rd c. BCE-3rd c. AD evoke warring chieftains and their spears (*ekku*).

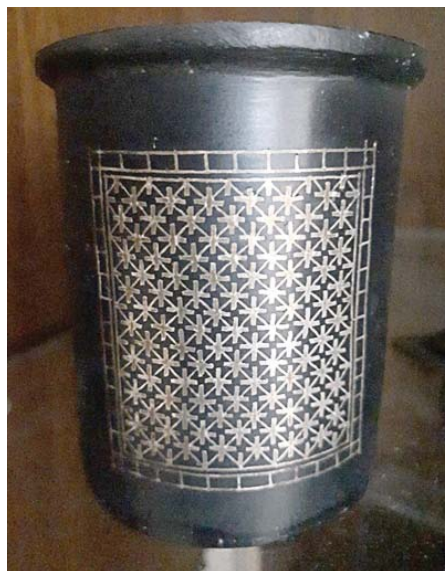
Fig 19: Bidriware vessel of zinc alloy of Persian influence

The remarkable artistic innovation of Bidri ware (figure 17), inspired by Persian inlaying traditions, developed under the late medieval Muslim Sultanate rulers of the Bidar region of Karnataka. The use of metallic zinc was made to make highly elegant metalware, of a patinated high-zinc alloy with 2-10% copper inlayed in silver (La Niece 2015), which was used to make hukka bases, ewers and other artefacts. The Bidri ware sample in figure 19 investigated by surface XRF analysis by the author had 90% zinc and 6% copper.

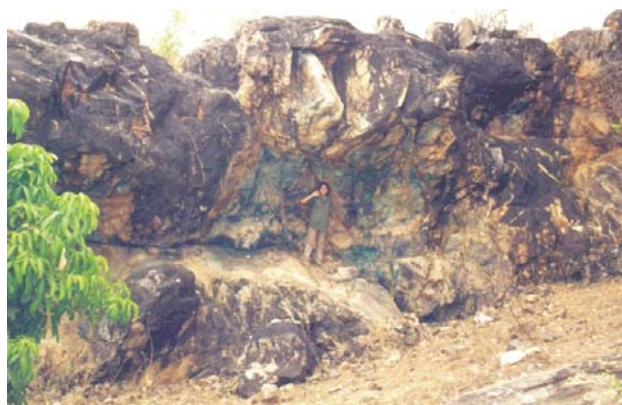
Fig 20: Agnigundala, Andhra Pradesh, old copper mine workings (Sharada Srinivasan visit of 1991)

using lead isotope ratio finger-printing and was found to fit a 5th *c.* AD attribution from the Andhra region (Srinivasan 1998, 2016a). The shape of the ingot/coin was also interesting akin to a solidified globular droplet with a flat bottom as it could have been collected at the bottom of the furnace by downward distillation. One of the important polymetallic deposits in southern India is in Agnigundala, Andhra Pradesh which lead isotope ratio studies by the author indicated was exploited at least by the early historic Satavahana period (Srinivasan 1996, 1999b, 2016b). Figure 20 is a view of one of the old copper mine workings.

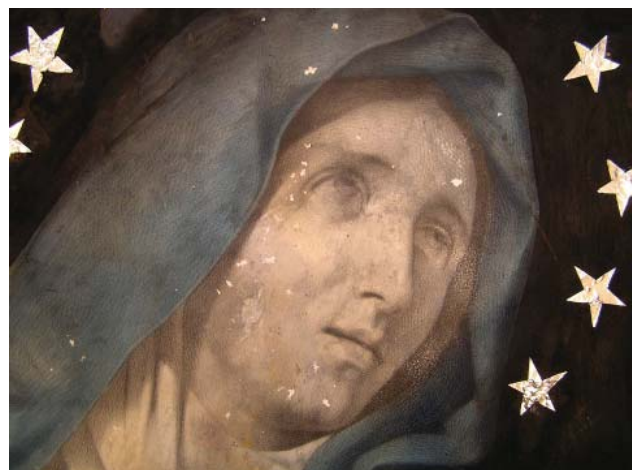
I start by discussing an object I worked on in Malta some years back. It is a coloured lithograph depicting Our Lady of Sorrows – the Virgin Mary who was in deep sorrow as she was experiencing the passion of her son Jesus Christ. This lithograph has suffered quite extensively (Figure 1). Firstly it has been given a black boarder around the figure of the Virgin

Fig. 1: Detail of the lithography showing insect damage, stains and aluminium foil stars

Mary, presumably to cover up some previous damage; it has suffered damage from silverfish, it has large water stains to the left, and to top it all someone had added silver stars using cooking aluminium foil at a later stage. Owned by a couple in their seventies, I was told that they wanted it to 'look good' because it had great sentimental value and had also been passed down to them in the family for a couple of generations or so. I knew the image could be enhanced with basic cleaning and retouching techniques but to what extent was I supposed to treat it?

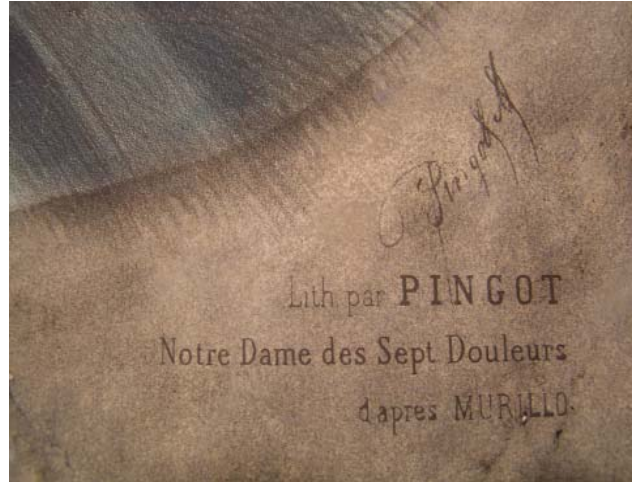
The work was very interventive and a great deal of retouching was required especially after the black colour in the background was removed. The removal of the colour incidentally revealed the names of the artist and printer which means that in cleaning, I was able to discover new information about the object (Figures 2 and 3).

Fig. 2: Detail after cleaning showing the names of the artist and lithographer

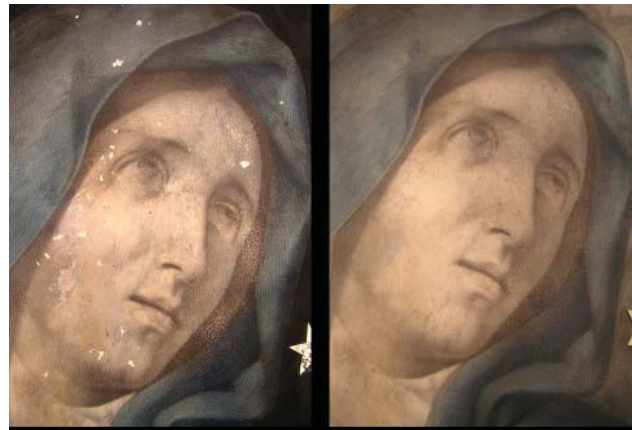
Fig. 3: Detail of the face of the Virgin before and after treatment

What is the conclusion about this artwork? As a conservator offering a service to others, I was compelled to follow the client's instructions on how to treat this artwork. Although the print was surface cleaned, a certain amount of patina was also retained. Of course I ensured that conservation grade materials were used throughout and that treatments were reversible as much as possible but ultimately conservation is about people and it was the owner's decision that I had to follow. The end result was ultimately a balanced one and was to the satisfaction and reward of both the client and myself.

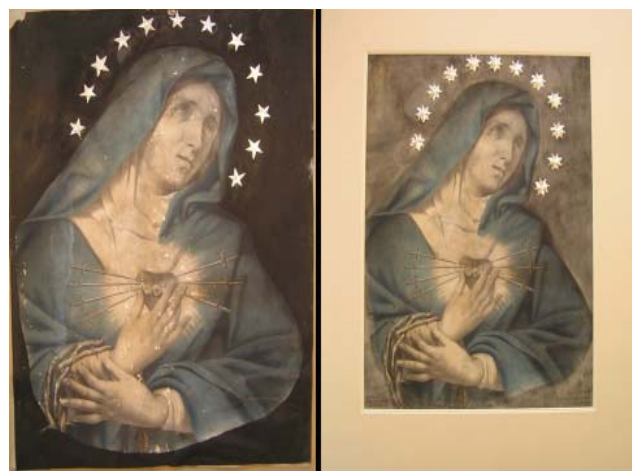
Fig. 4: 'Our Lady of Sorrows' lithography before and after treatment

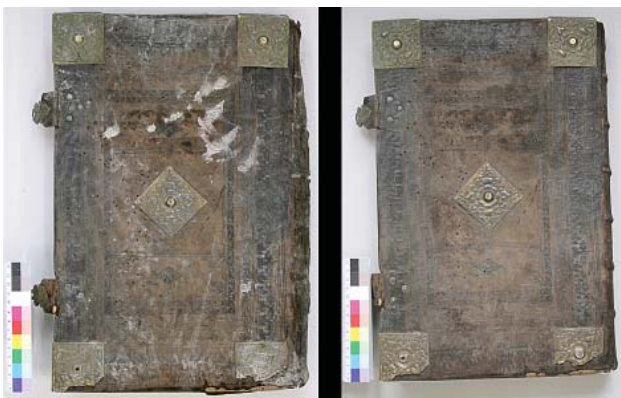
Fig. 5: Printed antiphonal, 1757, showing the leather cover before and after cleaning

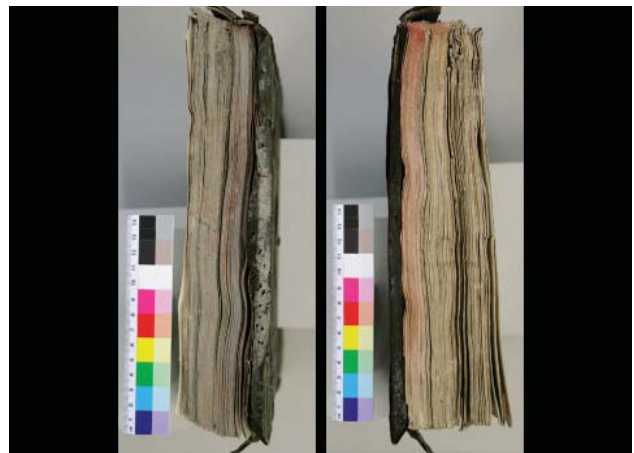
This project took place while in Switzerland and the book in question forms part of the music library collection of the Benedictine Abbey of St Andrew in Sarnen, near Luzern.⁷ The abbey was flooded in August 2005 leaving the library underwater for 72 hours.⁸ One of the books I was working on was a printed antiphonal dating 1757 (Figure 5). As seen in the images the binding was covered in mud from the flood, the leather was distorted and the front board and cover were missing (Figure 6). In spite

Fig. 6: The antiphonal showing distortions in the spine and the front board and cover that are missing

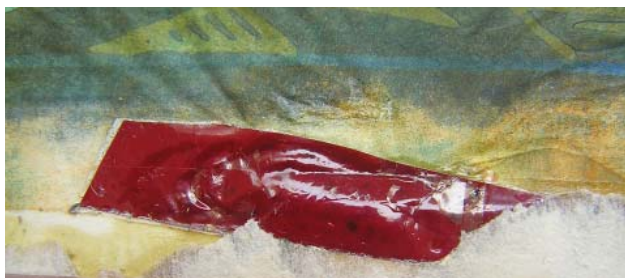
At first glance they did not appear to be damaged but upon close inspection it was clear that there was extensive damage from old repairs (Figure 8). These repairs were carried

Fig. 8: Detail of linocut by Cyril Power showing old repairs using red adhesive tape

out using a kind of shiny red tape that almost looks like duct tape which left a white adhesive deposit on the surface of the paper. Owing to the very fragile nature of their thin material, the prints had pulls and irregularities which were caused by the tension created from the old adhesive during mounting that was far stronger than it should have been resulting to planar distortions and undulations (Figure 9).

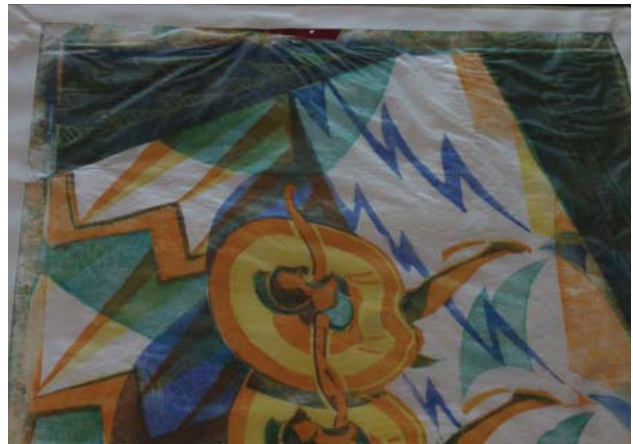
Fig. 9: Details of linocut showing irregularities and planar distortions from the incorrect mounting methods used in the past

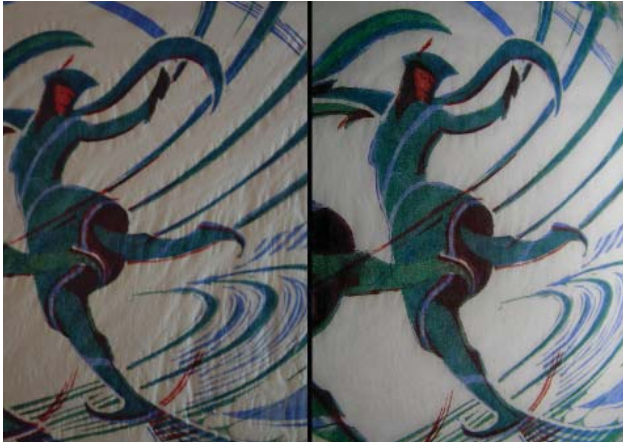
Fig. 11: Detail showing the smoothing out and flattening of distorted areas

was then flattened with a large heated spatula. Paper repairs were effected with very fine Japanese tissue in minute pieces using tweezers so that the joins were almost impossible to detect (Figures 10 and 11).

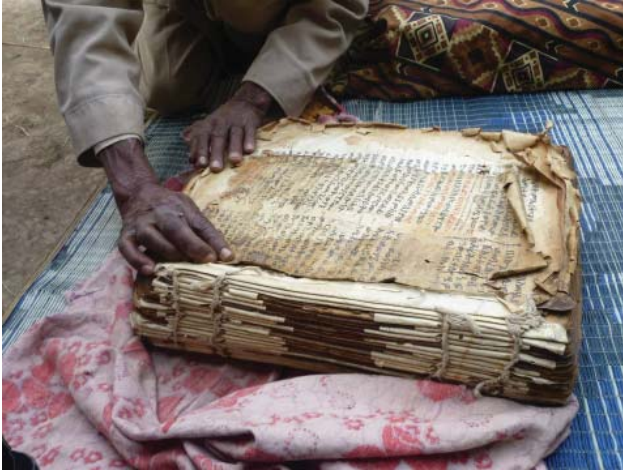
These Ethiopian liturgical manuscripts are objects of everyday use. As a consequence they also get worn and repaired quite often by members of the local communities (Figure 15).

Fig. 15: Ethiopian liturgical manuscript showing several repairs made by its owner

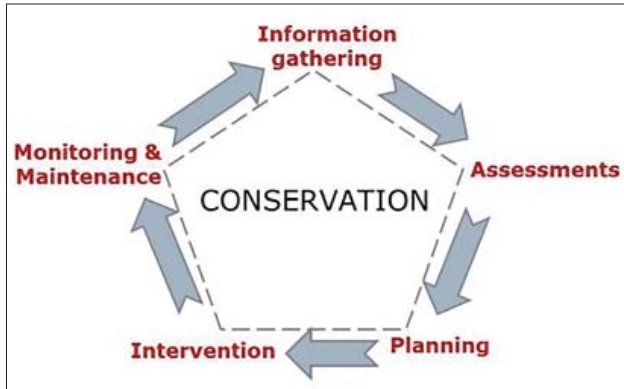
the Conservation Process”⁹ are illustrated as a circular diagram to emphasize that the conservation process is a repeating cycle in which monitoring and maintenance following the intervention.

Image 3: The Steps of the Conservation Process from Pique, James 2017¹⁰

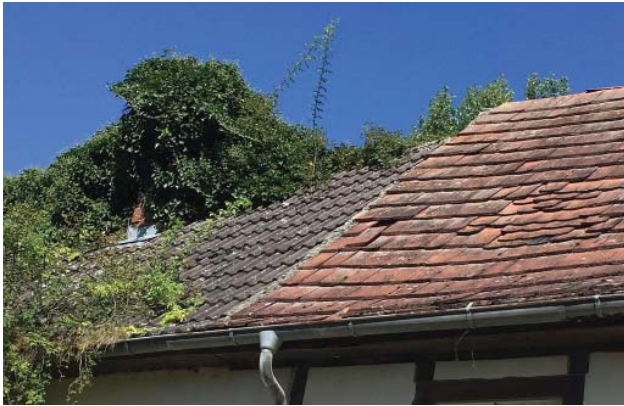
Image 4: Slipped, displaced and lost roof tiles (Beckett 2020)

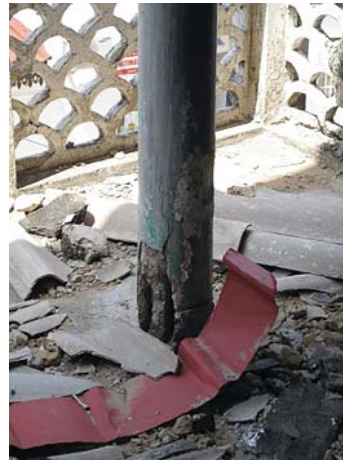
Image 7: Corrosion of reinforced early concrete pillars. (Beckett 2016)

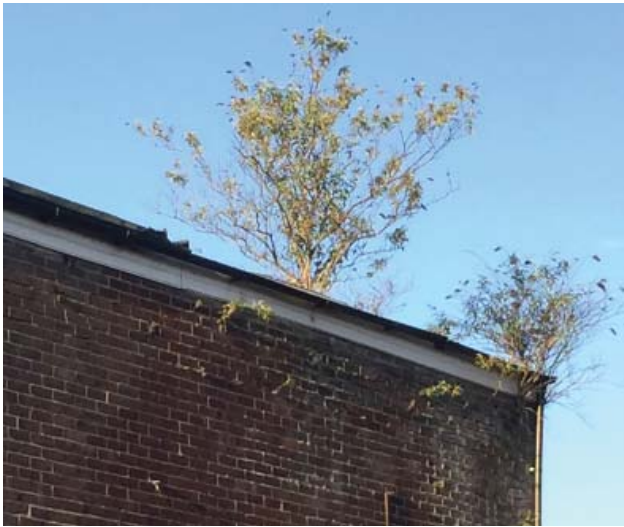
Image 5: Buddleia growing in rain gutter (Beckett 2020)

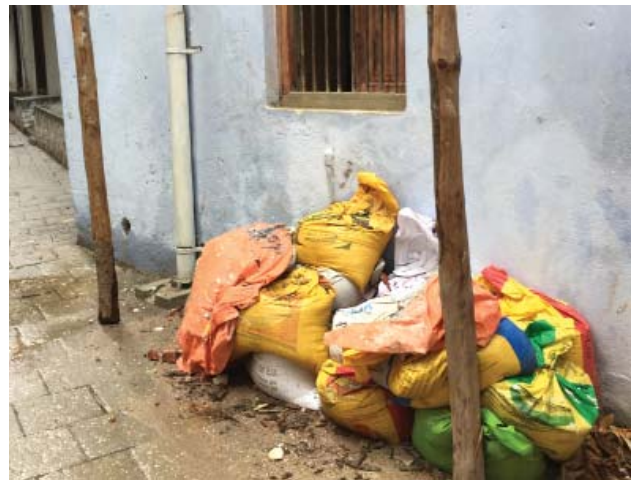
Image 8: Storage of bags with waste and contaminated building material against the historic wall (Beckett 2016)

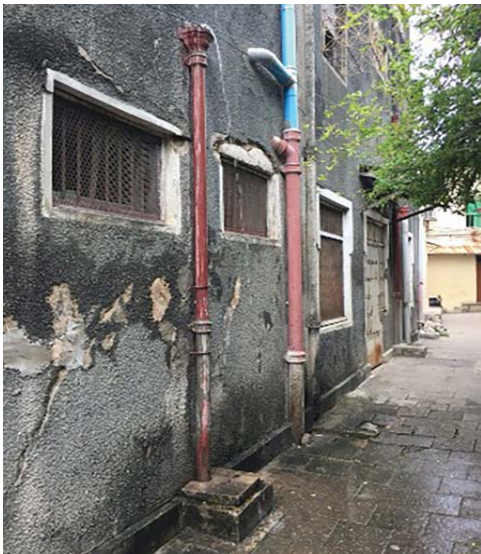
Image 6: Defect, overflowing downpipe (Beckett 2016)

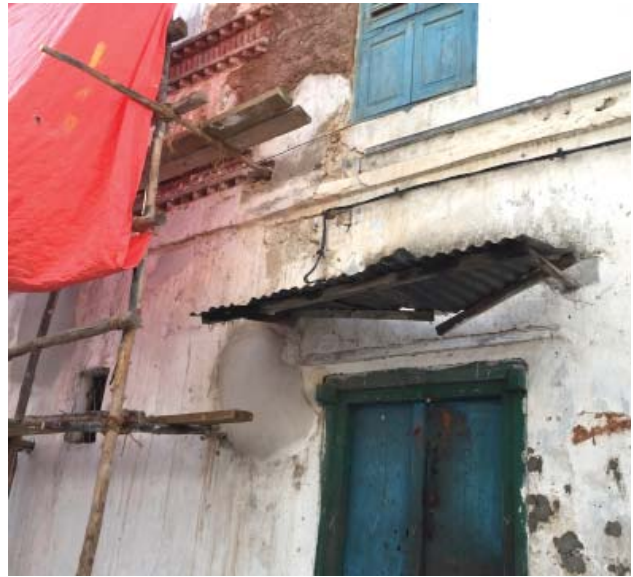
Image 10: Broken protective roof leads the water in the plaster of Hamamni Baths, Stone Town (Beckett 2016)

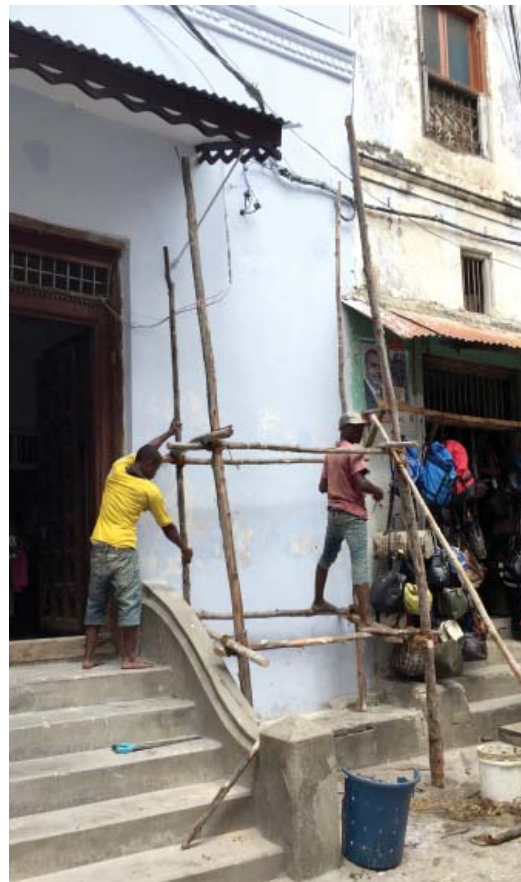
Image 11: Broken protective roof leads the water in the plaster of the “Upendo House”, Stone Town and activates soluble salts. (Beckett 2016)

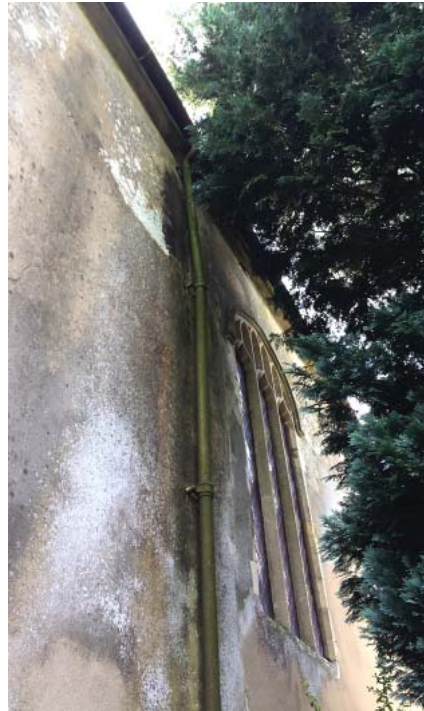
Image 14: Tree close to a historic building can hinder ventilation and cause mechanical damages (Beckett 2019)

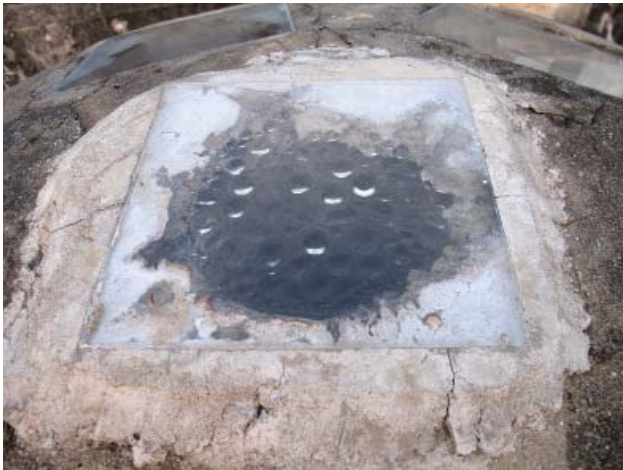
Image 13: Condensation moisture on the inside of the roof windows Hamamni Bath, Stone Town, Zanzibar (Beckett 2016)

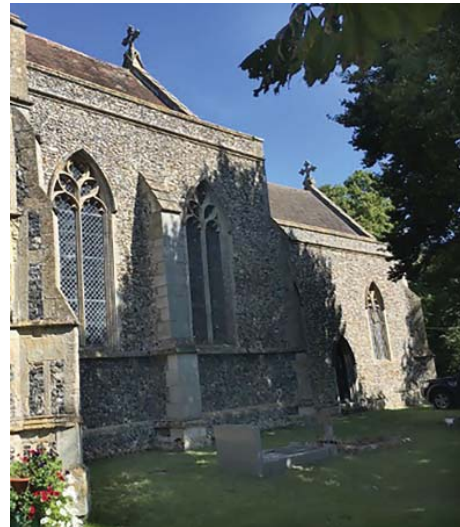
Image 15: Tree is casting a shadow on the historic walls (Beckett 2019)

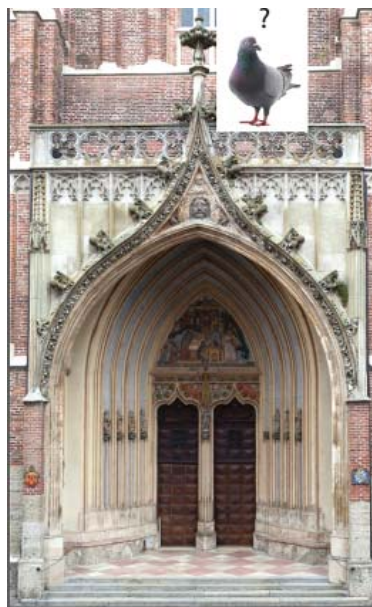
Image 18: The composed image shows the location of the bird dropping and water ingress (Beckett 2011).

sampling is required, which allows depth profile with characterization and quantity of soluble salts. The location and the predominance of Nitrates and Sulphates lead to the identification of one of main source of soluble salts – a high amount of pigeon droppings which accumulate on the roof above the Portal. The slightly acid,

high concentrated salt solution is distributed in the vaulted ceiling below by water infiltration.

This damage source can be reduced by inhibiting the birds to rest on the roof and regular cleaning of any droppings. Together with the repair and maintenance of the roof and water goods it will stop water infiltration and enables to transport the water controlled away from the precious portal.

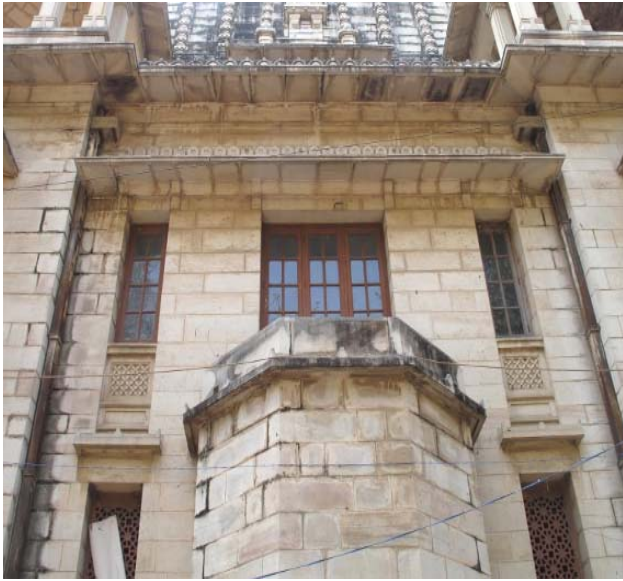
Image 23: Kirti Mandir: On the exterior there are two historic cast iron downpipes on the areas where the wallpaintings inside show defects.

With the inspection of the damaged areas from outside the building and the roof area, the source of the moisture and one source of soluble salts was clear. Similar to the previous example of St. Martins Church in Landshut, here the source of the water infiltration was caused by the leaking cast iron down downpipes and the pigeons which rest and contaminate the rain gutter inlet boxes. With regular maintenance these damages to the wallpaintings could have been avoided, reduced or at the very least slowed down.

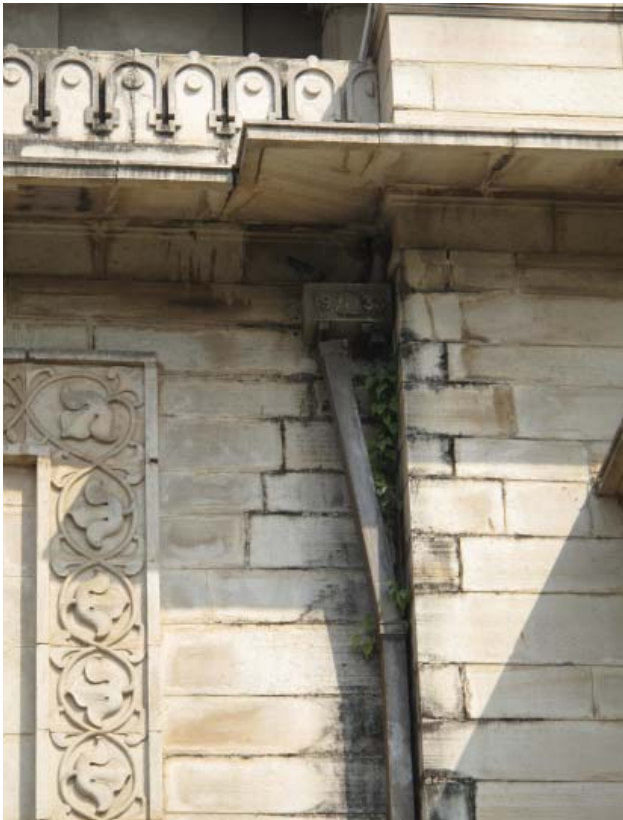
Image 24: Kirti Mandir: Cast iron downpipe. The biological growth indicates that water leaks out. Birds, here a pigeon is resting in the hoppers and contaminate the water and block the hopper.

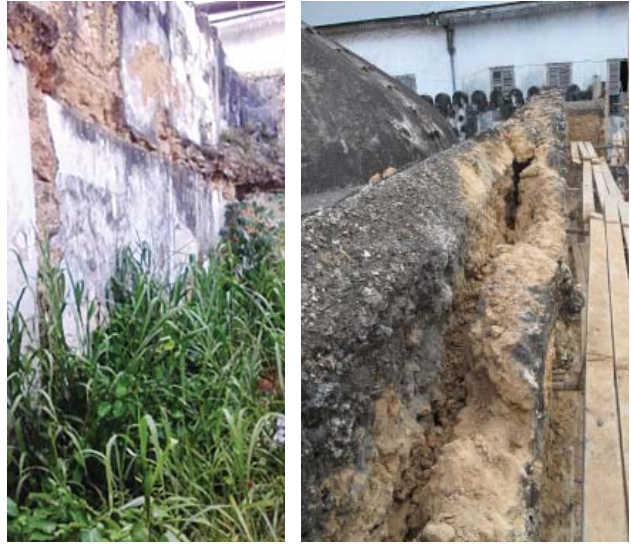
(Left) Image 27: Hamamni Baths, East wall exterior before clearing, waste and contaminated standing earth (Beckett 2016)

discovered outside of the west wall. This, at that time undeveloped building plot, was used as a waste dump and cat litter box. This contaminated and damp earth reached a height of 1.5 metre against the historic wall of the Hamamni Baths.

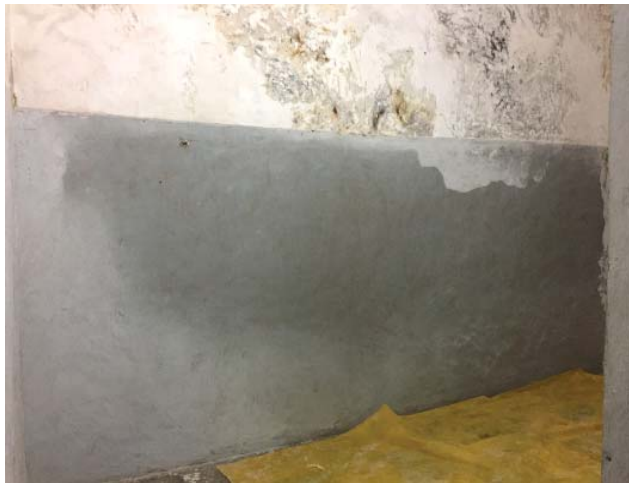
Image 29: Hamamni Baths, Interior. After rain the East wall is getting in one area. (Beckett 2016)

water and loose material could infiltrate deep into the cavity wall. Due to the closure of two previously open windows, and subsequently stopping the airflow and ventilation inside the different rooms led to raised humidity levels in the building and formed condensation on the glass panels of the small roof lights. The broken glass sheets added to the water ingress problem.

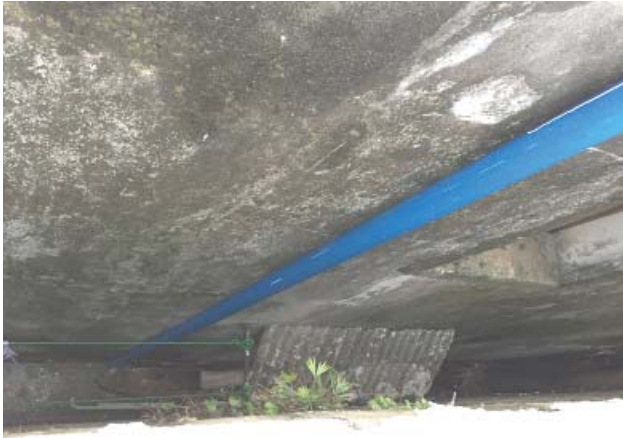
Image 30: Hamamni Baths. The downpipe from the neighbouring house drains the water into the east wall of the Hamamni Baths. (Beckett 2016)

At the north end of the west side of the building, the walls were frequently wet after rainfall. An investigation into the adjoining neighbour courtyard revealed, that a well-meant maintenance measure of the neighbour caused this damage. The new downpipe of the neighbouring house discharge directly into the wall of the Hamamni Baths.

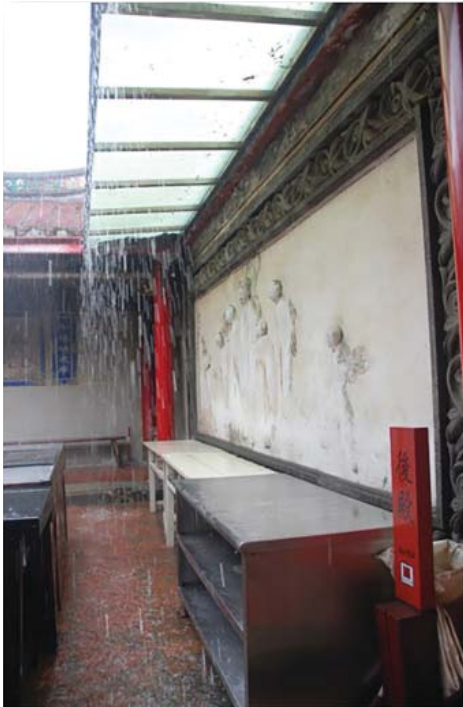
Image 32: Shuixian Temple, small. Protective temporary roof over the wall-painting stops direct rain. The later storage of the tables enables nevertheless the rain to bounce back onto the painting. (Beckett 2009)

It is a difficult task to preserve structures such as Temples, that are exposed to the environment, especially in the extreme climate, with varying temperatures and a monsoon season. Infuriatingly, the temples are built traditionally with no rain goods, to lead water away from the walls. This important task can only be achieved with constant maintenance and monitoring.

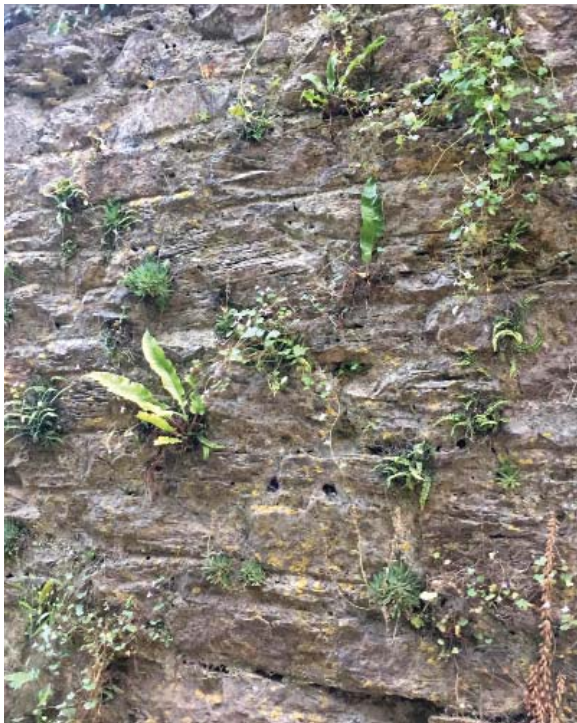
Image 36: Historic Stone wall with a variety of protective and harmful biological growth. (Beckett 2020)

Historic walls are often covered with algae, lichens and moss¹⁵. While some of the biological growth can be harmful, through chemical or physical processes, research show that most in contrary protect the historic stonework¹⁶. Moss often found on roofs and horizontal stonework can shelter stonework against temperature fluctuations and frost, but on the other hand it can block rain goods and drainages and this can cause water damage. This means, that the remove of the vegetation should be selective. Some of the biological growth can be also used as an environmental indicator for example for areas with high moisture or sun irradiation. Therefore, before any biological growth will be removed during maintenance, it should be decided on a case-by-case basis and if required in cooperation with a biologist. This information will be part of the maintenance plan.

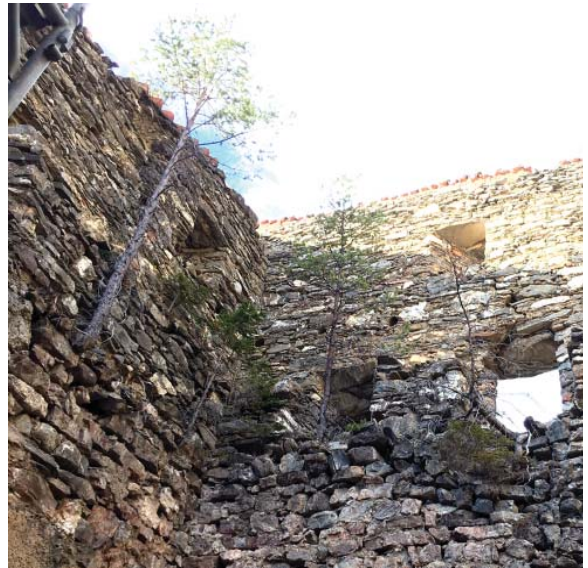
Image 37: Large trees on the historic castle ruin wall top causes stress through wind movements (Beckett 2018)

Any plants with woody roots such as ivy, buddleia, or even trees can cause physical stress to the historic masonry and should be controlled, managed and if necessary, removed to prevent any damages.¹⁷

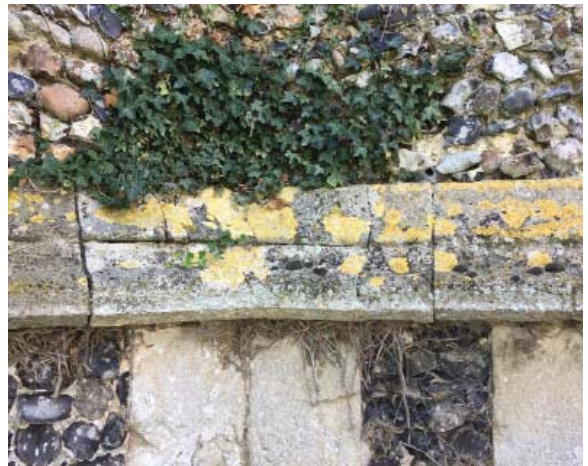
Image 38: The roots of Ivy an penetrate any voids and cause stress to the historic fabric (Beckett 2019)

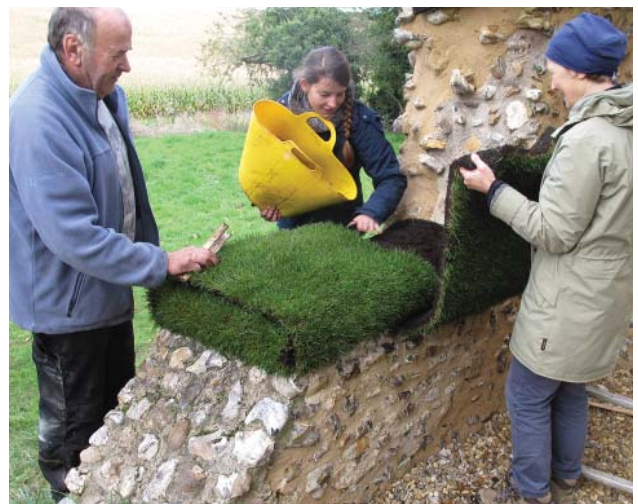
Image 39: Soft capping training to protect ruined wall top (Harvey 2019)

local succulents, called soft capping¹⁸. These green cover needs also regular maintenance – weeding. Controlling vegetation, soft capping as part of regular maintenance are definitely good activities for Community engagement.

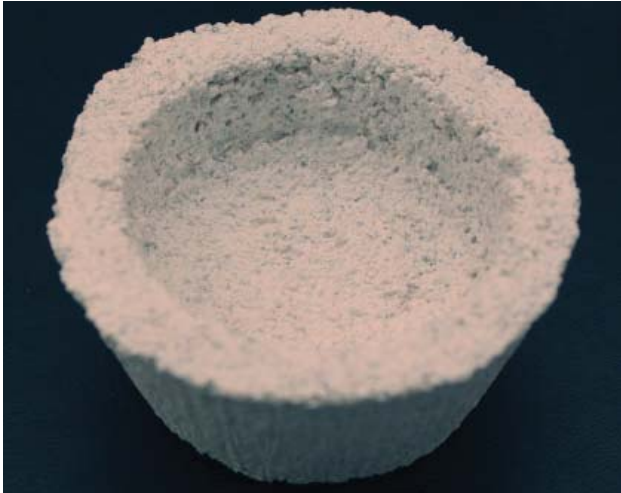
Fig. 3a: Shrinkage test. Plaster cup simulating a plaster pocket (Pasian 2017©)

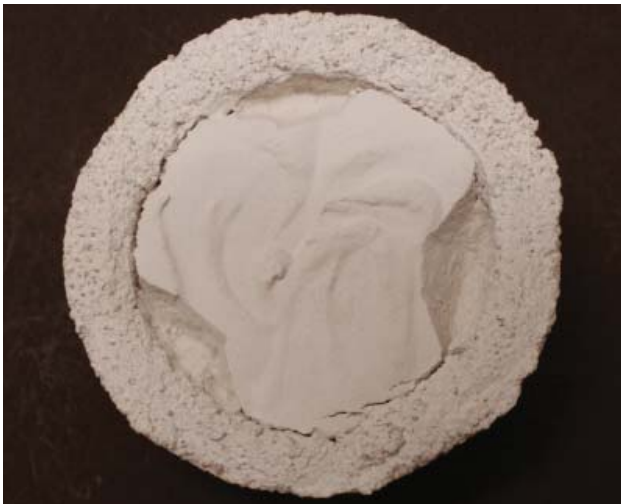
Fig. 3b: Shrinkage test. Plaster cup filled with grout: the grout has been excavated to assess shrinkage in depth; it shows shrinkage at the surface (probably related to fast evaporation), but not in depth (Pasian 2017©)

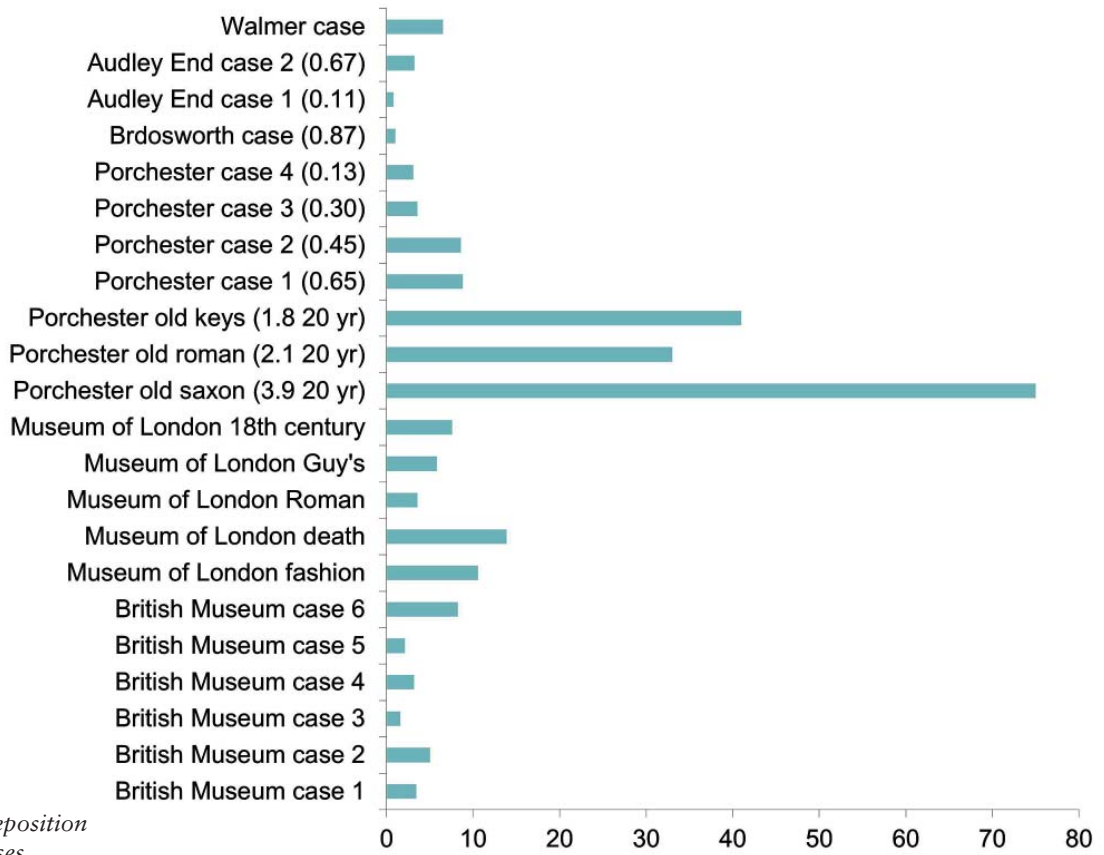
Fig. 9: Anion deposition rates in showcases

The exposure experiments showed no clear correlation between tarnish rate and hydrogen sulfide or carbonyl sulfide concentration in showcase environments. This is a different behaviour than that exhibited in room environments. The tarnish rate is generally related to the air exchange rate of the showcases.

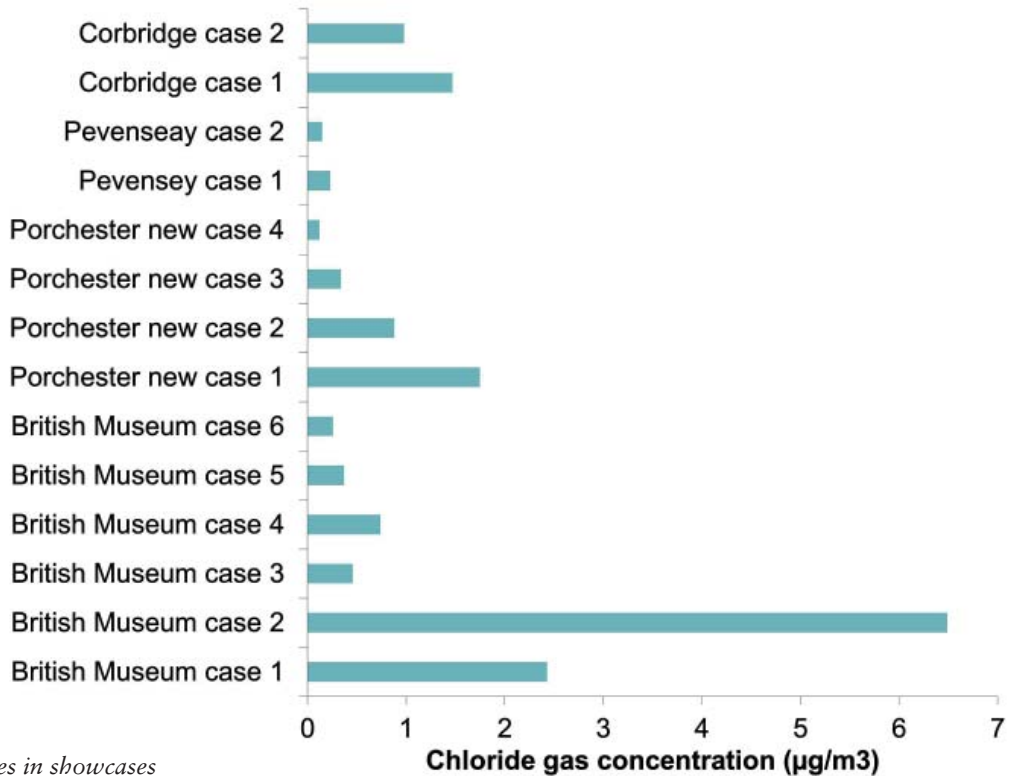
Fig. 10: Airborne chlorides in showcases

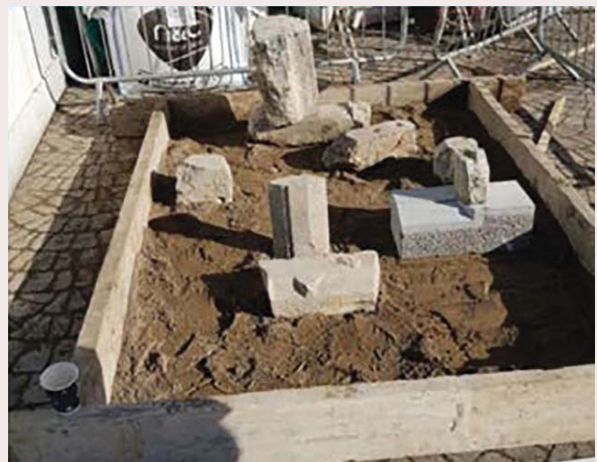
Fig. 4: Archaeological fragments, Quay St Galway

The image (figure 4) shows a sandbox with a number of different stone mullion and transoms. These are archaeological fragments recovered from the site in Quay St Galway. During the project agreement was reached with the local authority Heritage Officer on the appropriate mullion and transom replacements using this particular method.

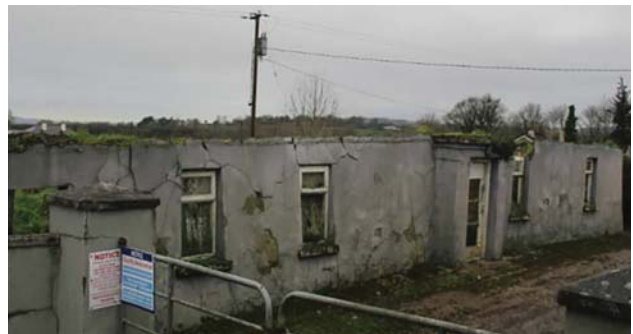
Fig. 11: The abandoned building with structural damage and loss of thatching.

Figure 10 shows an old thatched cottage (probably 18th Century) and figure 11 shows the same building in an advanced state of dereliction. The building had been the subject of a planning application to extend and restore in the early 21st century. ACP was not involved with the project and sadly the project was significantly delayed during the planning process which resulted in the owner abandoning the project to the detriment of the historic building. This is a sad case where the legislation and its implementation worked against the historic building.

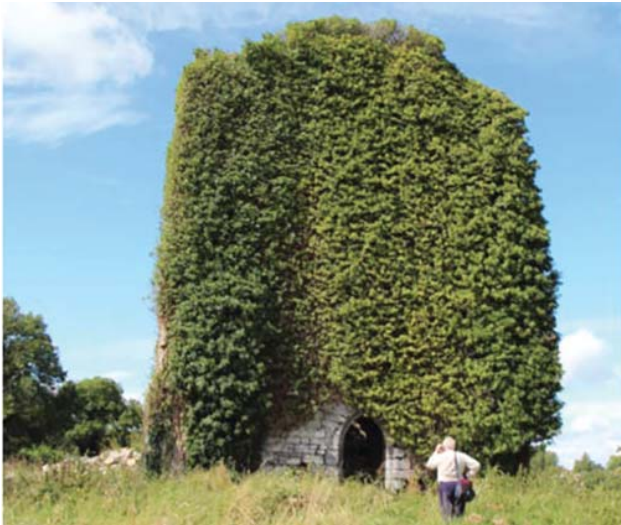
Fig. 12: Old tower house with overgrown ivy

The structure (figure 12) on the top, which is an old tower house overgrown with ivy and in a structurally unstable condition, is one of an example of hundreds of these structures in the Midwest of Ireland which have no apparent future. A small number of these have been refurbished as holiday residences at great

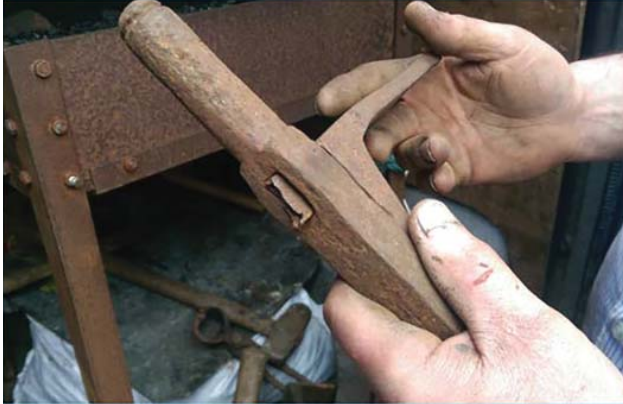
Fig. 19: Traditional jointing technique
