CONSERVATION INSIGHTS 2020

Lectures

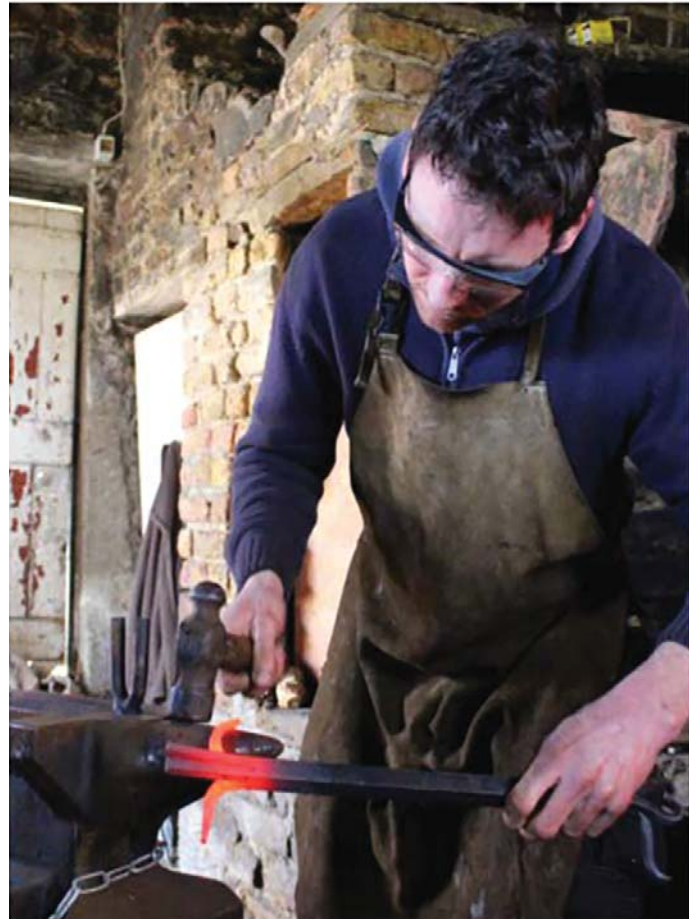
Fig. 21: Traditional method of wrought ironwork

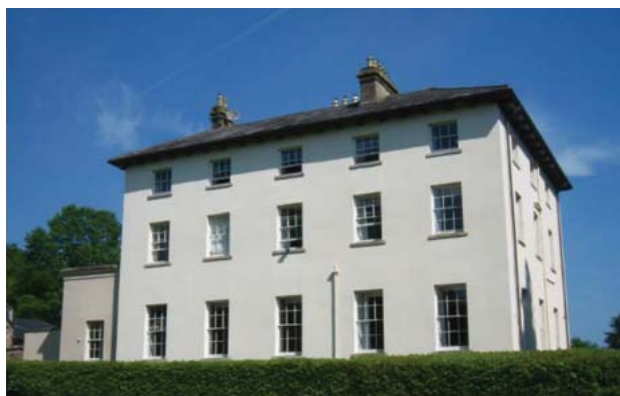
Fig. 24: A building with OPC plaster rendering

Another inappropriate use of materials is where OPC (Ordinary Portland Cement) pointing and/or render has been used and is now causing significant problems to the masonry such as cracking, delamination, water retention, etc. ultimately leading to structural failure and decay.

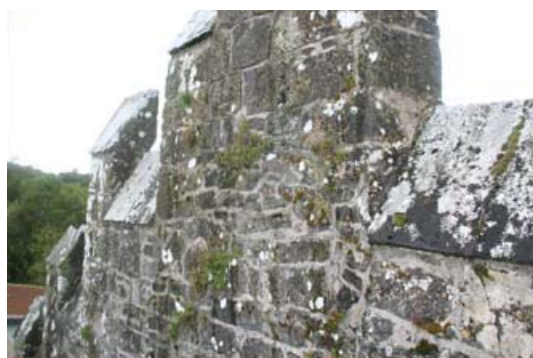
Fig. 26: Cement pointing done leading to stone damage

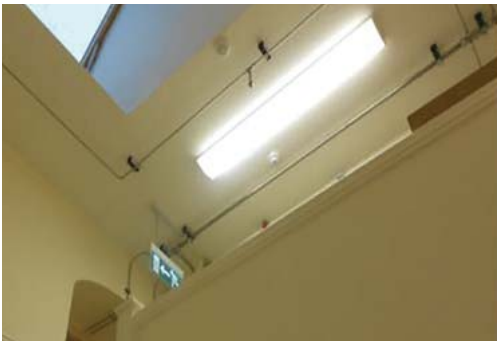
Fig. 28: Electrical fittings and fire safety equipment installed in traditional building

ACP has successfully upgraded many historic buildings to meet these requirements, but there are instances where some officials will not accept tried and tested solutions such as the introduction of high pressure mist systems in favour of fire escapes etc.

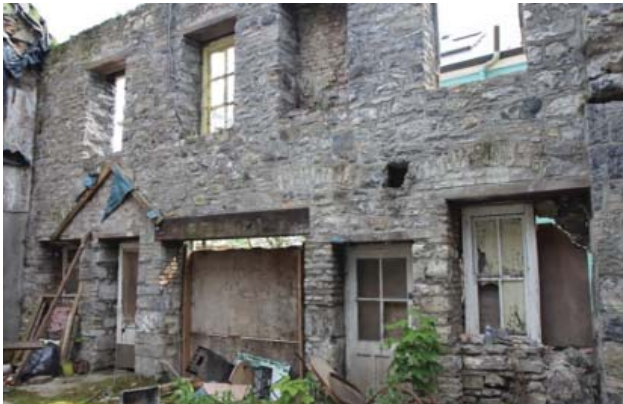
Fig. 31: The interiors of the property with the missing roof, windows and other architectural elements

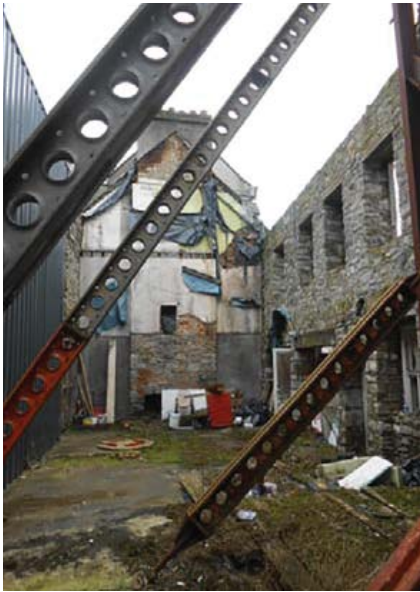
Fig. 33: All the internal walls had been demolished

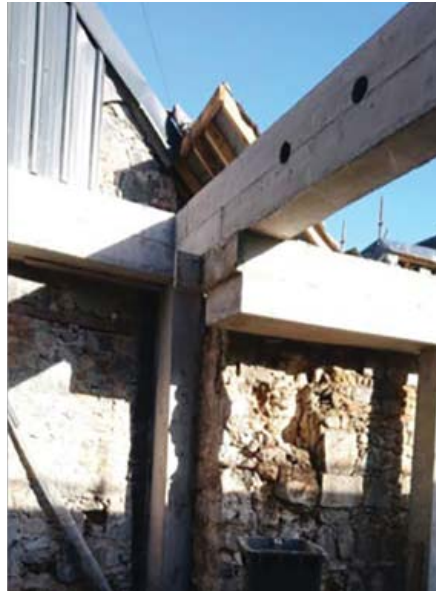
Fig. 34: Detail of the concrete frame designed to support the building

The original walls were not capable of carrying a new roof and floors due to their age and condition. A new concrete frame structure was designed to carry the roof and floors independent of the walls. This allowed for greater flexibility in designing the internal spatial layout.

The overall concept for the works was to construct a frame within the building that would carry all the structural loadings including floors, internal walls and roof. The concrete structure was specifically designed to allow it to be concealed within the final shop fit-out. It was also designed to ensure that the

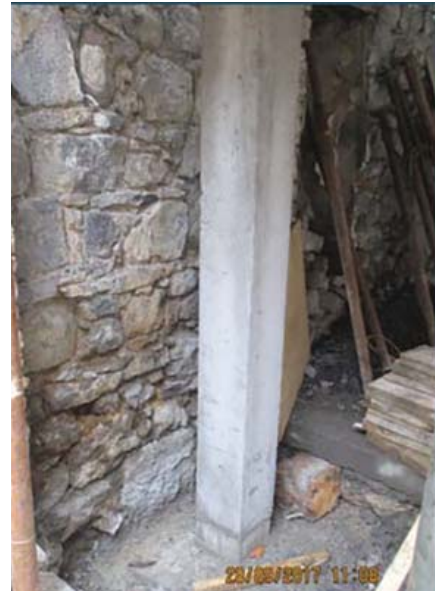
Fig. 35: Concrete column to carry the main structure

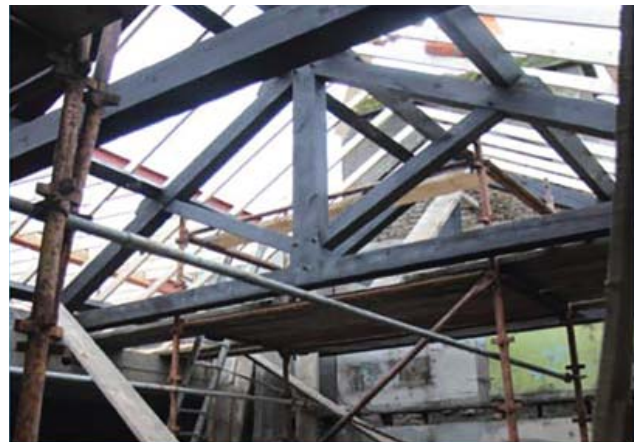
Fig. 37: The new roof being built on the concrete frame

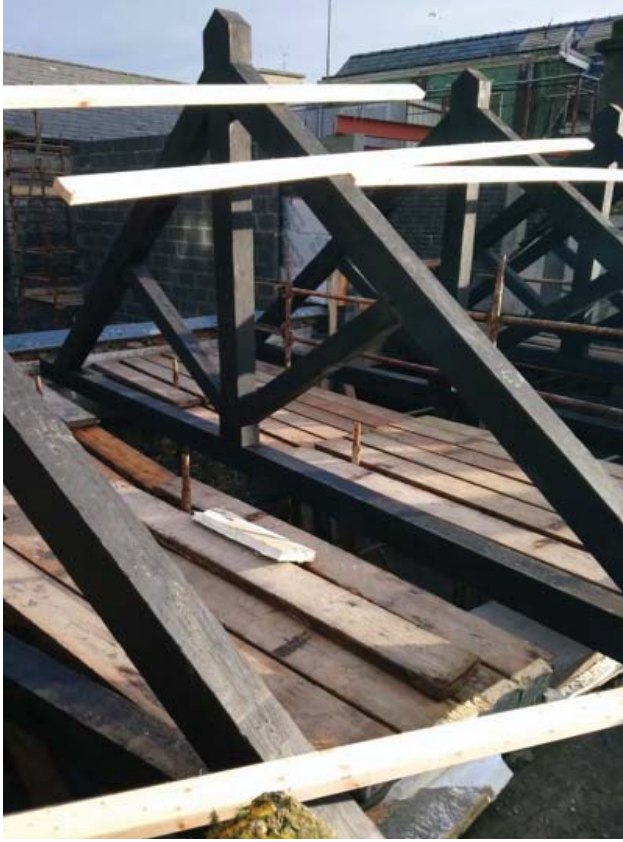
Fig. 38: 'King post' truss roof within the 19th century section of the building

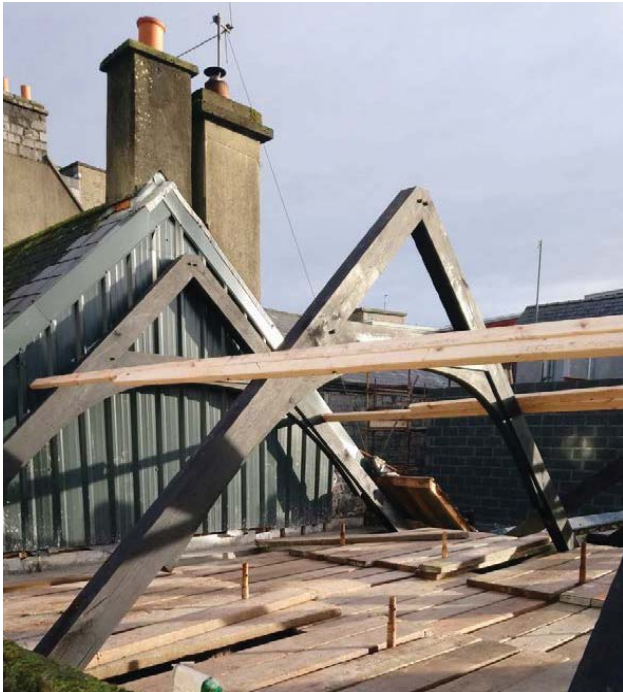
Fig. 39: Medieval style roof trusses were designed and constructed within the 15th century building section

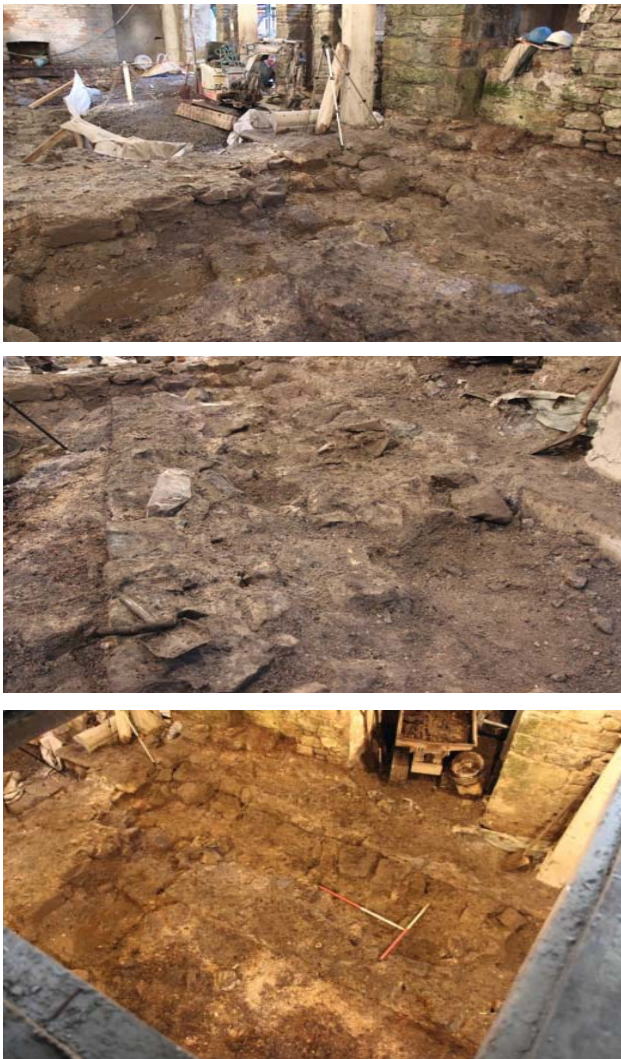
Fig. 42: Archaeological excavations in progress to explore the foundations of Caislean Na Gaillimhe castle believed to be on the site

Modern underfloor heating and flood barrier systems were all installed during the works but again were all concealed and are undetected within the building. During the excavations the original shore line and the foundations of Caislean Na Gaillimhe castle were discovered within the building (under the site) and these were recorded, preserved in situ and a section is left exposed under a glass floor. The archaeology was undertaken during the construction stage and was planned and coordinated with the contractor to allow for a phased approach.

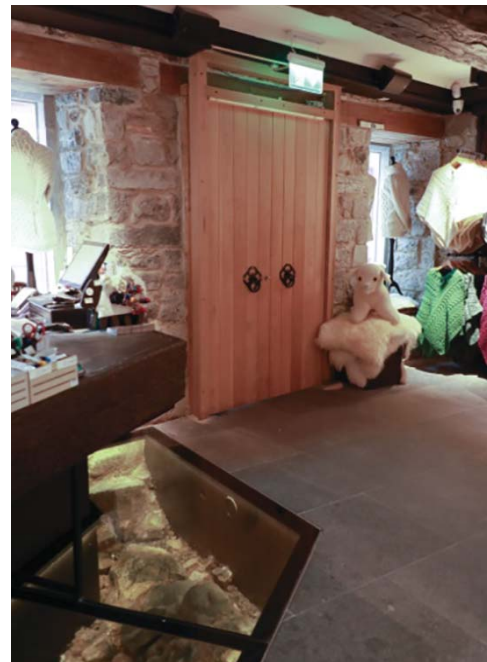
Fig. 43: The section of the castle wall excavated preserved under the building and illuminated for visitors

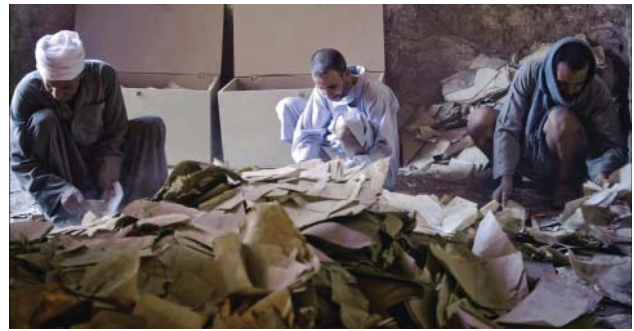
Fig. 1: The archive as initially found, Photo by Ayman Damarany

The Abydos Temple Paper Archive Project (ATPA) is a joint Egyptian-American mission under the auspices of the State Department of Antiquities and the University of California. When current curators reopened a room in the area known as the slaughterhouse in the Temple of Seti I in Abydos for photography by current investigators in 2013, thousands of archival documents of the Sohag inspectorate and the Egyptian Department of Antiquities were found scattered on the ground (Fig. 1).

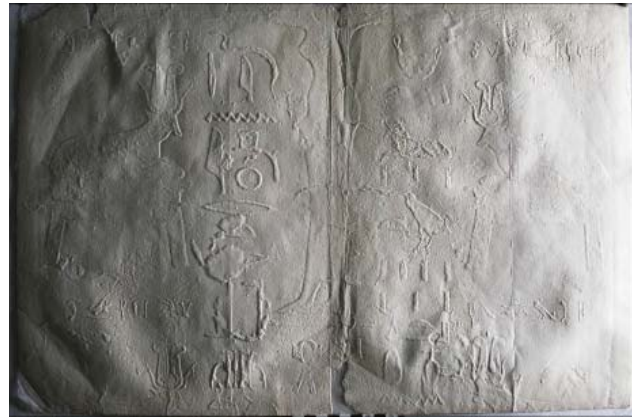
Fig. 3: An example of a squeeze found in the archive

mention different locations, even though they are related to the same topic. Thus, all separate sheets were given an index number (C), while the ledgers, which consisted of a ledger of entries, were given a ledger number (L). The entries within the ledgers were then given separate catalog numbers. Illustrations, maps, drawings, era (Fig. 3) and other forms of drawings were all given drawing numbers (D).

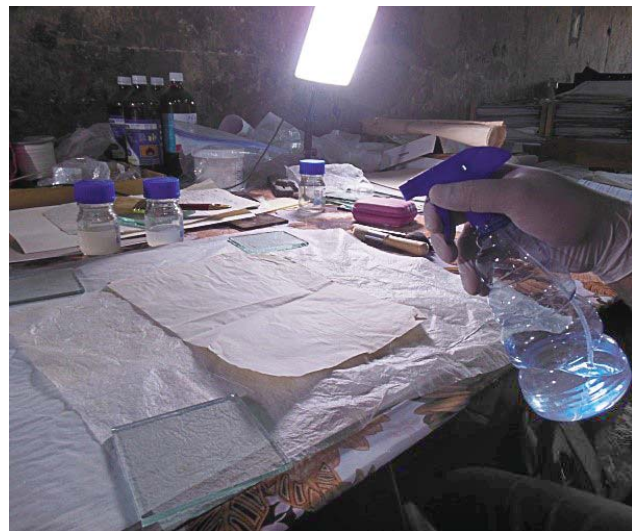
Fig. 5. The disinfection process applied by spray techniques

The disinfection process can be applied before any restoration treatments and/or after all conservation processes have been completed²⁰. The most common disinfectant in microbiology: 70% ethanol. Ethanol can also have a good toxic effect on fungi if the contact time is at least 2-3 minutes²¹ (Fig. 5).

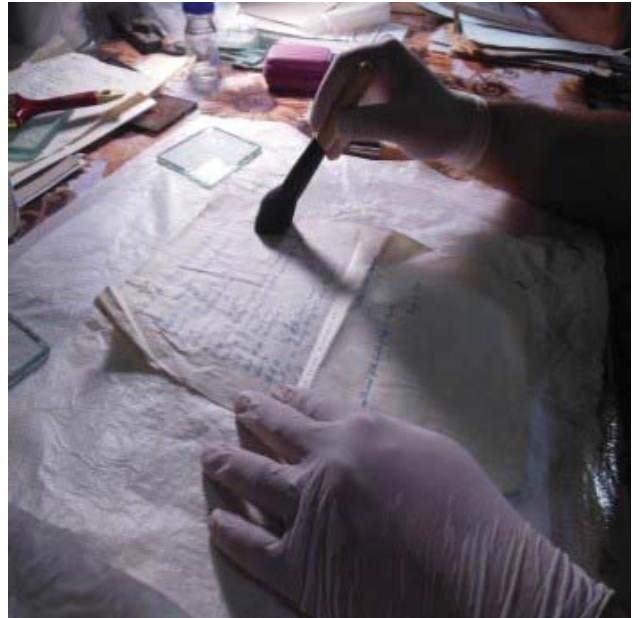
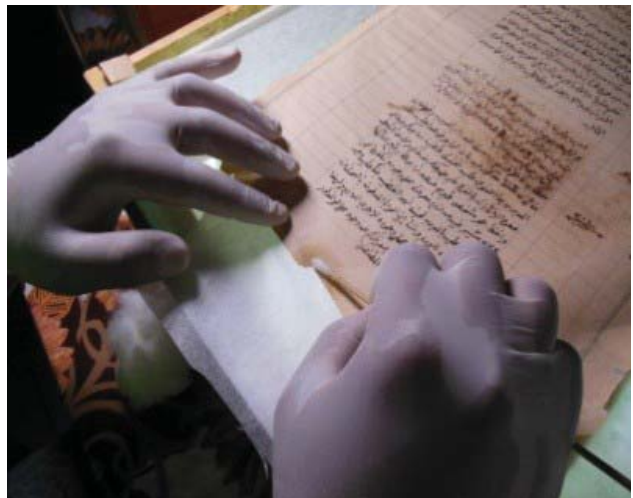
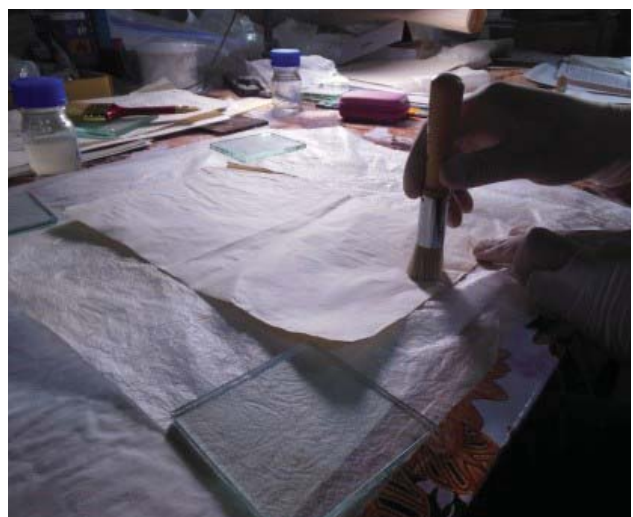
Fig. 6: Cleaning steps

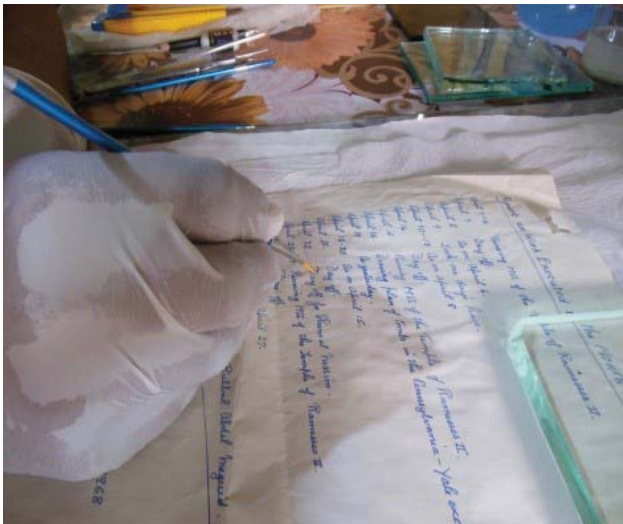
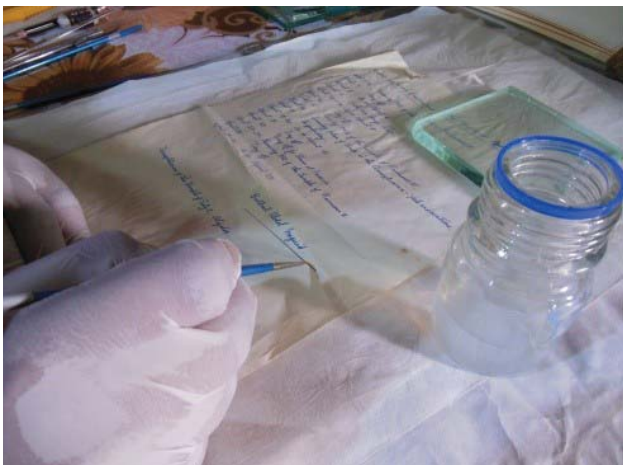
Fig. 7: Fixing some sensitive inks

different treatments should be measured²⁵. Many different materials have been used to fix water-sensitive inks. Many authors mentioned the use of Klucel G for this purpose. Klucel G (hydroxypropylcellulose) in ethanol at 0.5% was used. The area of ink is lightly painted with the consolidate using a very fine brush²⁶ (Fig. 7).

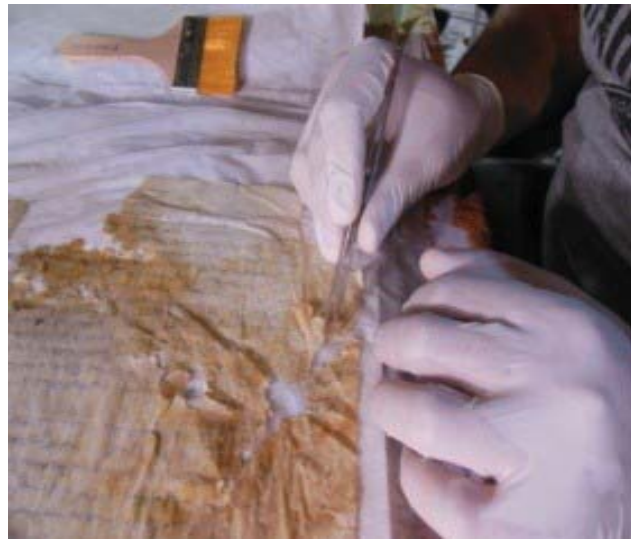
Fig. 8: Flattening steps

The mixture of alcohol and water is isotropic, meaning that both components will evaporate simultaneously. The solution has less surface tension than water, which causes the fibers to suffer less shrinkage. Removing creases and flattening the paper through moistening are determined according to the condition²⁷. 70% isopropyl alcohol can be applied directly

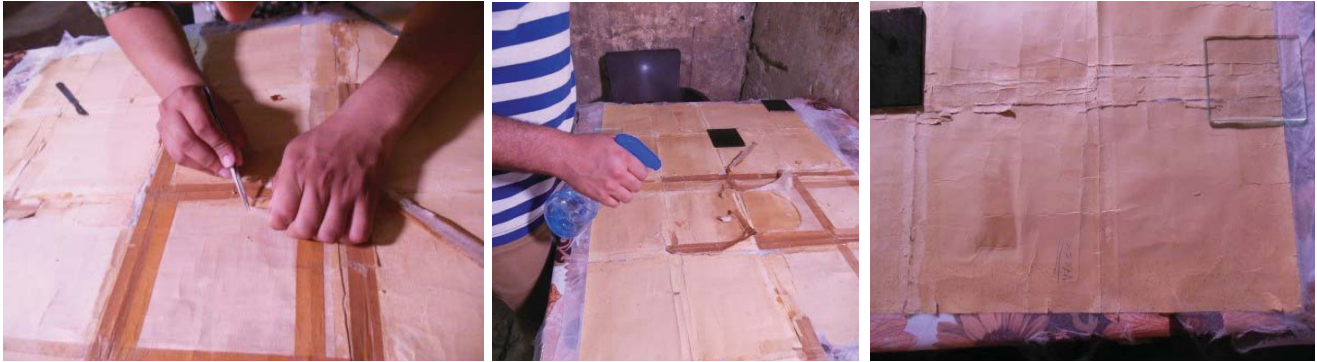
Fig. 10: Removing previous repairs

3.6 Previous repairs removal:

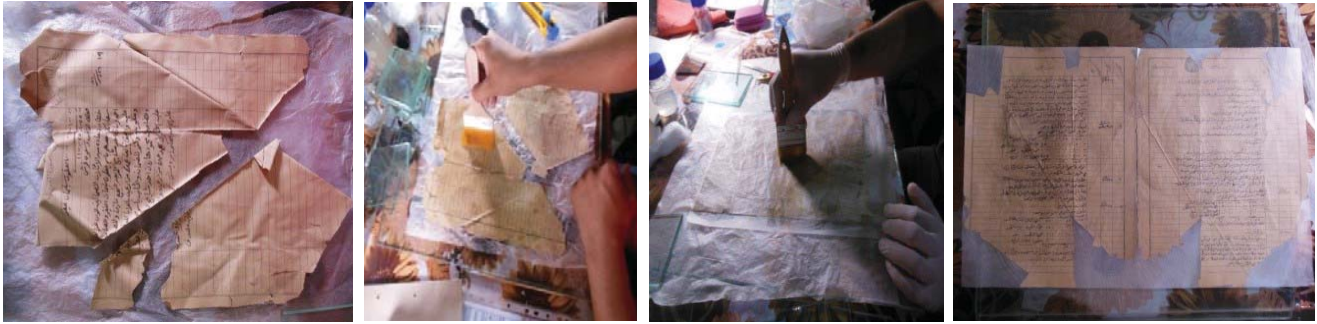
Fig. 11: Lining process steps of the weakened parts of the historical paper

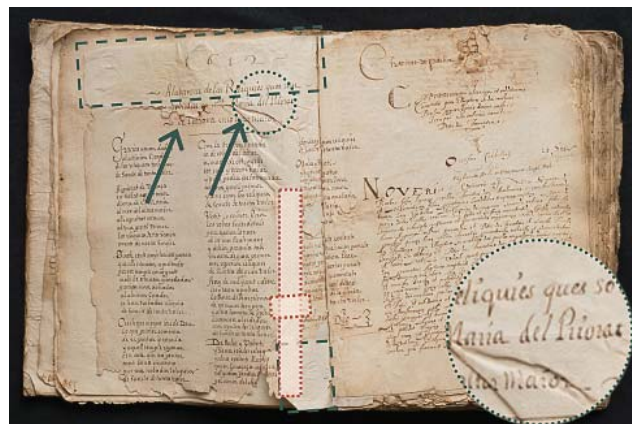
Fig. 2: Before conservation. Green discontinuous line squares the oldest adhered repairs. They caused severe tension on the original manuscript, which already had older creases. Orange line squares later pasted patches (probably repairing the creases due to the former ones). The circle enlarges a detail showing how accurately the writing on the repairs matches the text underneath. Manuscript from Regional Archive of Vallès Occidental (Terrassa, Catalonia). Foto: Pep Soler.

This 17th century manuscript is a very good example. Most of the repairs are contemporary to the writing of the manuscript and have written text on it, while hiding the former writing underneath (figure 2). The patches had been glued in a clumsy way, causing tension, wrinkles and subsequent abrasion on a much deteriorated paper.

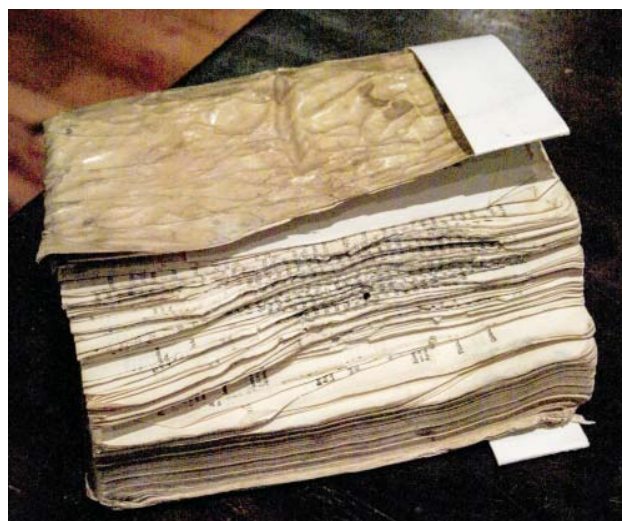
Fig. 4: Limp vellum binding with massive intended loss on folios and cover (after 1980).

A printed book with limp vellum binding and striking losses (figure 4).

A conservation report in the book explains: “Dated today all remnant of paper cancer (purple stain) has been eliminated. Bear in mind in case this paper disease arises again. October 27th, 1980. The conservator.”¹⁵

It is likely that the referred “cancer” was a fungal degradation, and it is implied that a surgical mutilation of any affected parts was executed as a conservation remedy. The eradication was indeed deadly effective, leaving no evidence of purple stains at all. The report does not provide further information, thereby the outreach and nature of the so-called disease cannot be weighted. In the mildest assumption that the treatment did save what’s left of the book from being completely lost, still it’s not for us to know what it was like before 1980.

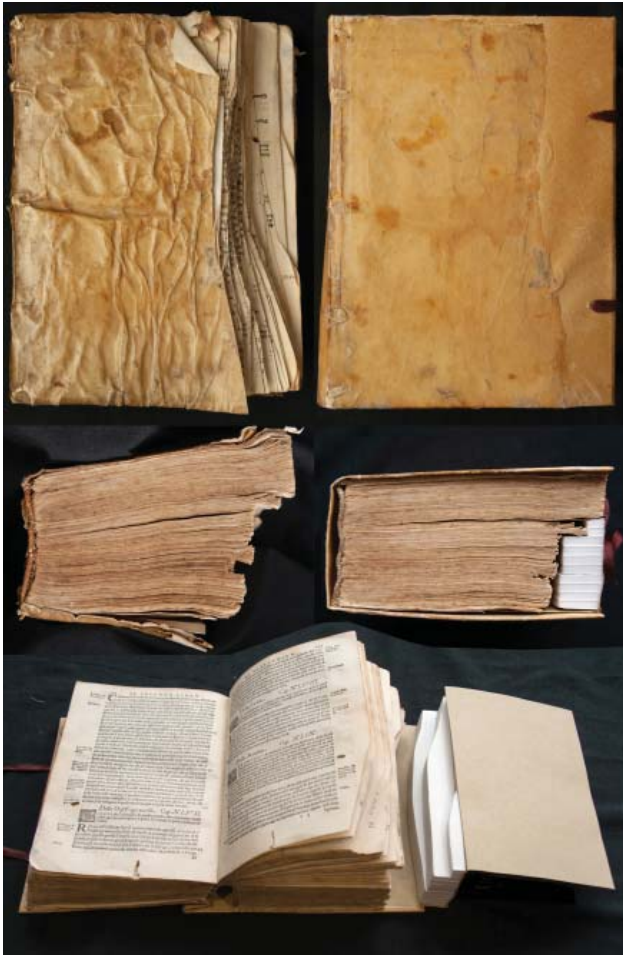
Fig. 5: Before (left) and after the conservation treatment in 2010 (right). Bottom: Foam-board to fit

which after all do not induce much further deterioration in case of handling, so only the binding was infilled, in order to recover the protective function of the book cover. A custom made foam board dovetails the shape of the textblock so that there's no distortion of the binding during storage (figure 5).

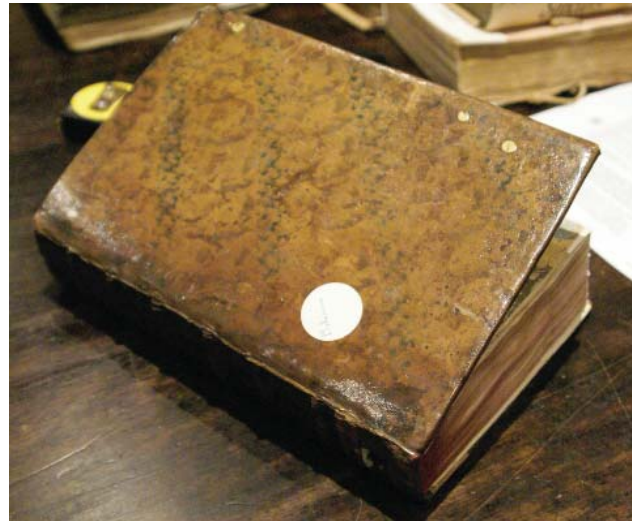
Fig. 6: Glossy leather and ineffective closing of the covers due to the shrinkage of the leather caused by the varnish

A printed book¹⁶ with red painted edges, marbled endpapers and Spanish decorated leather binding (figure 6). There were some

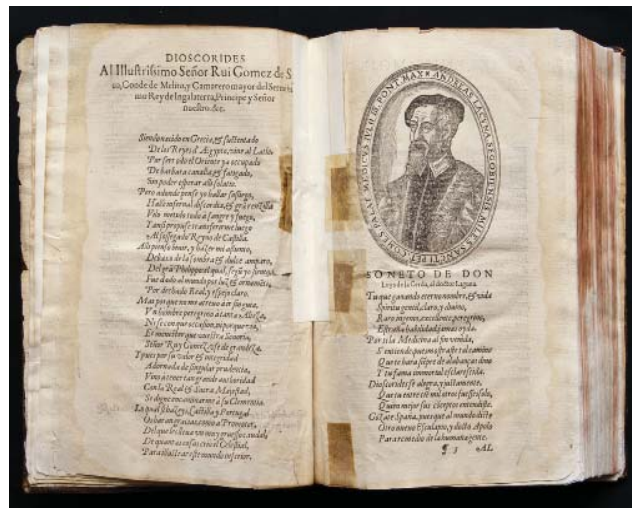
Fig. 7: Discolouration of the painted edge (right, bottom), tide-lines on the edges (left) due to bleach. Pressure-sensitive tapes and later paper patches (centre)

pressure sensitive tapes and later paper patches on top of them (figure 7). The treatment report of the former restoration was literally glued on the back marbled pastedown, stating that the book had been “Washed and restored by E.P. Some folios are missing at the end of the book. April, 1980”¹⁷.

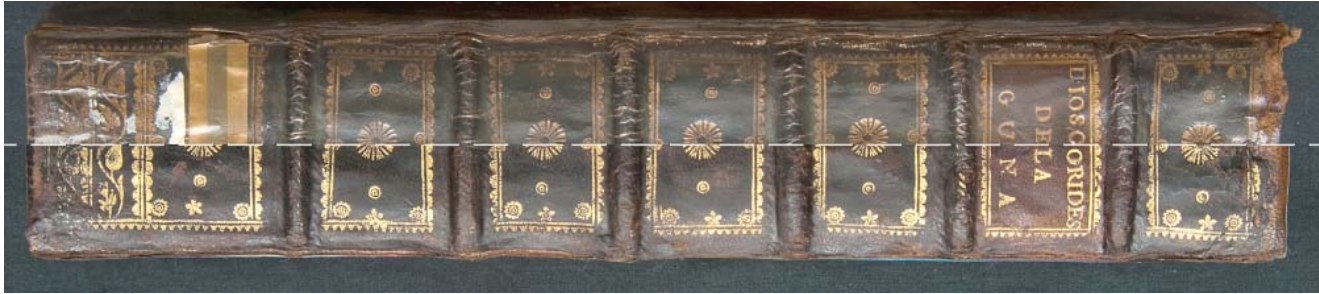
Fig. 8: Split image. Top: Treatment of 1980 (varnishing). Bottom: treatment of 2010 (varnish removal)

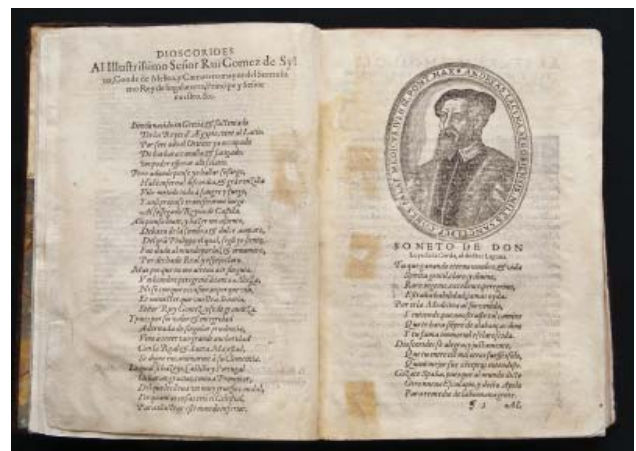
Fig. 9: After 2010: strips and tapes removed, tears consolidated again, tide-lines and bleach remnants reduced

As for the paper patches and pressure-sensitive tapes, they were all removed to prevent further damage (figure 9). The paper strips were mechanically obtrusive to proper handling and the tapes a source of oxidation on the paper fibres. It is well known that the tape carrier and adhesive remnants can be removed, but the oxidation derived from the ageing of the synthetic resin is far from being fully reverted.

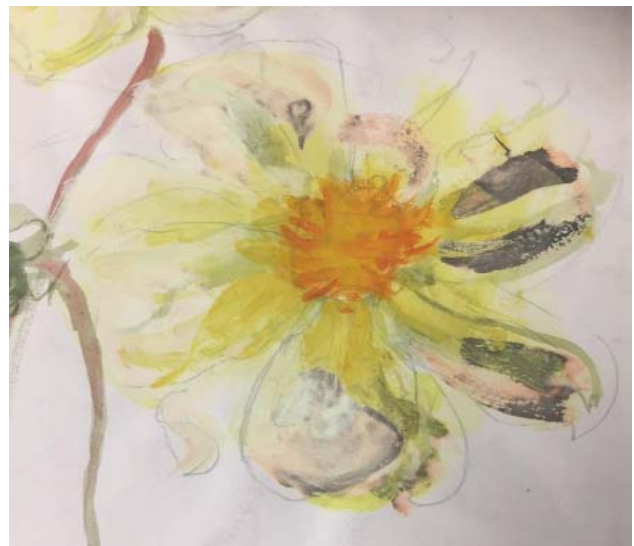
Fig. 1: Discoloration has resulted in unnatural peach and black tones. Cooper Hewitt Smithsonian Design Museum

Recognizing discolored lead white becomes easier with experience. The first clue is to spot unexpected coloration, as areas that should be highlights become dark instead.

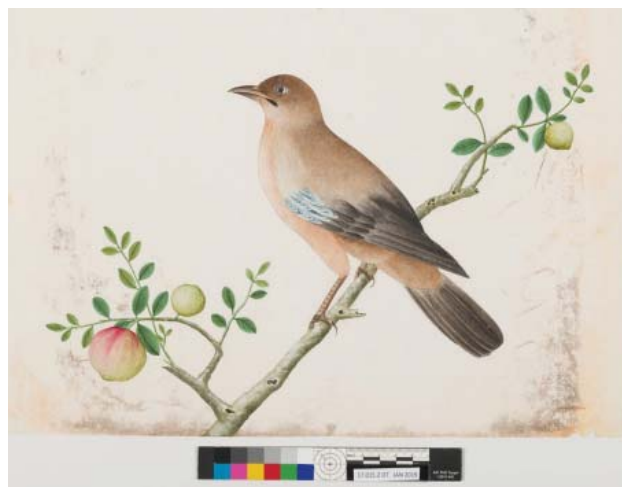
Fig. 3: Discoloration of lead white coating on paper; the edges and abraded areas were more exposed to atmospheric hydrogen sulphide. Academy of Natural Sciences of Drexel University

Lead white may also be used as a coating on paper. In this usage, the pigment is finely divided and lightly bound, so it may be particularly susceptible to chemical reactions. Unusual discoloration on paper due lead discoloration may also resemble mold staining, foxing, or grime. In a collection of lead white coated papers examined and treated by the author, abrasions also resulted in increased local discoloration, possibly because of the disruption of a protective binding layer.

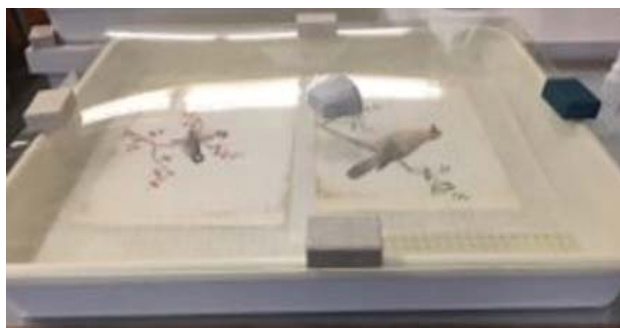
Fig. 4: Undergoing treatment in an overall vapor chamber. Academy of Natural Sciences of Drexel University

Vapor application of peroxide can be extremely successful and requires relatively less conservator time when the discolored lead white is finely dispersed and present over a larger area of the object. The object to be treated is placed in a sealed chamber with a dilute solution of hydrogen peroxide (as little as 3%). Risk of unintentional contact can be reduced by containing the peroxide in a saturated non-woven fabric at the bottom of a flat plastic tray while the object is held safely above on a plastic grate. Color changes can be monitored through a clear acrylic sheet that closes the

The exposure time in the vapor chamber can range from two to twelve hours, depending on the severity of the discoloration. The reaction is slow, but the conservator can monitor the progress while working on other projects, so this can be a relatively efficient approach to widespread discoloration. Although the object is exposed to elevated humidity, the paint is not fully wetted out so the vapor application technique can be used on water-sensitive media. This technique may not be appropriate for all objects because it will result in humidification

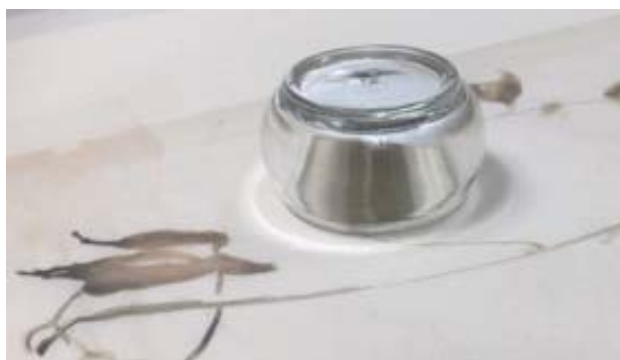
Fig. 5: Small vapor chamber. Academy of Natural Sciences of Drexel University

chamber when rested on the tray. Vapor exposure can also be limited by covering the artwork with a clear polyester sheet (Melinex or Mylar) with cutout openings exposing the discolored areas. Alternatively, a small local vapor chamber can be created over a specific area by inverting a glass container with a peroxide-soaked blotter fixed at the bottom (figure 5).

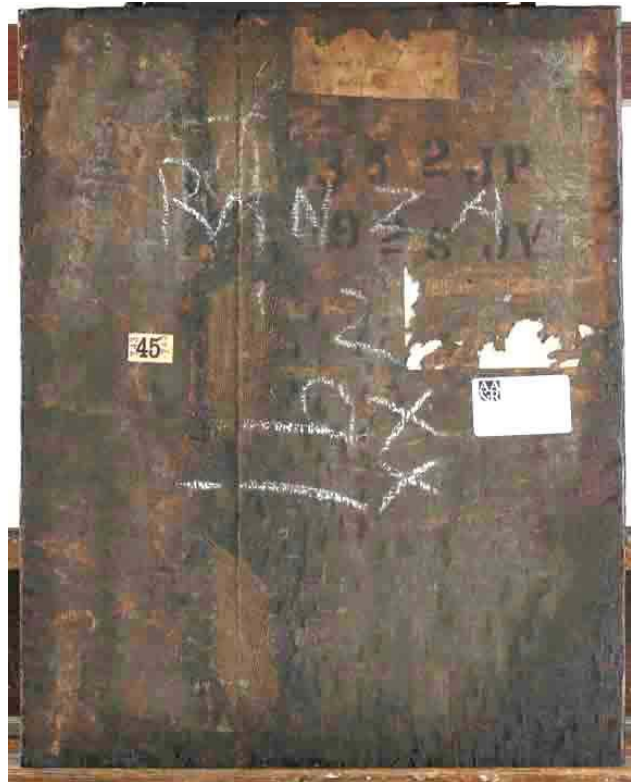
Fig. 10: Back of the panel

As has been said the painting is on an oak panel and from the 14th to the mid-17th century there was an extensive trade in oak planks from the Eastern Baltic (Fig. 9). In the Baltic the trees grew slowly giving them a straight grained, unlike in England or Western Europe where trees were encouraged to grow more rapidly and were cut down more quickly. Edward is painted on two planks, a wider and a narrower one, (Fig. 10). The wider plank has not been trimmed significantly. Its width is approx. 25cms, a width typical of boards from the Eastern Baltic

used in the 16th & 17th centuries. The original saw marks are still evident.

It was through dendrochronology that the following information was found: the panel's boards probably came from what is now N.E. Poland from a tree that was still growing in 1531, but likely to have been felled after 1539. Thus the panel was made from wood contemporary with Edward VI himself.

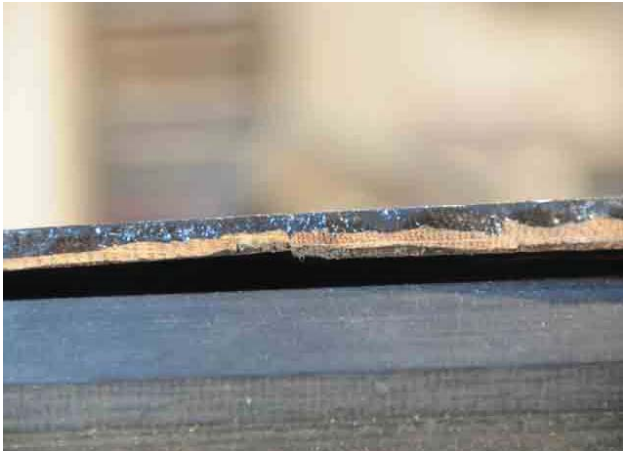
The panel's grain is vertical and visible at its top and bottom edges are tree rings, (Fig. 11). In temperate climates as the season's change there are subtly different seasonal variations each year. These variations affect the growing rate of plants and trees that in turn affects the width and distance between

Fig. 11: End grain of the panel showing tree rings

each tree rings. These variations have been studied and collated to produce master graphs. By taking accurate measurements of the distance between each tree ring, at the top and bottom edges of the panel one is able to create a graph that can be compared against the master graphs. This is dendrochronology.

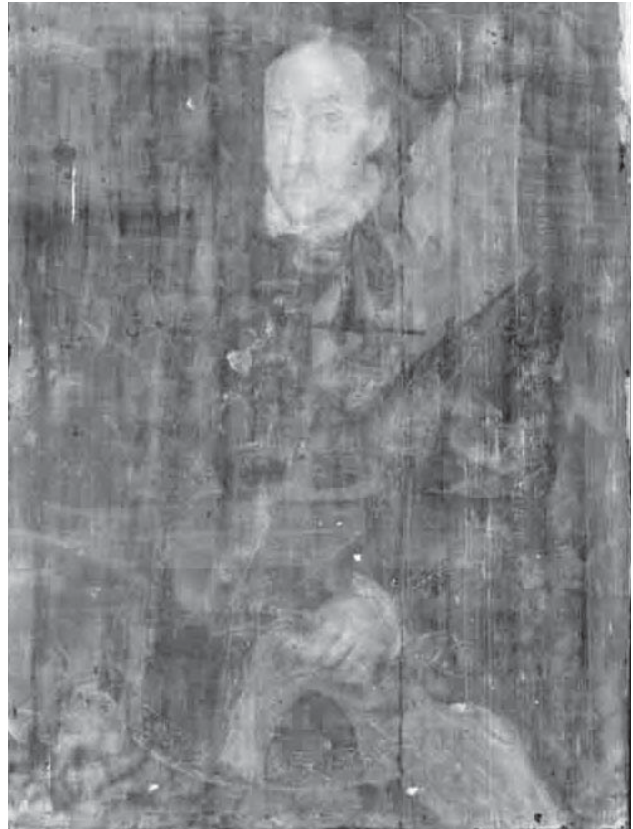
Fig. 12: X-Ray of the panel

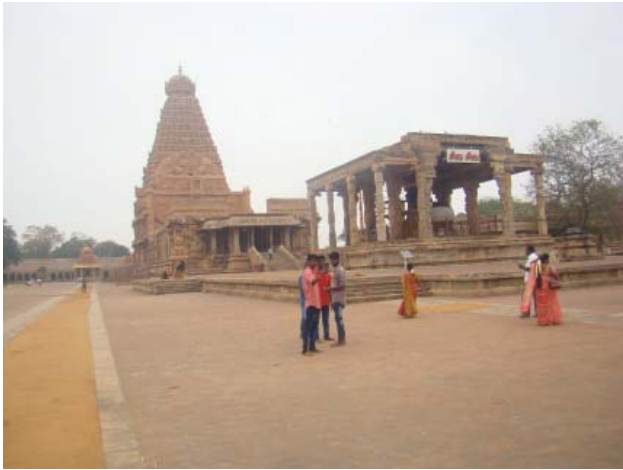
The Brhadisvara Temple is located in the town of Tanjavur, also called Tanjore, in Tamil Nadu in southern India. It was constructed around 1010 A.D. by Rajaraja I (985-1014 A.D.) of the Imperial Chola dynasty that ruled over large parts of South India and Sri Lanka from the mid-ninth to the mid-thirteenth centuries A.D. The temple has also been known as the Rajarajesvara Temple or Rajarajesvaram, after its founder. On account of its massive size (241m x 122m), the temple is locally called the Big Temple or *Periakovil* (Fig.1).

Fig. 1: Main Shrine and adjacent structures

In the Big Temple of Tanjavur, the main sanctum housing the *Shivalinga* is located almost at the centre of the large quadrangular complex (Fig. 1). The narrow vestibule or corridor on each of the four sides of the main sanctum is compartmentalized into five chambers corresponding to the five bays on the outer wall, thus resulting in two adjoining corridors meeting at right angles and sharing a common corner chamber (Fig. 2). In the eastern corridor alone, the middle chamber gives place to the doorway to provide access from the *ardhamandapa* (hall) to the east-

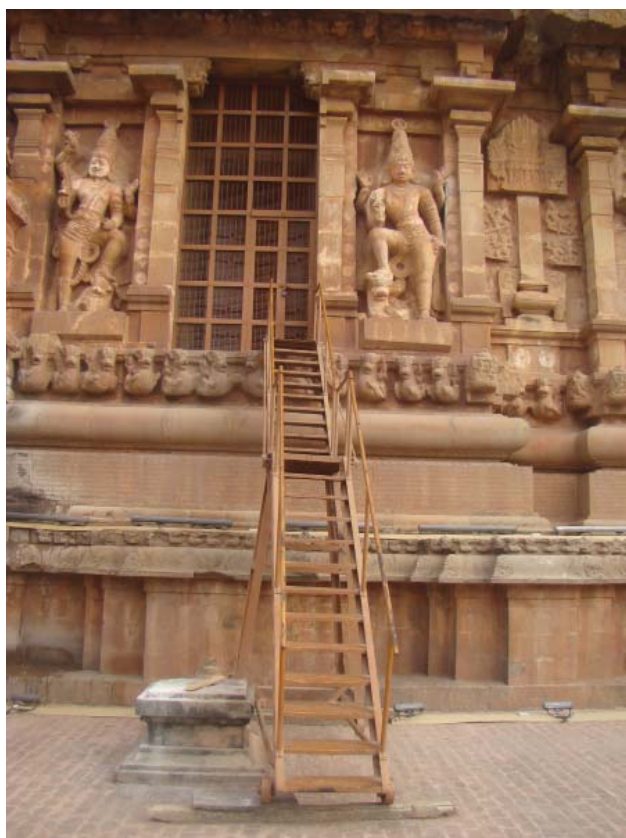
Fig. 5: Ladder leading to the circumambulatory passage

prevent the seepage of rainwater to the passage from the superstructure. In order to prevent soot and smoke from the sanctum reaching the painted walls, the two openings—entrance and exit—near the sanctum area were provided with tight-fitting doors, thereby also restricting public access to the painted passage. Presently, the passage is mostly accessed through the doorway in the middle of the southern wall. An iron ladder leads up to this doorway (Fig. 5).

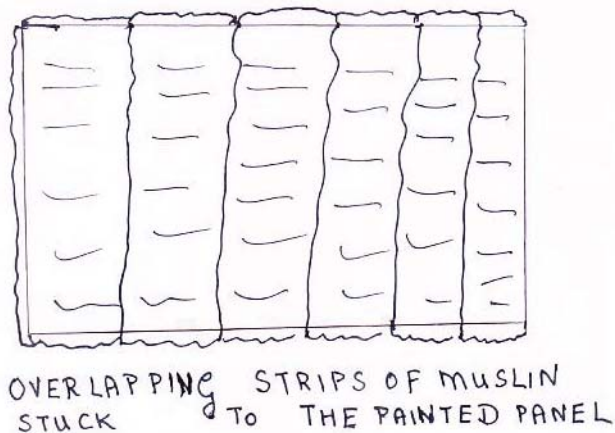
Fig. 6: Stage 1

- 1) First, overlapping strips of thin gauze, like the muslin cloth with slightly open weave, were applied with an adhesive such that the cloth firmly adheres to the painted surface without any air bubbles being trapped between the paint layer and the cloth (Fig. 6).

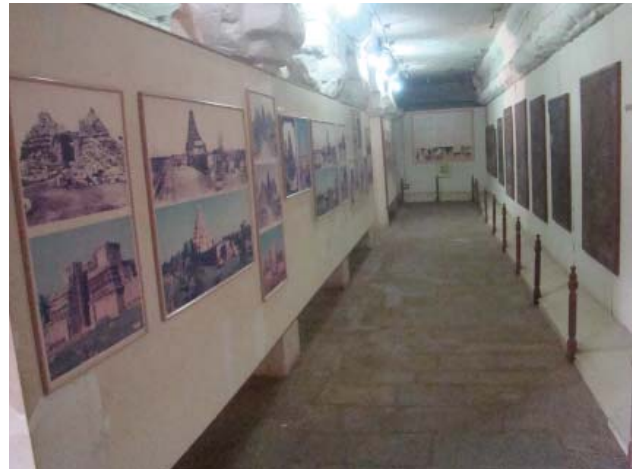
Fig. 8: Nayak period painting panels on display in a row – right wall

The Nayak painting panels are now displayed in a small museum within the temple (Fig. 8, 9). The museum also exhibits large photographs of the Chola paintings (Fig. 10). The passage bearing the Chola paintings is presently not open to the public.

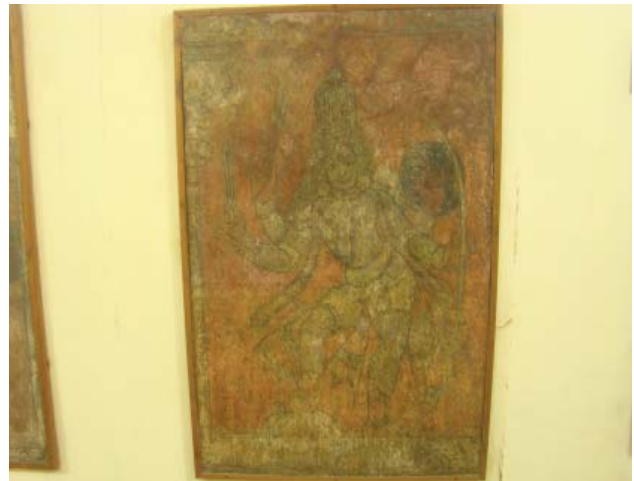
Fig. 9: Nayak period painting on display – close-up view

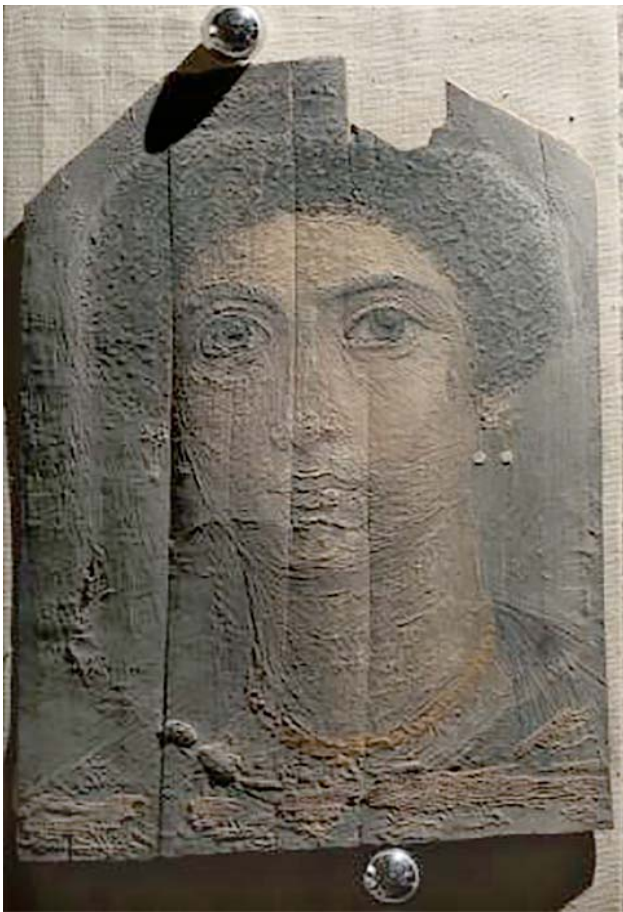
Fig. 1: Painting being studied with RTI

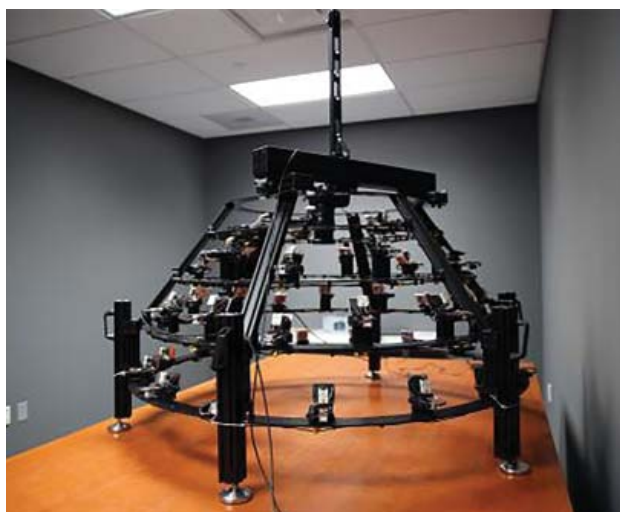
This can be achieved through the use of a dome, which consists of a light-proof structure with a large number of bulbs, each of which can be turned on individually to provide sufficient illumination to allow the fixed digital camera

Fig. 3: Standard RTI equipment

suspended over the artifact to take an image. By taking a sequence of images using all the lights, the data required for processing is acquired.

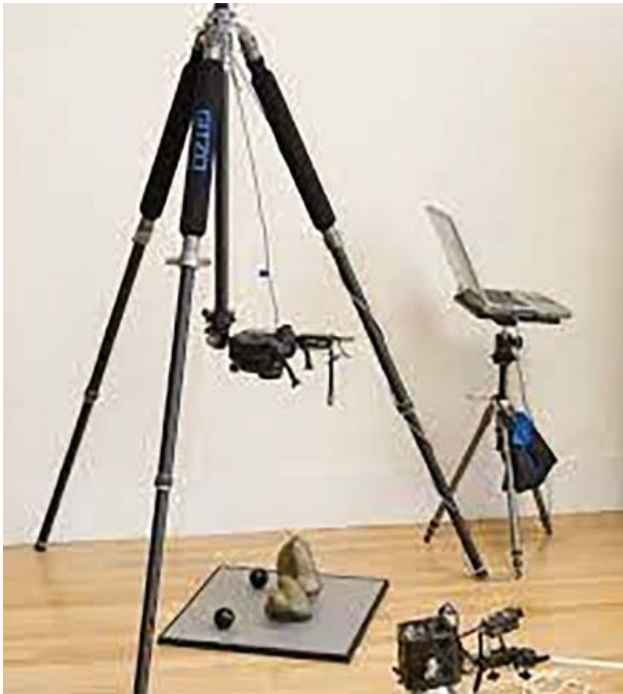
The recommended method is to connect the camera to the computer, and use the computer to control it for testing the setup, and when

Fig. 4: RTI photography

shooting the images. This way, one can trigger the camera and flash directly from the computer and download and name images at the time of capture.

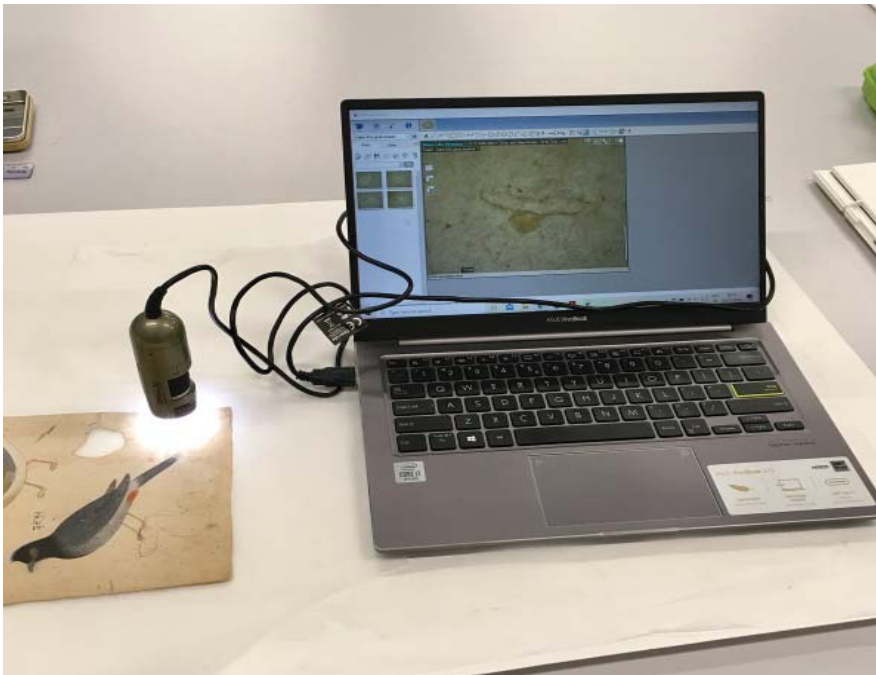
Fig. 6: Observation of the paper features with the dinolite® AM4113T-FVW

A excel spreadsheet form has been developed according to then various fields to be studied. Surface data (observation with the *Dinolite*®) (Figure 6) and structure data (mould imprints, thickness, look-through, etc) (Figure 7a, b, c, d) and composition of the pulp with sampling and fibre identification. Alongside the study of the MV drawings, the corpus is enlarged to

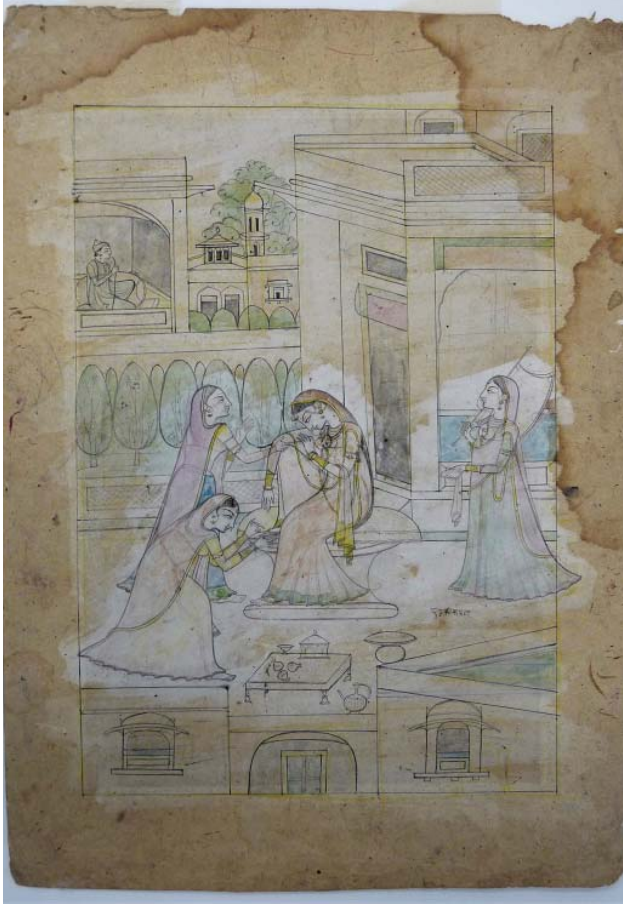
Fig. 9: Representation of Manini Nayika on the recto. Black ink and watercolour on Indian handmade paper, circa 1810-30, Kangra, RV-3025-59
