CONSERVATION INSIGHTS 2020

Lectures

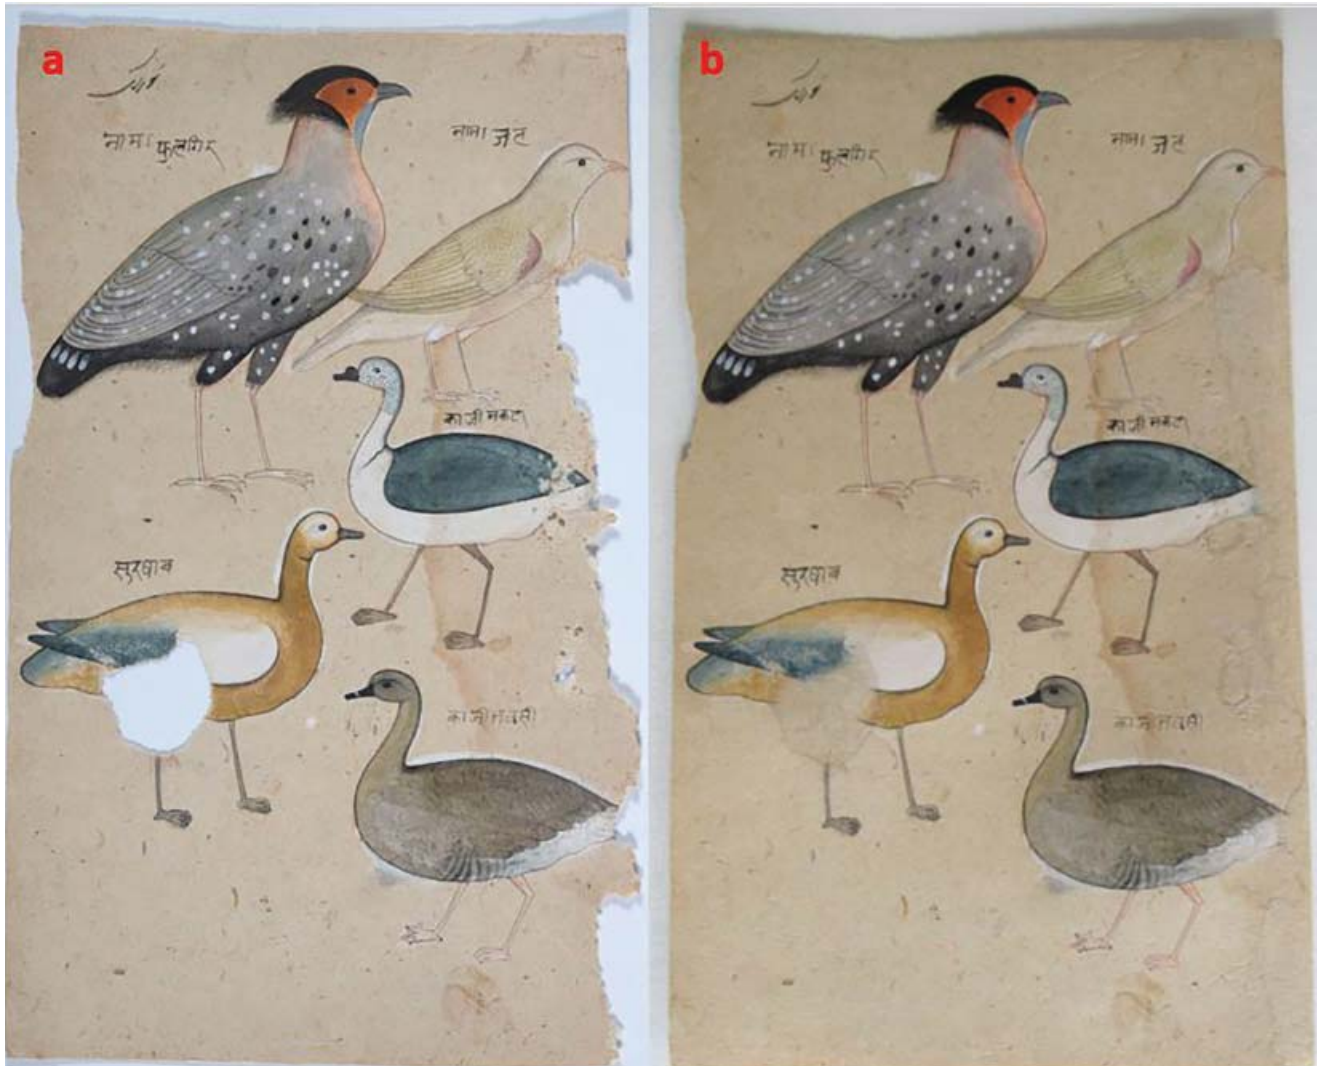
Fig. 11: Depictions of five Himalayan birds, before conservation (a) and after conservation (b), Kangra, circa 1820, opaque watercolour on Indian handmade paper, RV-3025-104

The paper supports were mended with remoistenable Japanese tissue paper ($9\text{g}/\text{m}^2$) precoated with a mixture of wheat starch paste and methylcellulose (50/50). Then, the losses

were filled in either with ancient historical paper from Rajasthani ledgers books or samar paper from Izhar Neumann. Both papers were tested and the results were positive, therefore it has been decided to use them as their texture matched perfectly with the original supports. In some cases, the infills were toned with watercolour. The contour of the loss was pin-holed on the conservation paper and cut and the resulted infill was pasted with wheat starch paste onto a supportive layer of remoistenable tissue paper. The result was judged sympathetic and matched with the expectations (Figure 11).

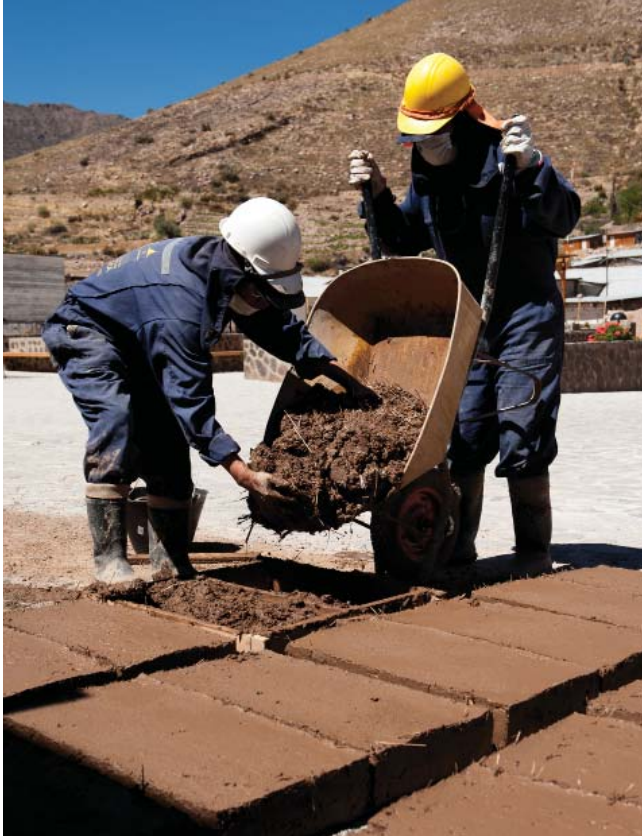
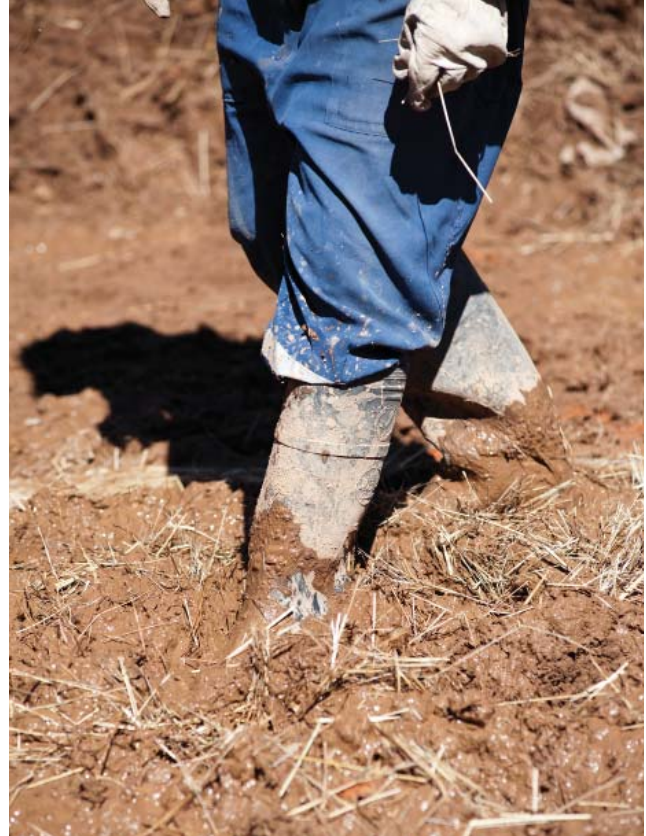
Fig. 1: Making adobe in Arica-Parinacota, Chile (Photos: Cristian Heinsen)

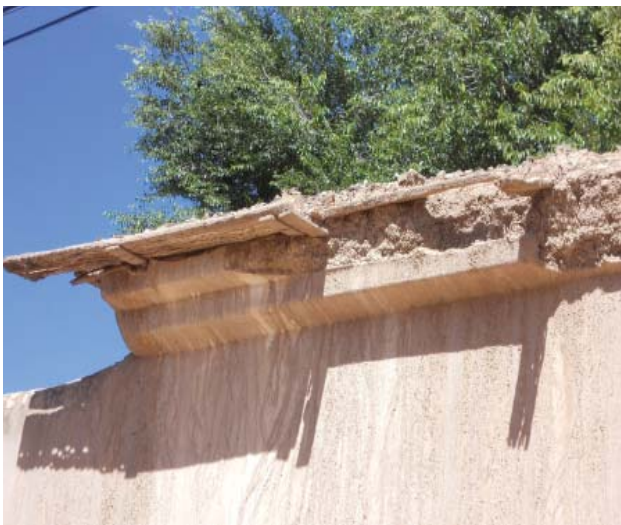
*Fig. 2: Adobe cornice damaged by moisture
(Photo: Marcelo Magadán)*

Earth constructions are **sensitive to moisture** and therefore require protection from rain, water penetration by capillarity and salt crystallization; they are **sensitive to wind erosion**; and structurally, **only work well in compression**, require a load distribution since they do not admit point loads, and in seismic areas, require reinforcement, especially at the angles and the connection between walls and foundations. Because of these vulnerabilities, earth is considered a “non-engineered” material (Quiun, Daniel, 2012). Earth construction **requires continuous maintenance**, and deteriorated mud dwellings can offer an ideal **habitat for insects and parasitic vegetation**.

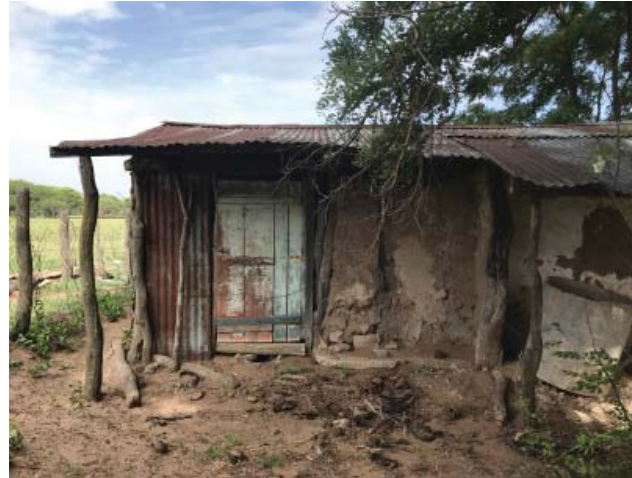
Fig. 3: Poorly maintained adobe (Photo: Kevin Gartner)

The lack of preventative conservation is a symptom of the loss of the culture of maintenance in general, but it specially affects earthen construction because of its susceptibility to water and earthquakes. In several examples mentioned before, we saw that many of the collapses caused by seismic movements occurred in structures that had not received proper maintenance. The cumulative effect of earthquakes requires constant maintenance,

otherwise, it eventually results in partial or total collapse. Earthen constructions can offer a habitat for insects and invasive vegetation but only when they are riddled with cracks and holes. A well-preserved adobe or rammed earth wall can be as much or more sanitary than a concrete or brick wall.

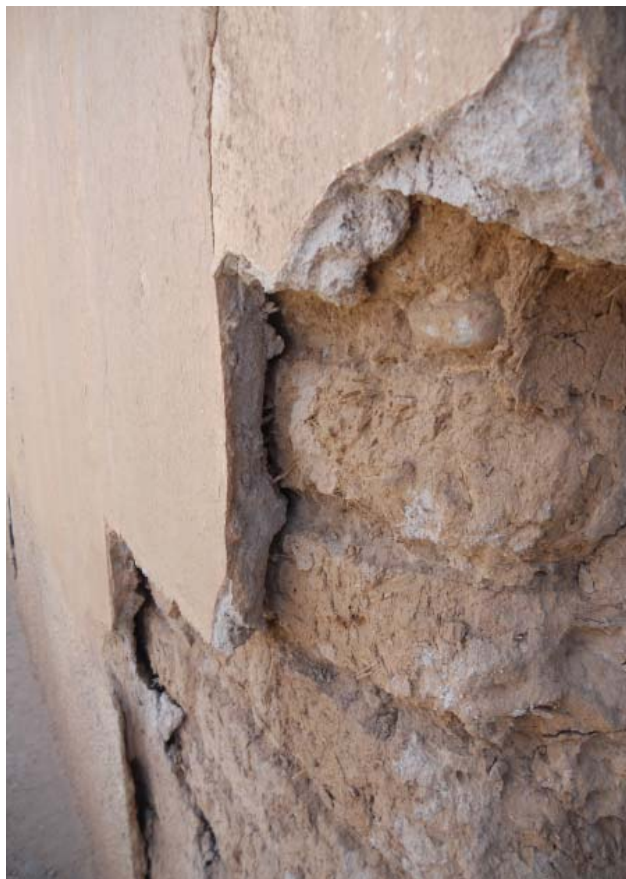
*Fig. 4: Cement coating on adobe wall
(Photo: Marcelo Magadán)*

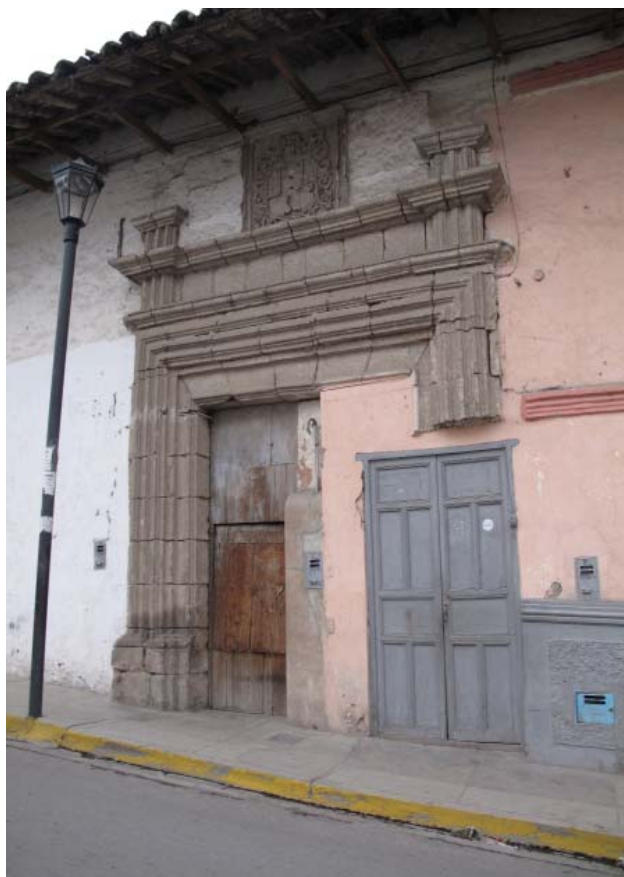
Fig. 5: Inappropriate opening (Photo: Norma Barbacci)

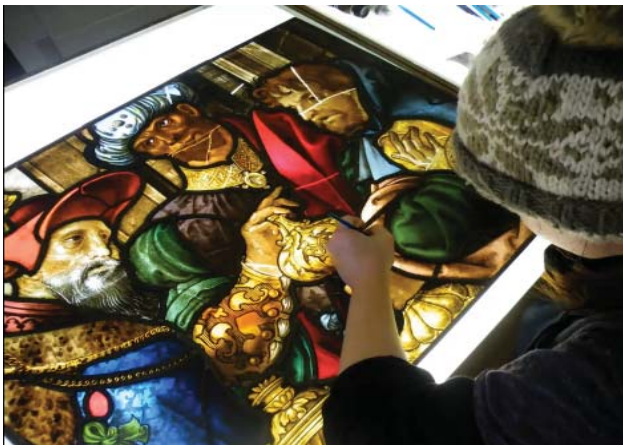
Fig. 2: Touching in of resin repairs with artist's acrylic paint on the light box

Over the years, Holy Well Glass has undertaken remarkable breadth of work to underline the stylistic differences from differing periods. Figure 2 shows a remarkable 16th century panel

from Sam Fogg gallery, demonstrating the touching in of resin repairs with artist's acrylic paint on the light box. Every white line denotes a resin repair, where disfiguring repair leads have been removed, returning the panel to near the artistic intent of the original artist. Figure 3 shows a repair to a magnificent panel by one of the greatest medieval craftsmen Thomas of Oxford from Winchester College.

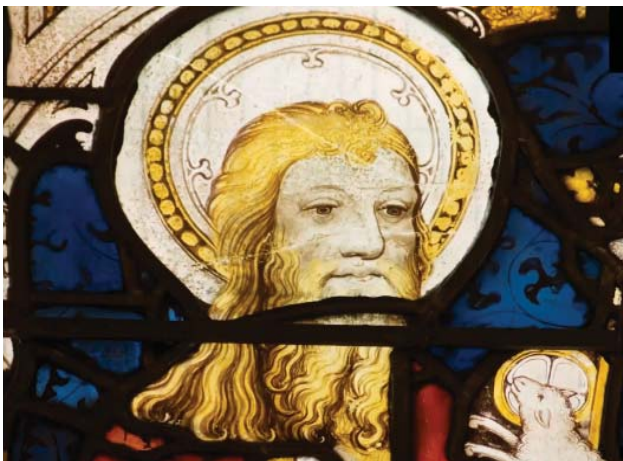
Fig. 3: Repairs in a to panel by Thomas of Oxford from Winchester College

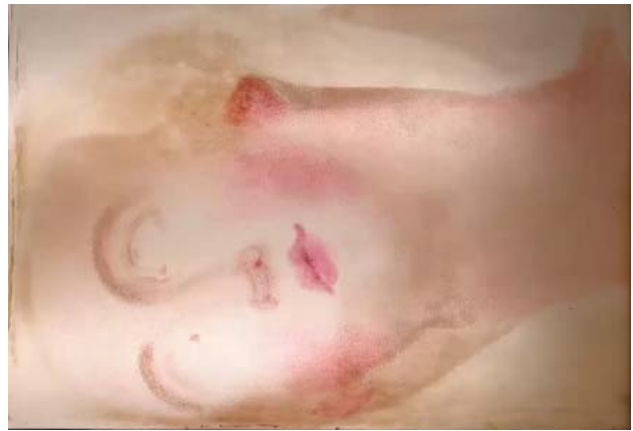
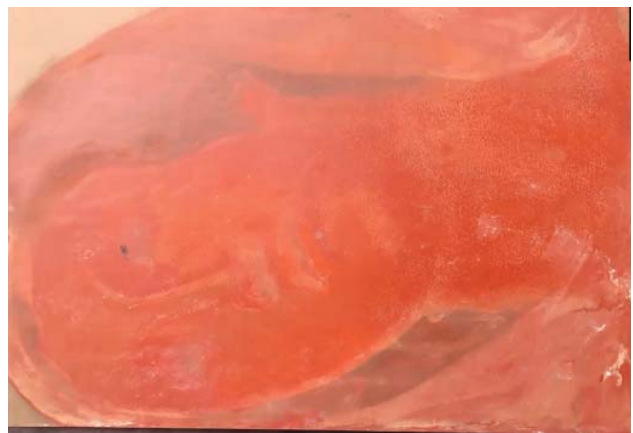
Fig. 4: Layered technique of Francis Eginton of Birmingham

is illustrated in figure 4. Eginton, who was an associate of Matthew Boulton at the celebrated Soho manufactory, developed the technique of sandwiching together, two, sometimes three pieces of paper thin crown glass with stippled transparent enamel on all faces of the glass, giving this extraordinary three – dimensional result.

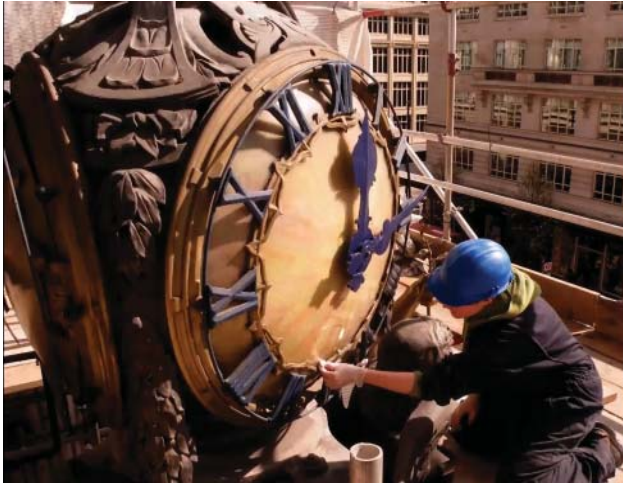
Fig. 5: Repair work being undertaken on a clock belonging to Selfridges department store

Not all glass is in windows, the fascinating clock in figure 5 belongs to Selfridges department store, which has two huge curved sections of glass containing literally millions of tiny glass beads forming orange ‘flames’. When

backlit, the effect is marvellous. Here, a scaffolder had unfortunately hit the front face and cracked the glass, and in-situ resin bonding is being undertaken to stabilise the structure.

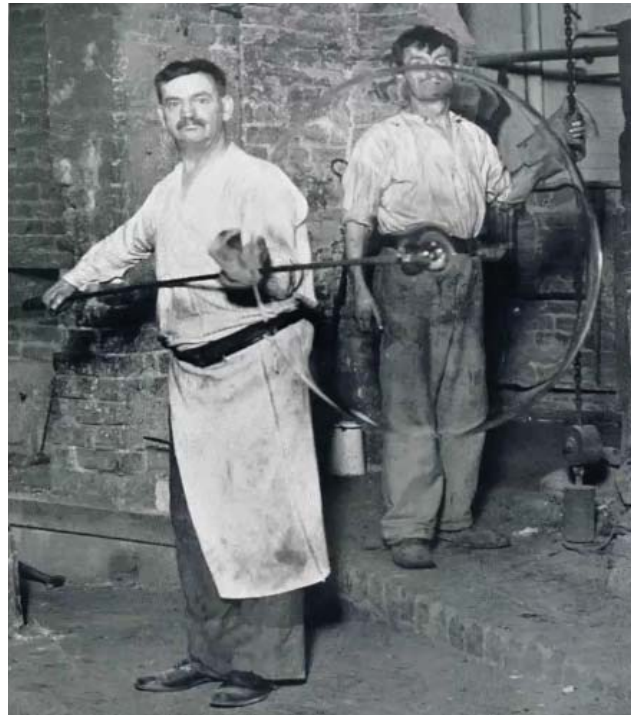
Fig. 6: Crown glass being spun by glass blower

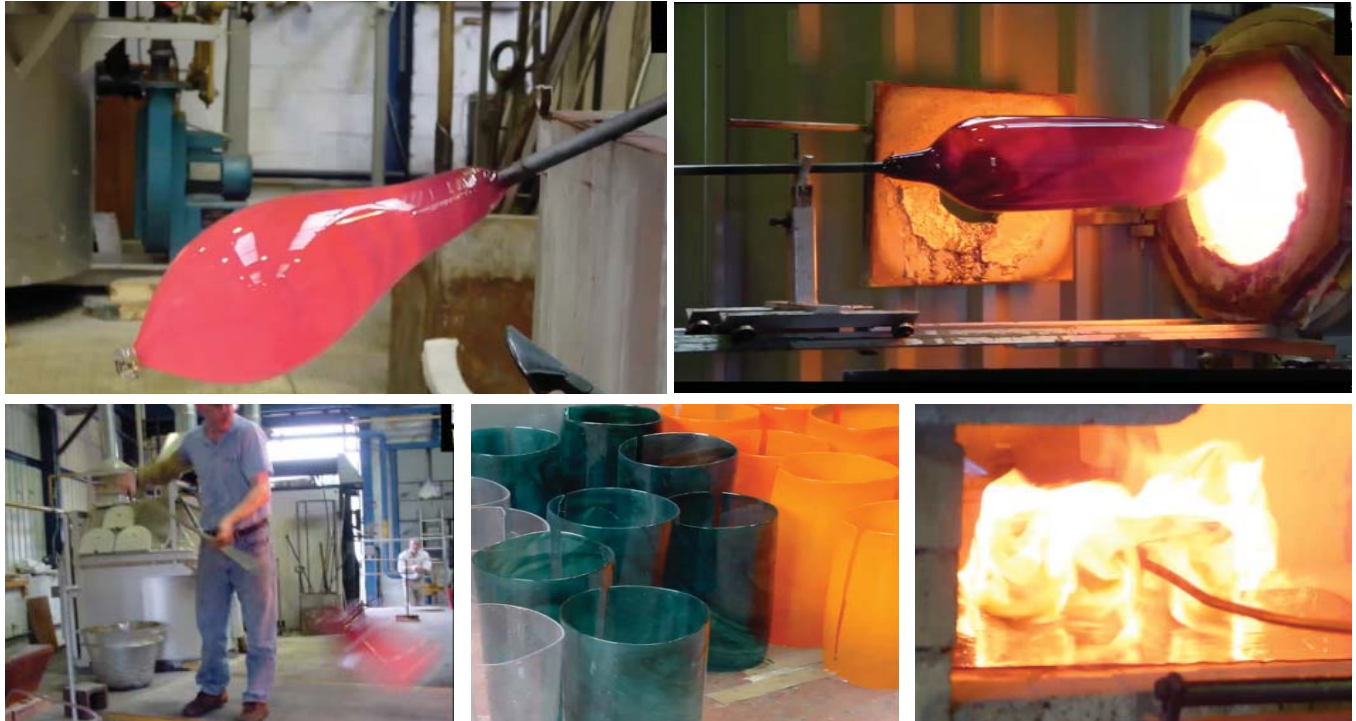
Fig. 7: Cylinder glass process

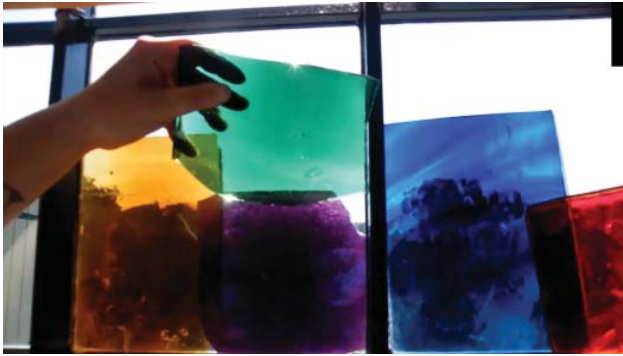
Fig. 9: Pot metal glass

etc. The colour is added 'in the pot' – hence the common term 'pot metal glass' (figure 9). Glass can also be gathered and blown in layers – termed 'flash glass'. For example, many ruby and blue glasses are flashed with white glass, because the colour is so intense, it would be difficult to see through.

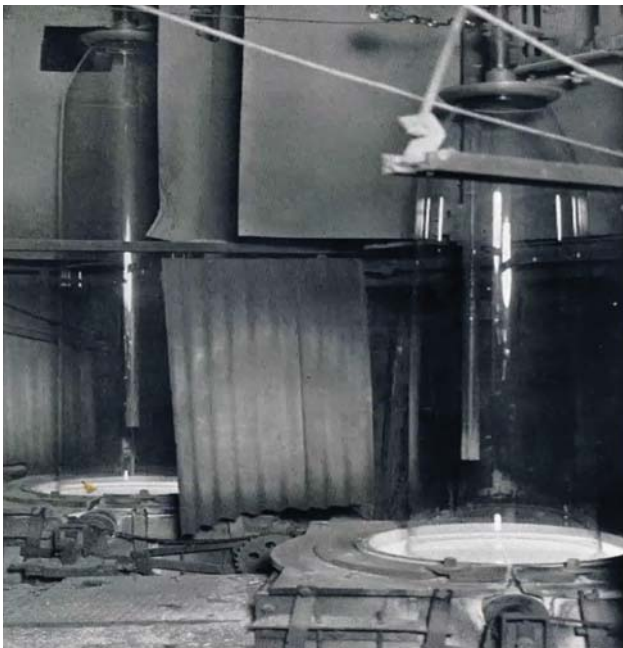
Fig. 10: The ‘improved cylinder method’, the large scale mechanization of the cylinder glass process

Of course eventually the processes were modernised and mechanised. Figure 10 shows the ‘improved cylinder method’ where huge

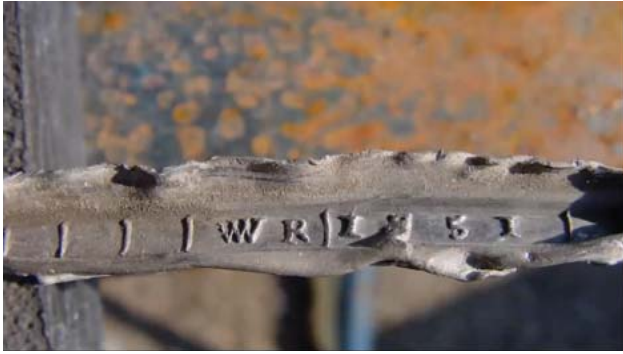
Fig. 12: Maker's mark and date on the lead

Originally the leads were cast into wooden, then iron moulds, then in the 16th century, milled were developed to extrude the leads to the sections required. Figure 12 shows an 18th century lead, with the maker’s mark and date embossed from the wheels of the mill. Needless to say, historic lead, especially very rare cast medieval leads, should be carefully identified and conserved.

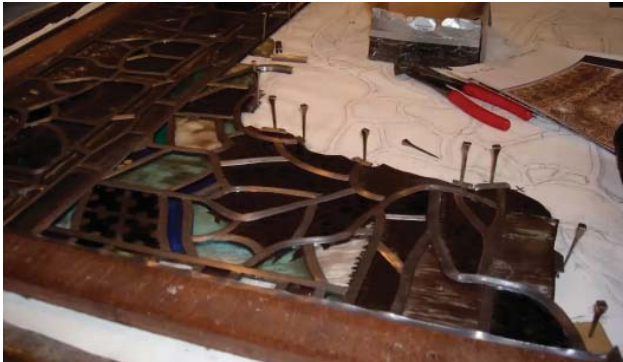
Fig. 13: Leading process

Figure 13 shows the leading process. Rubbings are taken from the original lead

work, and used as a guide to allow dismantled panels to be re-constructed. Careful rubbings not only show the relative positions of the glass, but give important information about the flow and length of particular leads – very important in historic figurative glazing.

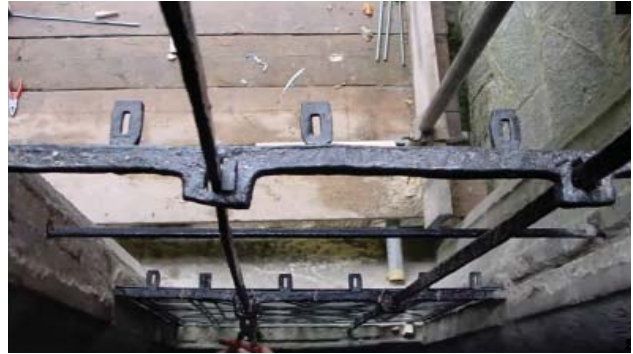
Fig. 14: Support system

Stained glass windows will not self-support. Iron bars have always been set into the stonework to support windows, and frequent strips of lead originally, then copper, the material favoured today for its greater

strength, are soldered to the stained glass panels and twisted around the support bars. Lead ties are often tied in attractive rosettes. Simple tie bars are set into pockets in the stonework, more complex interwoven 'ferramenta' are common. In the remarkable original support system, dating from around 1307 shown in figure 14, the system is typified. Panels sit on the projecting lugs, and are secured by wrought iron wedges. This fixing system was ubiquitous in England (and across Europe – where it is still commonly used) until the 19th century, when English glaziers moved to stacking panels one atop another, with overlapping division leads – a retrospective step if ever there was one.

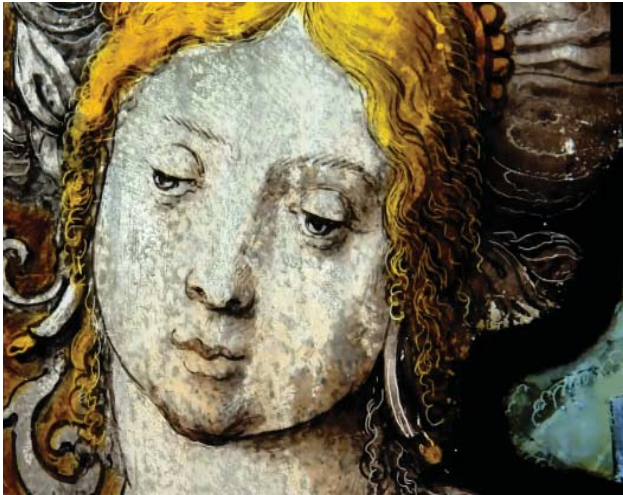
Fig. 15: Stained glass from Vyne Chapel (National Trust) with traditional surface decorations

The lovely image in figure 15 from the Vyne Chapel, National Trust has all of the traditional applied surface decoration techniques. The features are painted with glass paint or grisaille – a mixture of ground glass and iron or copper oxide, carried in a water or oil based medium, and fired onto the surface in a kiln at around 670 degrees. This technique has been in continual use since at least the 10th century. Silver stain was introduced in the early 14th century. Nitrate of silver, suspended in a clay carrier and thinned with water, is painted, usually on to the back of the glass, and fired in the

kiln at about 550-600 degrees. The glass is stained yellow, although glass type and kiln manipulation can be skilfully used to achieve a range of colours from pale lemon yellow through to deep red.

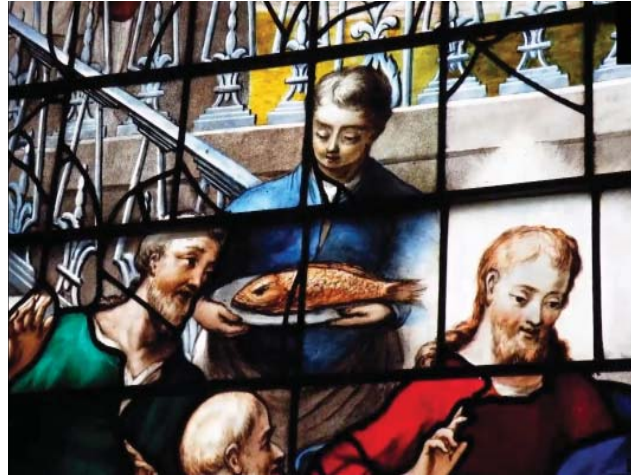
Fig. 17: 16th century enamelled window by Joshua Price

surface. Figure 17 shows an enamelled window by Joshua Price from the 16th century, where almost all of the coloured detail is applied with enamels on white crown glass.

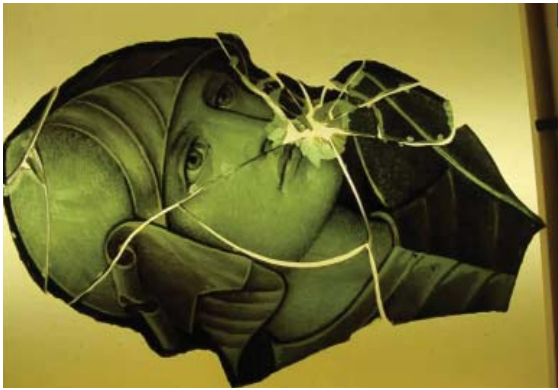
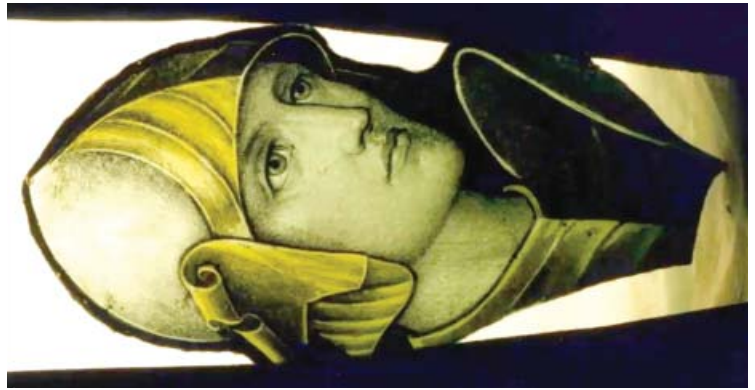
Fig. 18: Before and after images of repair work done using epoxy resin

Epoxy resins with a very similar refractive Index to glass can be used to bond glass, avoiding the need for intrusive repair leads. The resins must be accurately measured by weight. Figures 18 and 19 show examples of repairs using this technique.

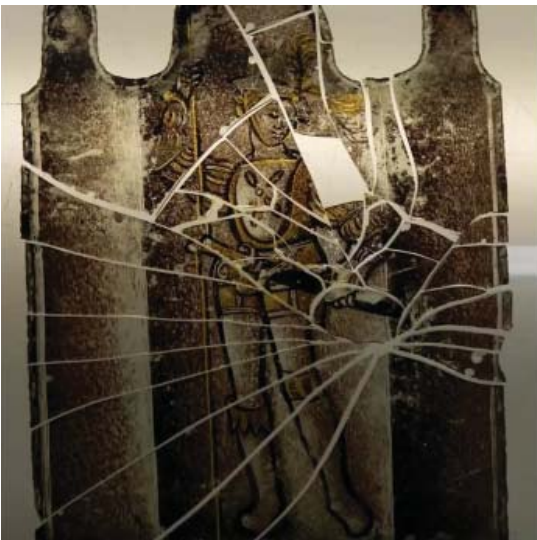
Fig. 20: Copper foil technique

Figure 20 and 21 show the Tiffany, or copper foil technique, which can be used to good effect to produce very thin repair leads. An adhesive backed copper foil is applied to either side of the crack, and soldered with a small soldering iron. The technique is very subtle, and very easily reversible.

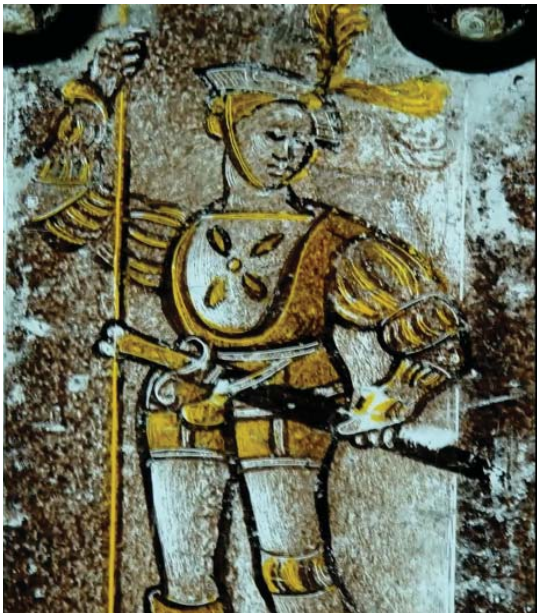
Fig. 19: Before and after images of repair work done using epoxy resin

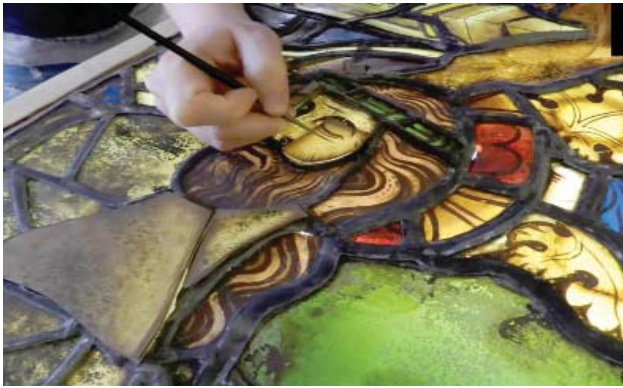
Fig. 23: Repair work on the head of Christ

replacement of the head of Christ from the great Crucifixion panel (figure 23).

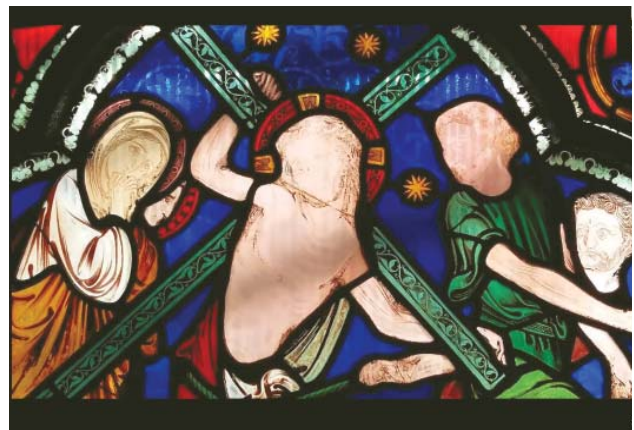
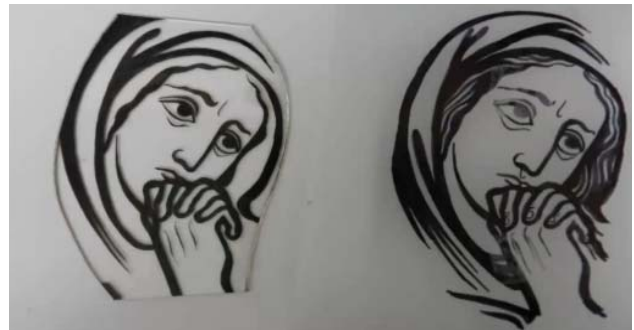
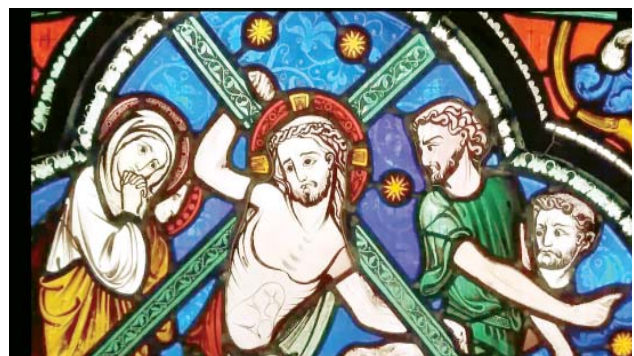
Fig. 25: Painted details lost in a panel hence new painted plates were created and inserted so that the losses are now covered

Another interesting project was the conservation, including re-leading of the 19th century Great East Window at Worcester cathedral by Hardman (figure 24). Of particular interest is the usage of painted 1mm thick painted plates to support the images in critical areas where painted detail has been lost through under-firing (figure 25) and re-leading of these huge windows (figure 26).

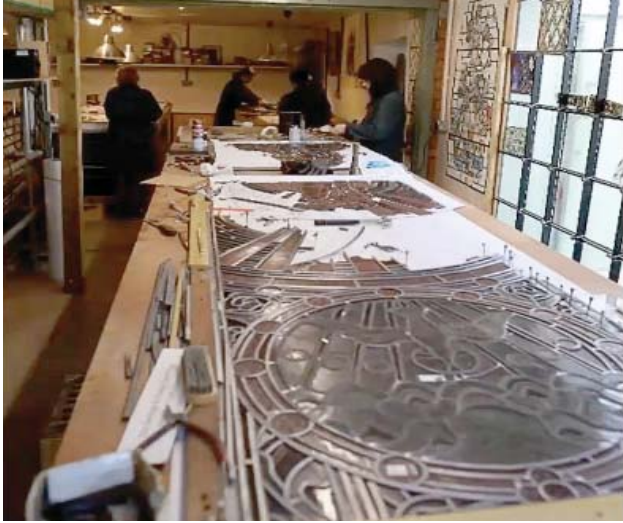
Fig. 26: Re-leading of the Great East Window panel

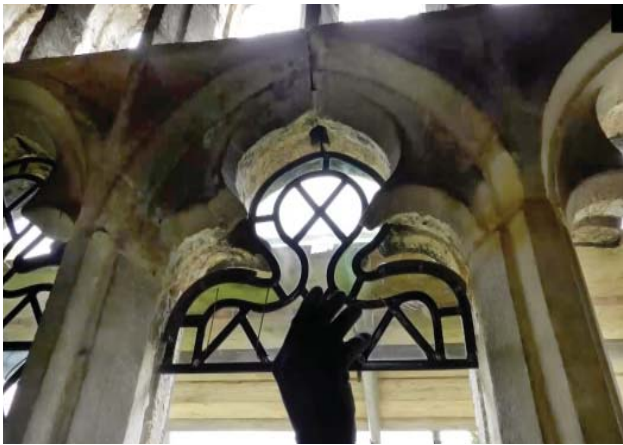
Fig. 27: Stained glass panels being inserted into the groove in the stonework

Stained glass panels fit into grooves in the stonework (figure 27). It is imperative that accurate templates are taken to ensure accurate fit. Lime mortar should always be employed. Figure 28 shows the mortar being roughly applied, compressed and attended by water spraying, and finally scraped back to raise the surface of the aggregate and ensure curing of the lime.

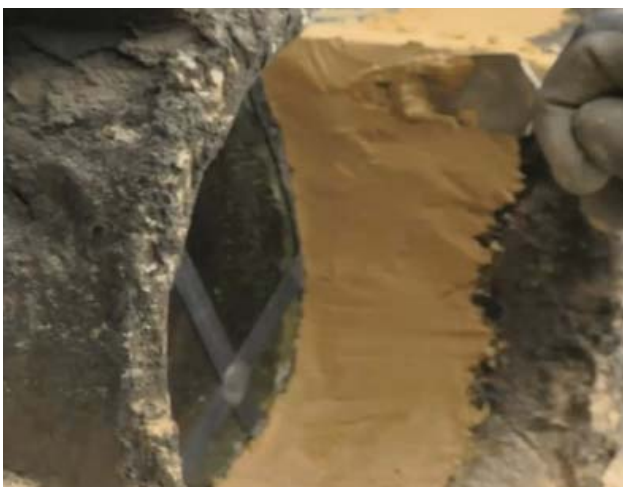
Fig. 28: Application of lime mortar for fixing panels in stonework

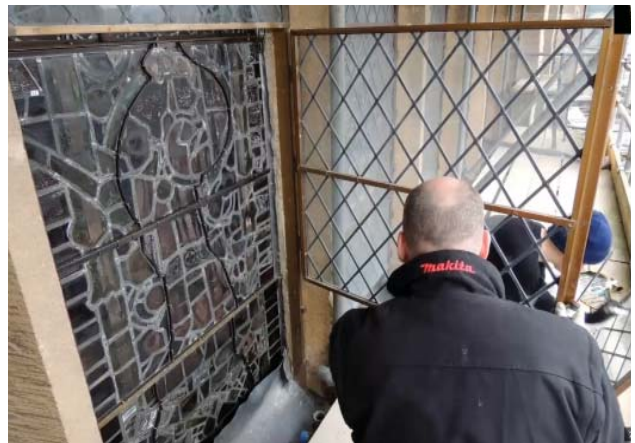
Fig. 29: EPG system

Figure 29 shows the EPG system applied at Wells cathedral, with hinged bronze opening frames corresponding to the panels of medieval glass. Note the additional shaped vertical bronze bars inserted as extra support as the decision was taken not to re-lead the stained glass.

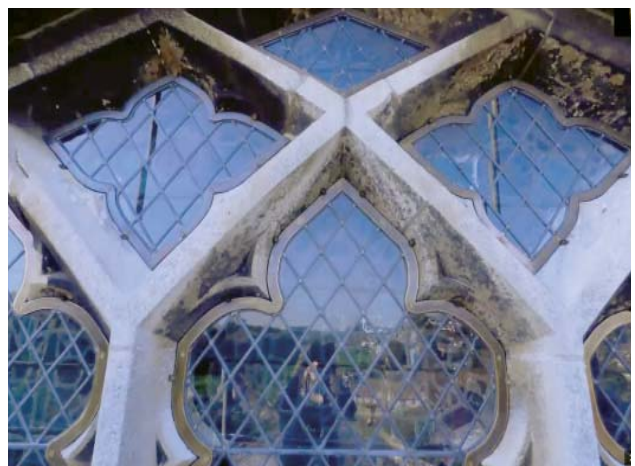
Fig. 30: EPG system where 3D scans were taken to cut bronze frames for external glazing

3D scans were used to produce accurately cut bronze frames for the tracery sections. Figure 30 shows the same system refined for medieval glass at Exeter cathedral, meaning that the external glazing is completely invisible from ground level. Images Figure 31 show partial EPG system, used to avoid architecturally intrusive treatment of entire windows. Holy Well Glass is involved in the

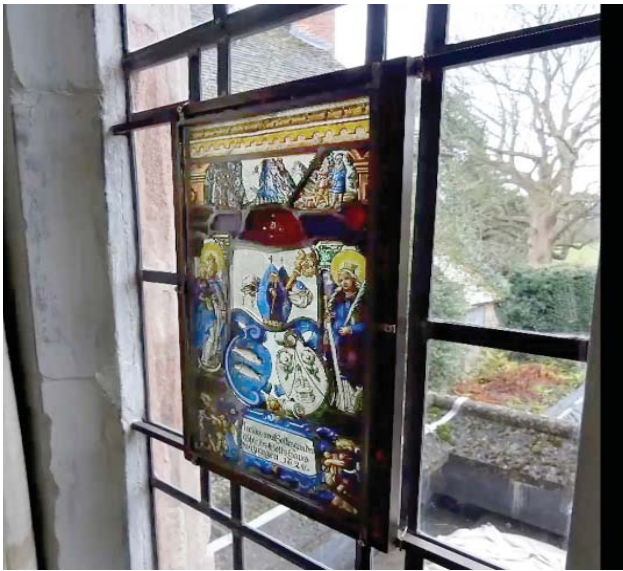
Fig. 31: Partial EPG system

technical evaluation of partial EPG, and the application of EPG to tracery sections, in an important collaboration with Tobit Curteis Associates, a study sponsored by Heritage England at Exeter cathedral.

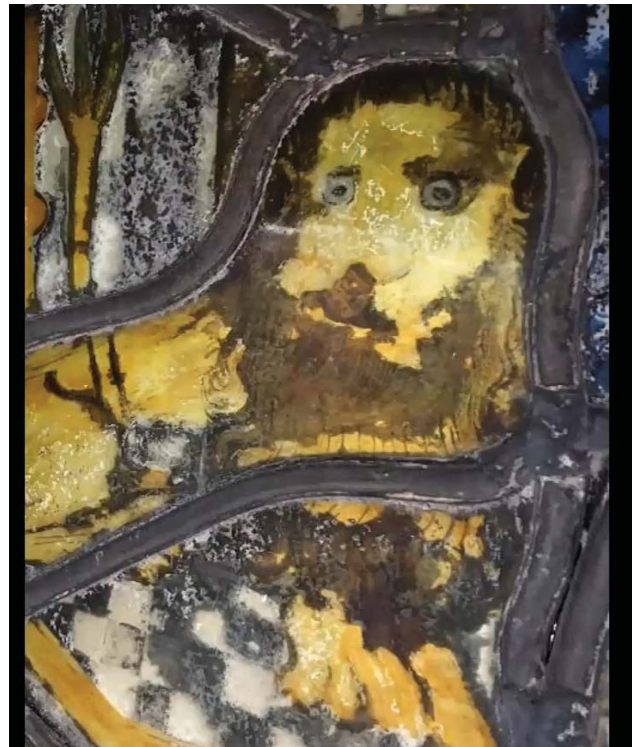
Fig. 32: Extensive paint loss in the window

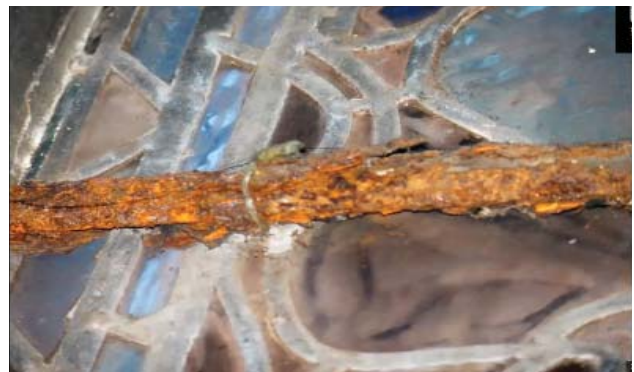
Fig. 33: Highly damaged tie bar

It was here that cross- referencing with another project at Gloucester cathedral became critical. Shown in figure 33, local damage to tie bars were being discussed. An important document in the archive at Gloucester detailed

a 19th century survey by the cathedral architect, which highlighted the installation of large coke burning Gurney stoves in many cathedrals and great houses in England. It was evident that these stoves had been installed at Winchester, and were in operation well into the 20th century. Research into the fuel, and the huge amounts burned at Winchester, allowed conservation scientists to accurately model the alteration of the surface layer to window SII, and the cause of the paint loss.

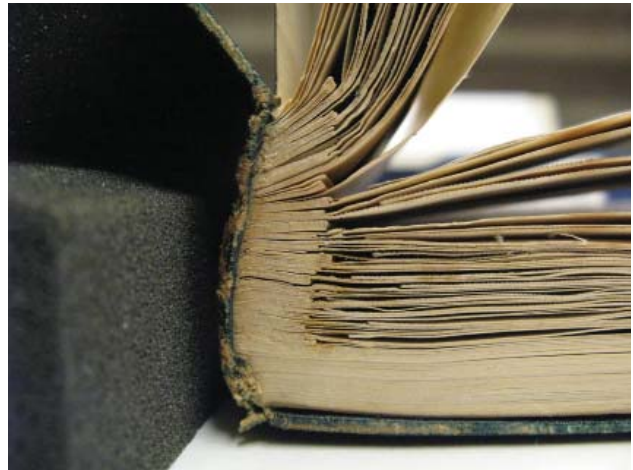
Fig. 2: Traditionally sewn album with leaves removed to accommodate addition of photographs to textblock. Author's study collection object

Bookbinders accommodated the addition of the photographs into the pages of traditionally sewn books in various ways and altered the structures to account for the thickness of the new contents in manners similar to those employed to bind volumes with intaglio or woodblock prints. Initially, leaves were removed (fig. 2), folios were back-hooked and sections were sewn with compensation stubs, these stubs approximating the thickness of anticipated additional materials.

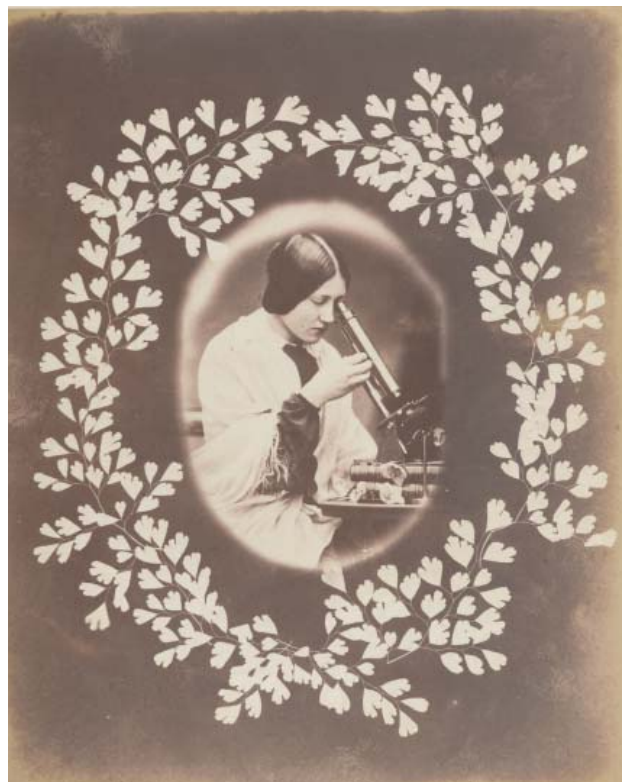
Fig. 4: Llewelyn, John Dillwyn, [Emma Charlotte Dillwyn Llewelyn's Album], 1853-1856. Image of "Theresa", edge discoloration from attachment adhesive around the edges of the print

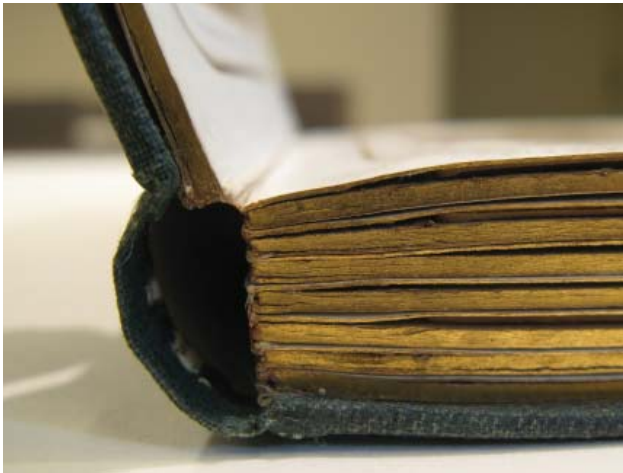
Fig. 5: Primary hinge guarded leaf structure, from tail. Osborn's Gallery, Charleston, SC [The Evacuation of Fort Sumter], 1861. 12.6 x 9.4 x 2.5 cm. The Metropolitan Museum of Art, Gilman Collection, Museum Purchase, 2005 (2005.100.1174.1-.16)

beginning in the 1860s, the larger format cabinet card albums, are found in great numbers across institution and personal collections. Though there are numerous variations in their structural details, the primary hinge album and the secondary hinge album with board stubs are two very recognizable styles. Comprising the textblock, the leaves of guarded leaf albums each consist of a board from which has been excised a recess just larger than the object to be inserted. Paper facings are adhered to both sides of the board, each of which serves as a device to frame the image beneath and as an overmat to keep the carte de visite or cabinet card in position. In albums with primary hinges, the leaves are joined one to the next with cloth or paper guards, adhered underneath the facing papers of the conjugate pages at each opening (fig. 5). In albums with secondary hinges, the board or folded cloth stubs are sewn or adhered together at the spine edge, with the board leaf then guarded to the stub (fig. 6). In both the primary and secondary hinge guarded leaf albums, the opening action relies on the continued fold endurance of the guards that hold the textblock together, rather than on the thread, spine liners, paper drape, adhesives, or other traditional methods of opening support utilized by bookbinders over the centuries. Photographs on their rigid supports are slid into position in the leaves either from the tail, or through a slit in the page front, to sit back-to-back in the recess cut from the board, each object's recto then matted for the viewer underneath the paper facing. The design of these albums allows for relatively straightforward insertion of a photograph, but they are not conducive to changing the order of prints by removing and reinserting them, which often results in damage to both the delicate images as they are slid in and out of the specifically designed recesses, and to the paper facings.

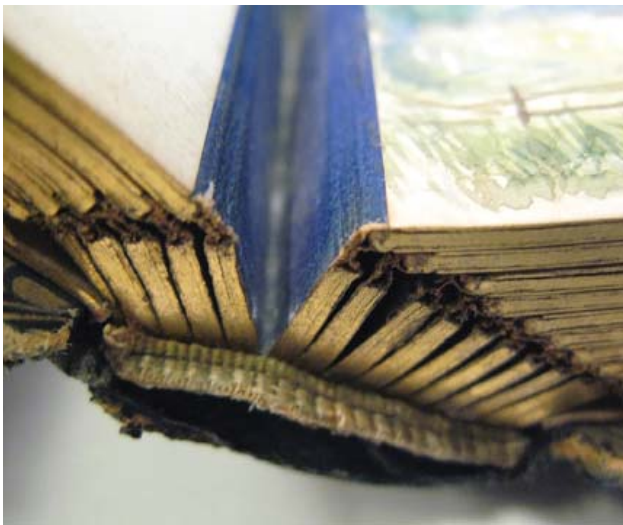
Fig. 6: Secondary hinge guarded leaf structure, from tail. Harvey, Emily Clare, [The Harvey Album], 1868. 23.8 x 19.4 x 3.8 cm. The Metropolitan Museum of Art, Purchase, The Horace W. Goldsmith Foundation Gift, through Joyce and Robert Menschel, 1998 (1998.166)

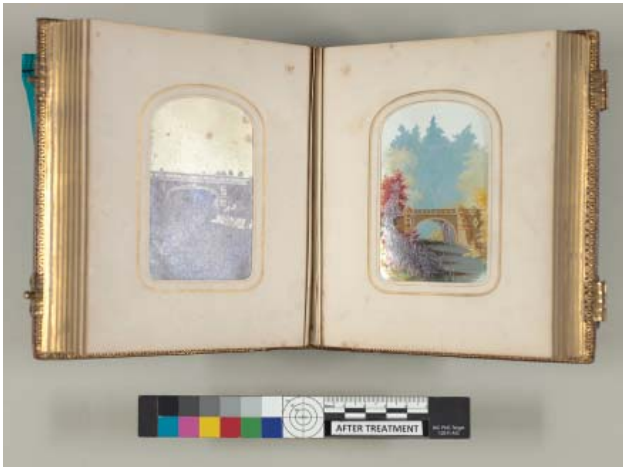
Fig. 7: Jackson, Ambrose; Stacy's Photographic Carte de Visite, Publisher, [Carte-de-visite Album of Central Park Views], 1860s. 15.4 × 13.4 × 3.9 cm. The Metropolitan Museum of Art, Bequest of Herbert Mitchell, 2008 (2015.400.199)

The *Carte-de-visite Album of Central Park Views* (figs. 7 and 8), with cartes produced in the 1860s by Stacy's Photographic Carte de Visite and gouache and varnish paintings by American artist Ambrose Jackson, is filled with images of New York City's newest treasure at the time, Central Park. The first and perhaps most famous park in the United States, Central Park was constructed between 1857-1863, years that coincided with an explosion in the popularity of the carte de visite. The *Carte-de-visite Album of Central Park Views* is bound in full maroon leather, with a blind raised pattern on front and back boards, and two brass clasps at the fore-edge that swing from the back to the front board. The guarded leaf structure of this album's textblock is constructed with folded compensation stubs made from cloth, the extension of which serves to attach the stiff leaves of the book block at the secondary hinges.

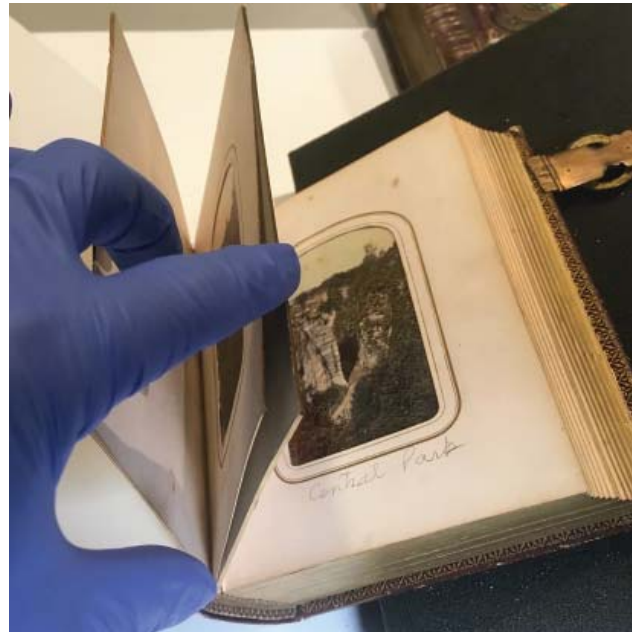
Fig. 8: Jackson, Ambrose; Stacy's Photographic Carte de Visite, Publisher, [Carte-de-visite Album of Central Park Views], 1860s. Paper facing lifting away from board

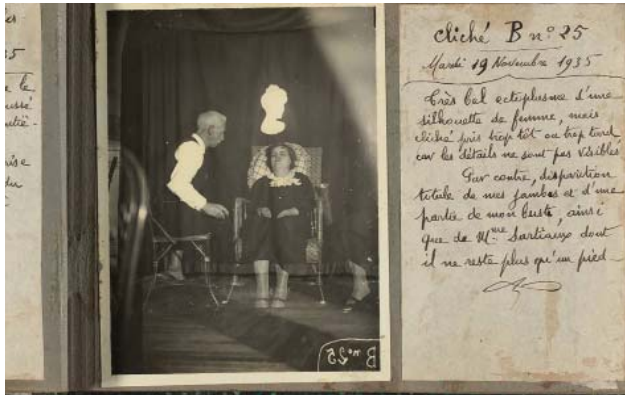
Fig. 9: *Unknown*, [Album from the Archive of the French Medium Henri Matthouillot], 1920-1938. Side sewn album with gelatin silver prints and manuscript descriptions. 11 x 7.9 x 1.5 cm. The Metropolitan Museum of Art, Gilman Collection, Gift of The Howard Gilman Foundation, 2005 (2005.100.383.2)

The single sheets of the small side-sewn volume [*Album from the Archive of the French Medium Henri Matthouillot*] from 1920-1938 (fig. 9), are bound with a cord laced through two holes that extend through the cover and the textblock. Gelatin silver prints are mounted overall, recto and verso throughout, adjacent to lengthy manuscript ink notations written on slips of paper. A very simple structure, its

continued function relies on the fiber strength of the textblock paper, and the continued fold endurance of the leaves and cloth spine covering, where all of the opening action occurs. The gelatin silver photographs in this album are quite stable, but they are mounted side by side with their descriptions and when the volume is closed, the adhesives and the inks rest in contact with the conjugate photographs' surfaces. The loosely side-sewn structure offers limited planar stability for the album, and the user must be careful to avoid allowing the delicate and glossy surfaces of the photographs to rub against one another or the mounted annotations. With prints adhered almost to the fore-edges on each verso, the user risks touching the faces of the photographs in turning the leaves unless aware of the layout before handling. This is a good example of when to include handling instructions on the protective enclosure labeling.

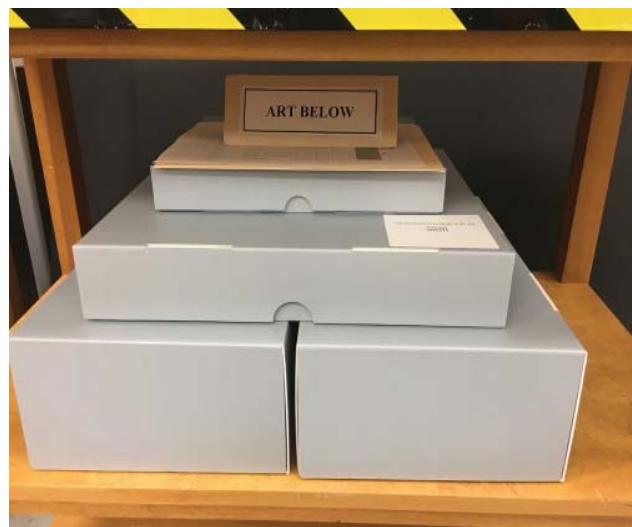
Fig. 10: Heritage® board protective enclosures for volumes containing photographs

Providing protective enclosures for albums made from Heritage® or other similarly tested board (fig. 10), (rather than housing them in cloth-covered drop spine boxes), ensuring that storage and exhibition materials have passed the Oddy test and Photographic Activity Test, and maintaining a stable environment during storage, research, and display will result in

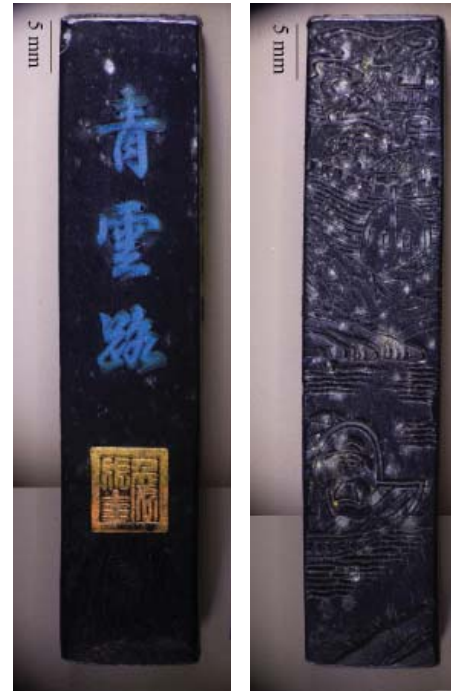
Fig. 2: Wang Jin Sheng (汪近圣), Chinese Ink Stick 青云路, Qing Dynasty, 1cm x 5cm x 0.5cm, from the Charles Roberson & Co. Presentation Box for the Department of Science and Art, Art Materials Research and Study Center at the National Gallery of Art, Washington, D.C.. Photomicrography by Tammy Hong

This story on nineteenth-century ink began with a presentation box by renowned British artists' materials manufacturer Charles Roberson & Co. housed in the Art Materials Research and Study Center at the National Gallery of Art (Fig. 1). This presentation box that dates to the latter half of the nineteenth-century was made for the Department of Science and Art, a government sanctioned body that administered the British arts education system from 1853 to 1899. The box's compartments held ten watercolor cakes embossed with the Roberson emblem, six brushes, a ceramic mixing palette, and most conspicuously, a Chinese ink stick (Fig. 2) from the Qing Dynasty ink studio, Wang Jin Sheng (汪近圣).¹ An initial exami-
