CONSERVATION INSIGHTS 2020

Lectures

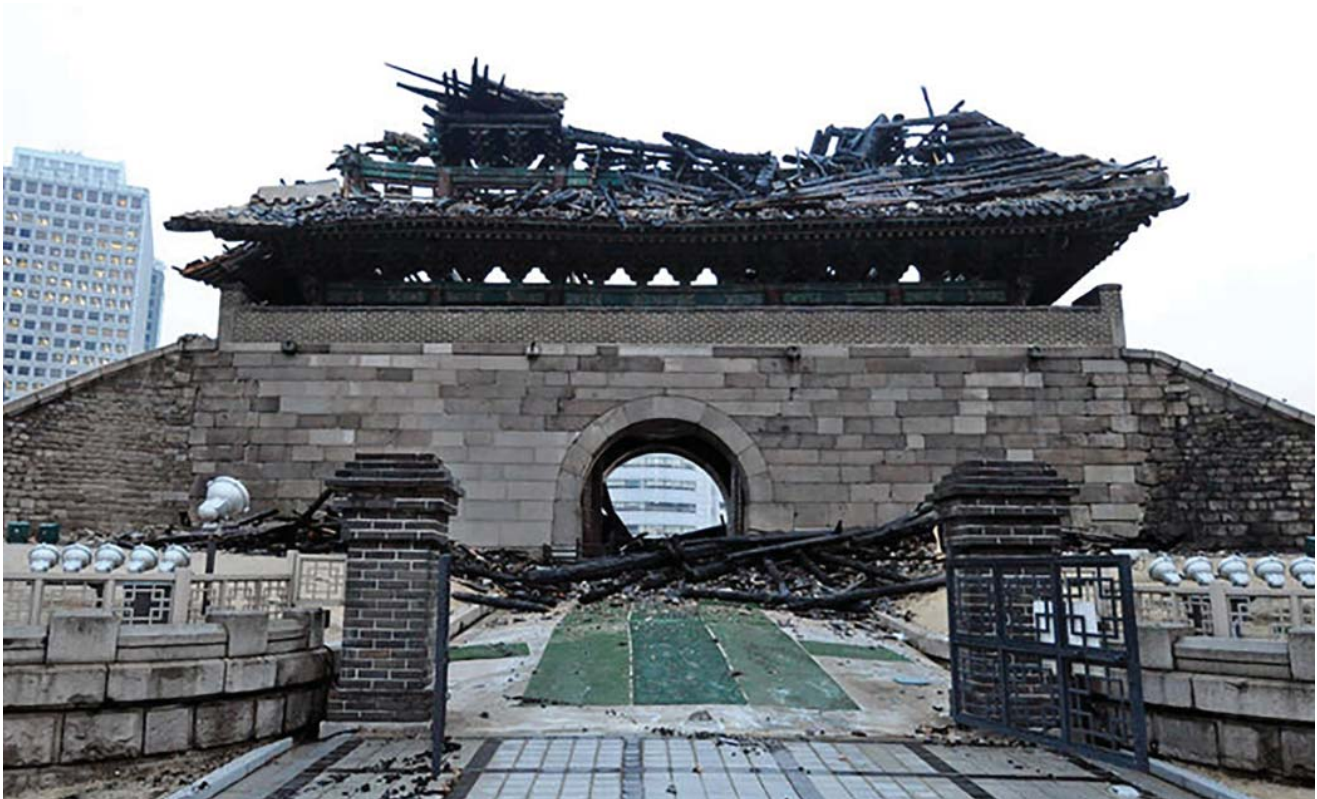
Fig. 8: Sungnyemun after the 2008 fire

An example of deliberately making life difficult in a conservation context is the restoration of Sungnyemun a 14th century ceremonial gateway in Seoul, South Korea. This monument was severely damaged by fire. (Fig 8.) The subsequent restoration was carried out using traditional methods and materials, scrupulously avoiding any use of modern mechanical methods. Even the iron tools for stone-cutting were made on site using traditional skills.
